ACCIDENTS INVESTIGATION BRANCH
Department of Trade and Industry

Hawker Siddeley HS 748 Series 2
aircraft G-A TEK and G-A TEH
of Channel Airways
Report on the accidents at Portsmouth Airport,
Portsmouth, Hampshire on 15 August 1967

Civil Accident Combined Report Nos EW/C/0179 and EW/C/0180

Aircraft: Hawker Siddeley HS 748, Series 2, G-A TEK and G-A TEH

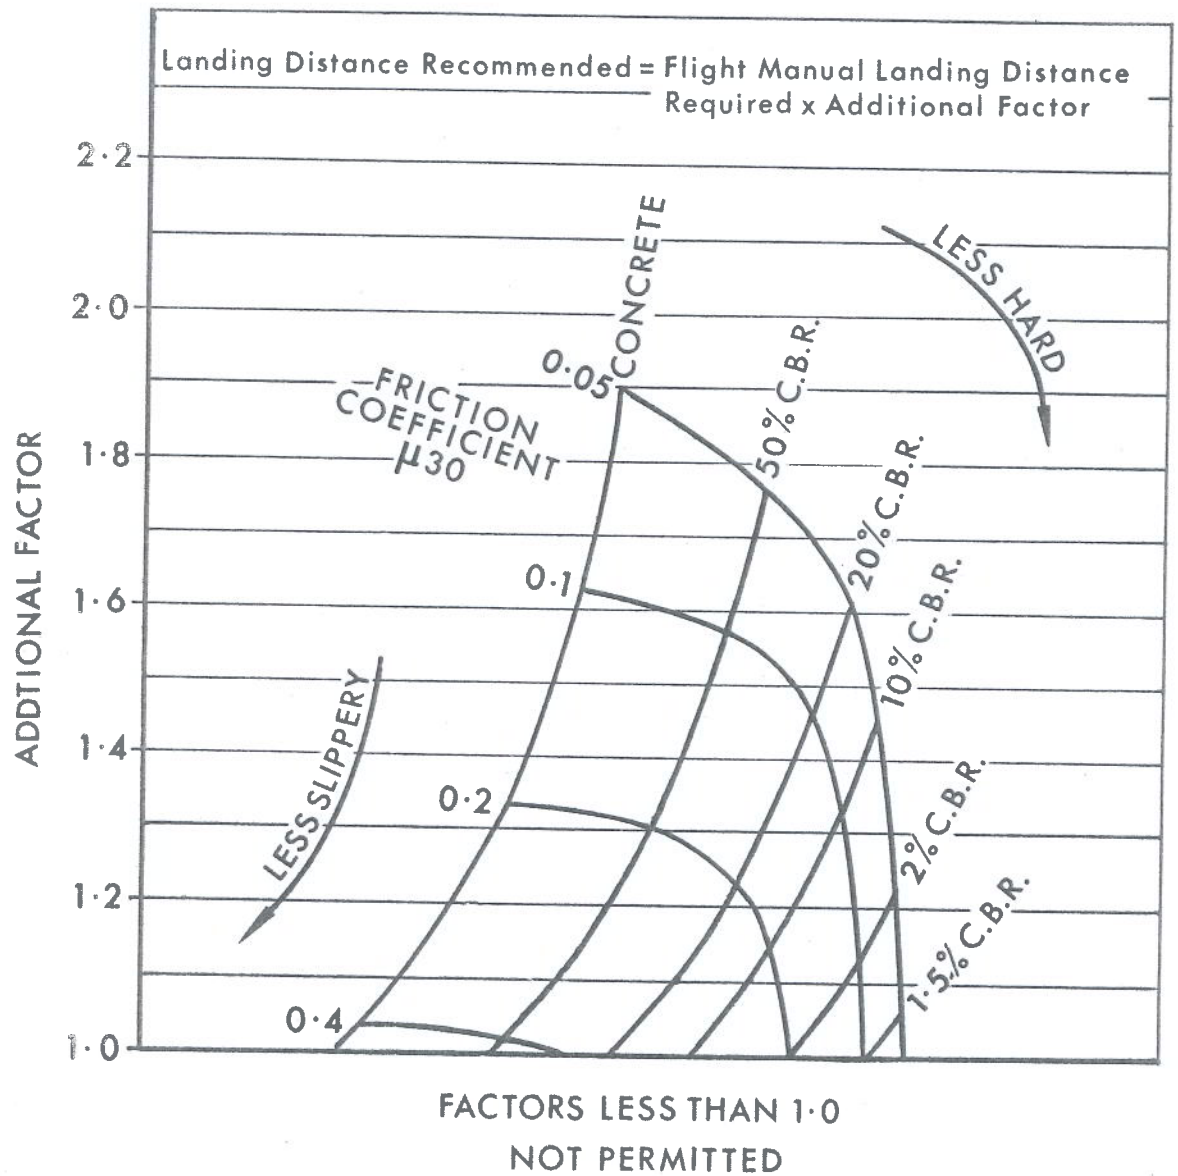
FIGURE 1

Figure 1 has been constructed on the basis of the tests results to show the additional factor recommended. Surface friction and hardness are expressed in the way they were measured during the tests, i.e., friction coefficient at 30 m.p.h., μ 30, and hardness as California Bearing Ratio (CBR) at a depth of 3 ins. The conditions covered in the tests, and the estimated conditions applying at the time of the two incidents, are listed in the following tables :—

It will be noted that the only conditions likely to require an additional factor on the landing distance are a combination of a hard surface and a very low friction coefficient, e.g. an ice covered paved runway or an unpaved runway with very hard sub-soil and a thin slippery layer on top. On such surfaces the high drag from the discing propellers and the large flaps rapidly reduces the aircraft speed from touchdown to about 40 knots. By this speed the propeller drag has fallen to a low value and changes to a small thrust as the speed approaches zero. This characteristic, common to all Dart engine/propeller combinations, causes the final part of the ground run to increase considerably on the slippery surface.

EFFECT OF SURFACE FRICTION AND HARDNESS ON LANDING DISTANCE REQUIRED
