Accidents Investigation Branch
Civil Aircraft Accident Report No EW/B 122

Aviogenex Aircraft TU-134 A, YU-AHZ.
Report on the Catastrophy which occurred
at 'RIJEKA' Airport, Yugoslavia, on
23 May 1971

REPORT ON THE CATASTROPHY OF AVIOGENEX AIRCRAFT

DIRECTORATE GENERAL OF CIVIL
AERONAUTICS

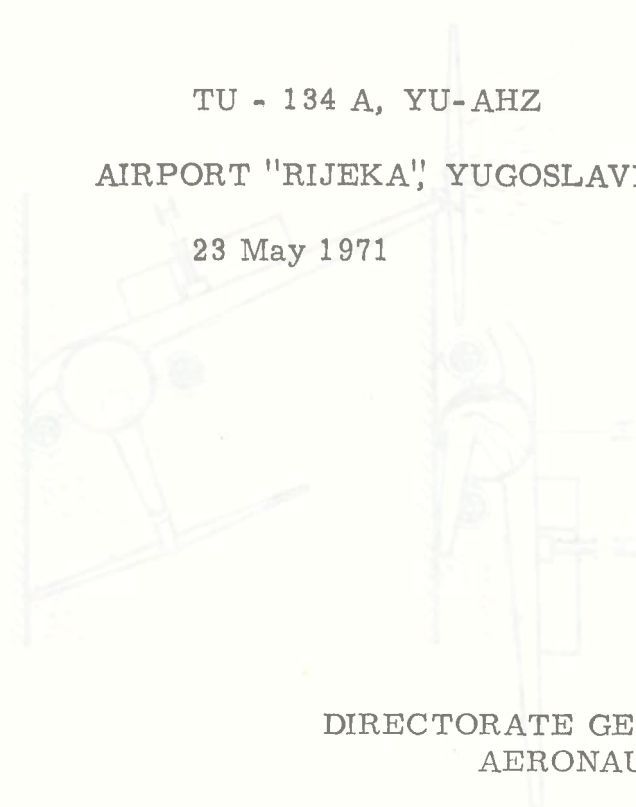
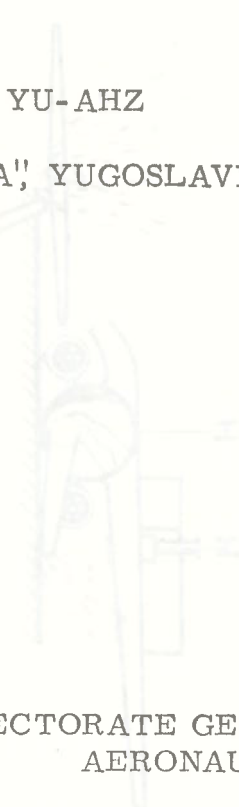
SKETCH No. 1

SURVEY OF LOADING AND
RUPTURE OF THE AIRCRAFT YU-AHZ
SKETCH

The aircraft touched the runway at a speed of 260 km/h and afterwards the right wing broke, the aircraft turned over and the fire broke out (Figure No. 2). In the ensuing fire, the aircraft burned out together with the passengers.

- the initial failure occurred in the right wing between the sixth and seventh rib because of the combined loads on the attachment point of the landing gear to the wing.

Fire broke out 0,45 sec after the first touchdown of the right leg, at the moment when inner portion of the right wing flap touched the runway. The Figure No. 2 depicts the wreckage of the right wing, wreckage of tail surface and turning over of the aircraft. Fuel leaked out of the broken right wing onto the runway and was immediately set on fire by sparks which resulted from the contact of the flaps with the runway. At the same moment the fire-fighting system was automatically activated. The system carried out its function and prevented fire in both engines as well as on the APU in the tail cone. Besides extinguishing the fire, the system also disconnected the electrical power supply from main power supply source and closed the ventilation of the generators.
