Air Accidents Investigation Branch

**Report on the accident to
Sikorsky S-61N, G-BEWL
at Brent Spar, East Shetland Basin
on 25 July 1990**

This investigation was carried out in accordance with
The Civil Aviation(Investigation of Accidents) Regulations 1989

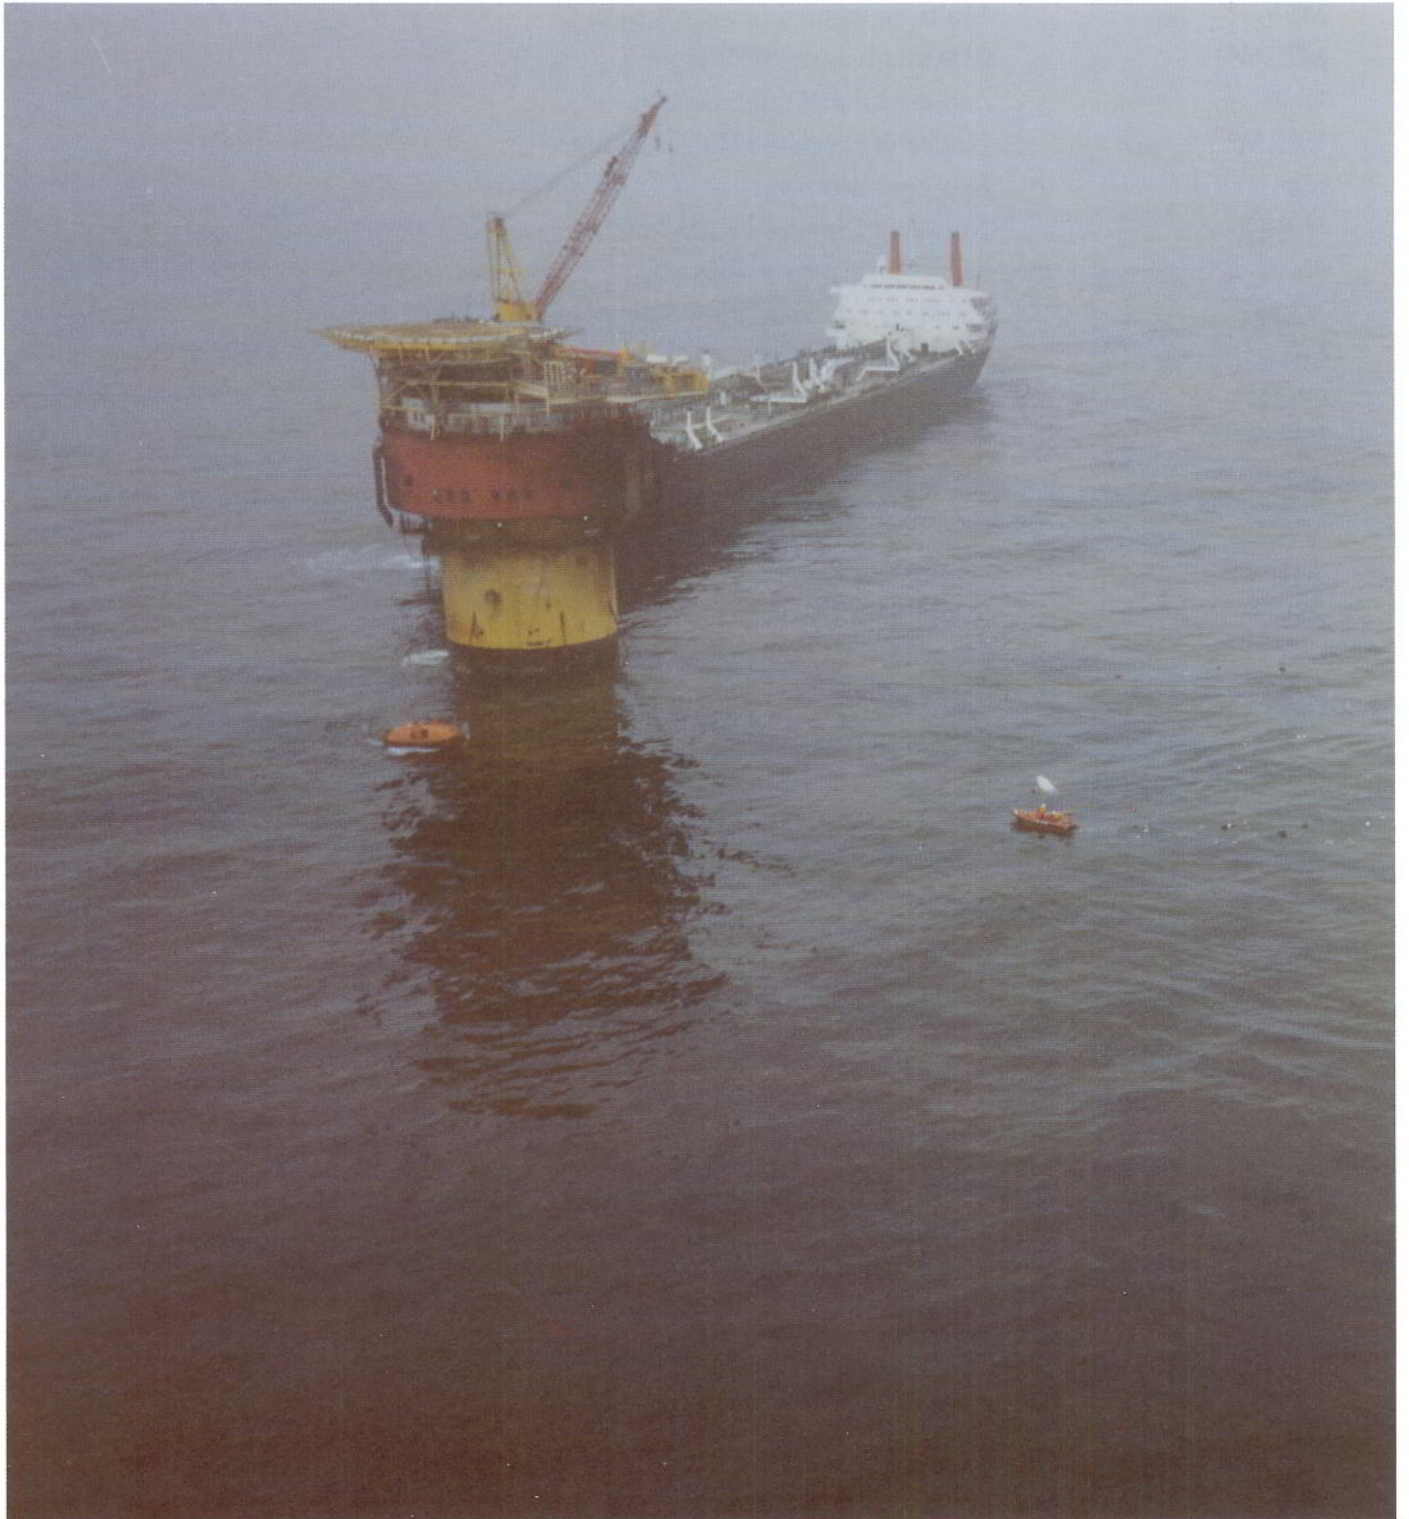
Brent Spar at approximately 0950 hrs. on 25 July 1990.
