Fragmentation and other damage features of the fan of No.1 engine from G-OBME

Aircraft Type and Registration:	Boeing 737-400, G-OBME	
No & Type of Engines:	2 CFM 56-3C high by-pass turbo-fan engines	
Year of Manufacture:	1988	
Date and Time (UTC):	8 January 1989 at 2025 hrs	
Location:	Kegworth, near East Midlands Airport, Leicestershire	
Type of Flight:	Scheduled passenger	
Persons on Board:	Crew - 8	Passengers - 117 + 1 infant
Injuries:	Crew - 7 (serious)	Passengers - 47 (fatal).
	1 (minor)	66 + 1 infant (serious)
		4 (minor)
Nature of Damage:	Aircraft destroyed	
Commander's Licence:	Airline Transport Pilot's Licence	
Commander's Age:	43 years	
Commander's Total Flying Experience:	13180 hours (of which 765 were on Boeing 737-300/400 types)	
Information Source:	AAIB Inspector's Investigation under the Civil Aviation (Investigation of Accidents) Regulations 1983

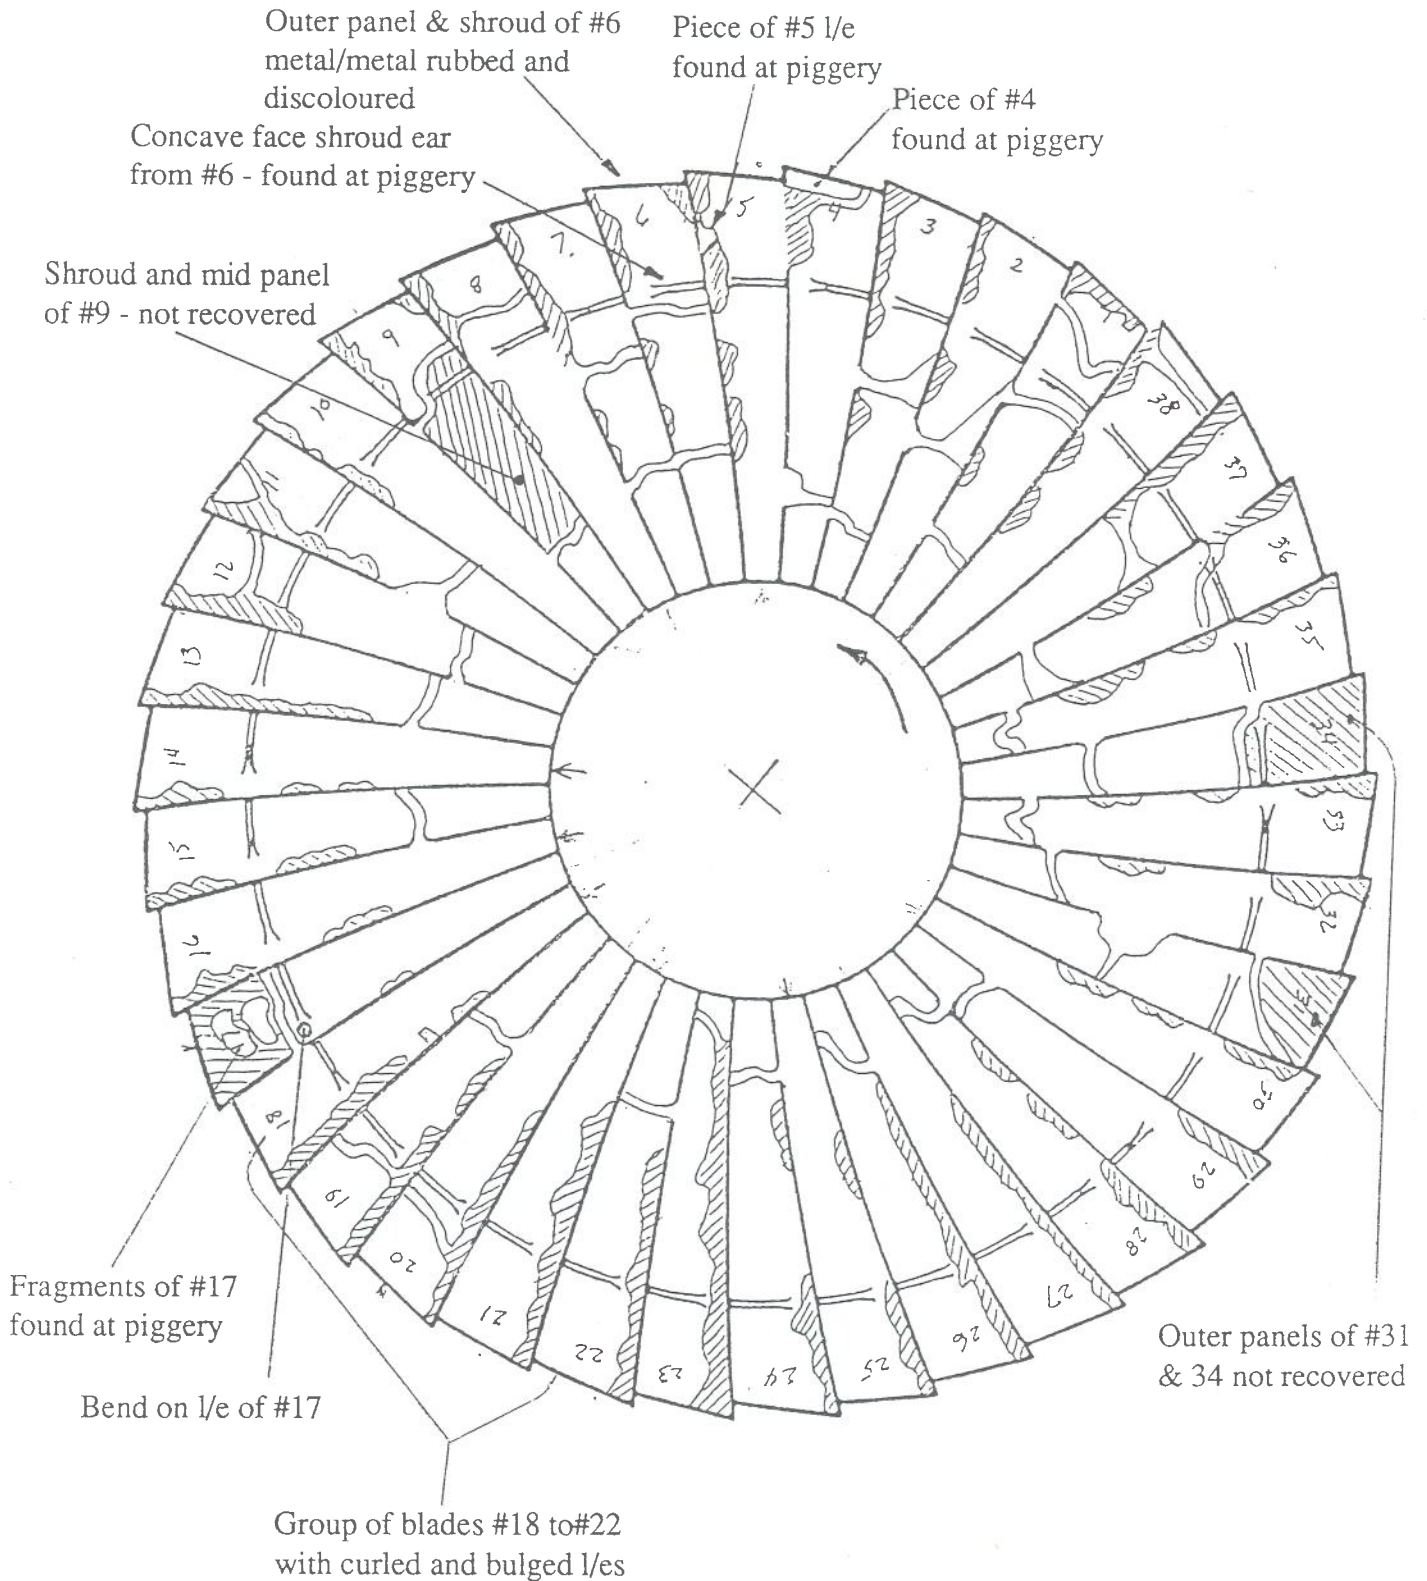
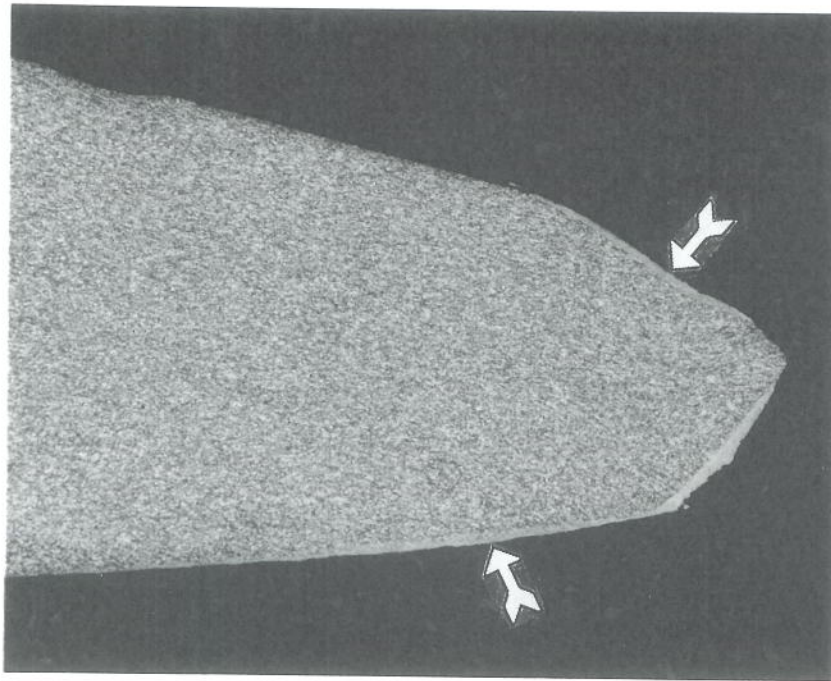
Figure 3

Microsection through the leading edge of blade 17 immediately below the plane of the fatigue crack.

This shows the even microstructure of the blade material as a whole and where the microstructure has been modified by high energy impacts.

The arrows point to the pressure (lower) and suction face impact facets where a shallow modified layer can be seen. The leading edge itself shows a much deeper bright modified layer.

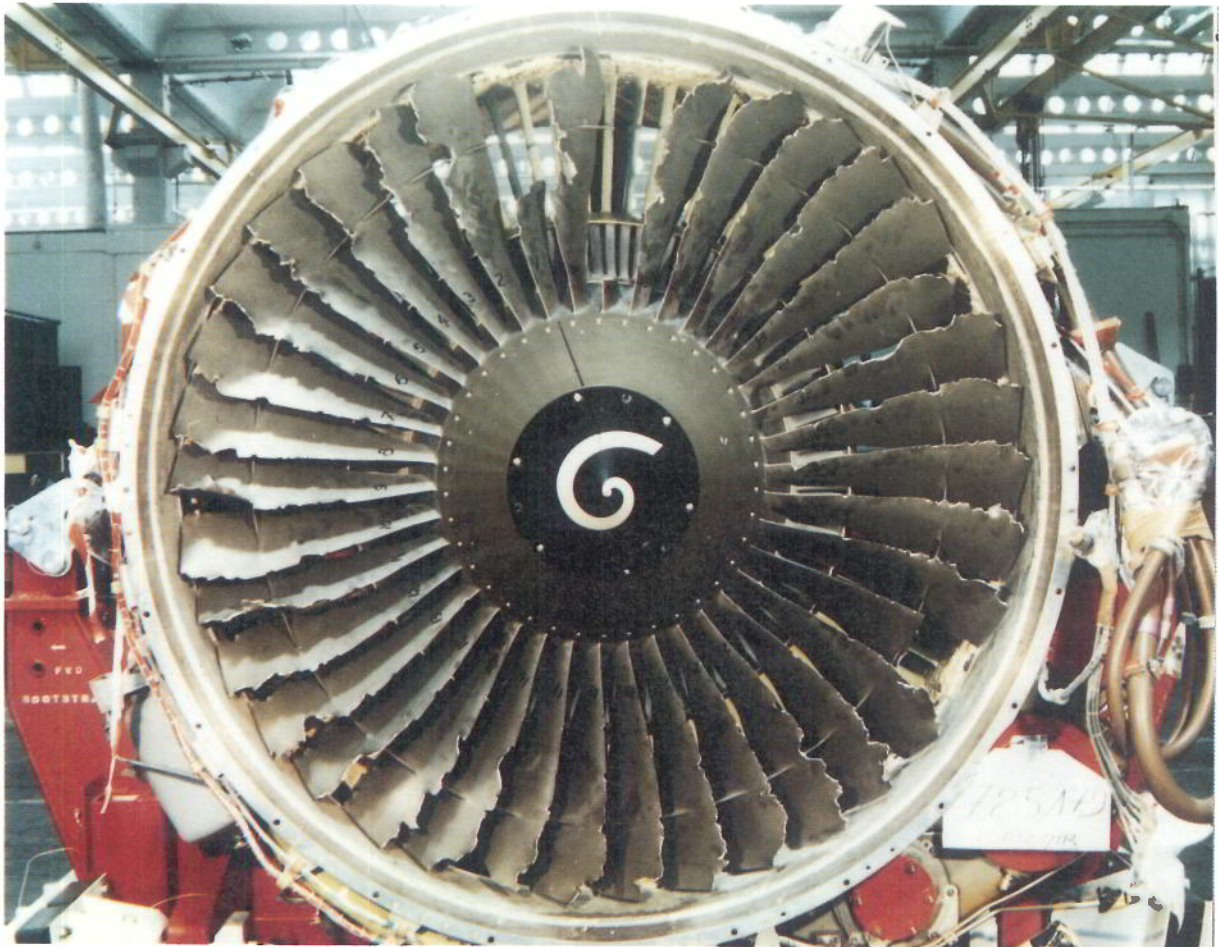
Figure 4(a)

View on front of fan of G-BNNL after in-flight fan blade outer panel separation showing the very severe leading edge damage to all the remaining blades.

Note also, at the 12 o'clock position where a full blade and a half blade have been broken away.

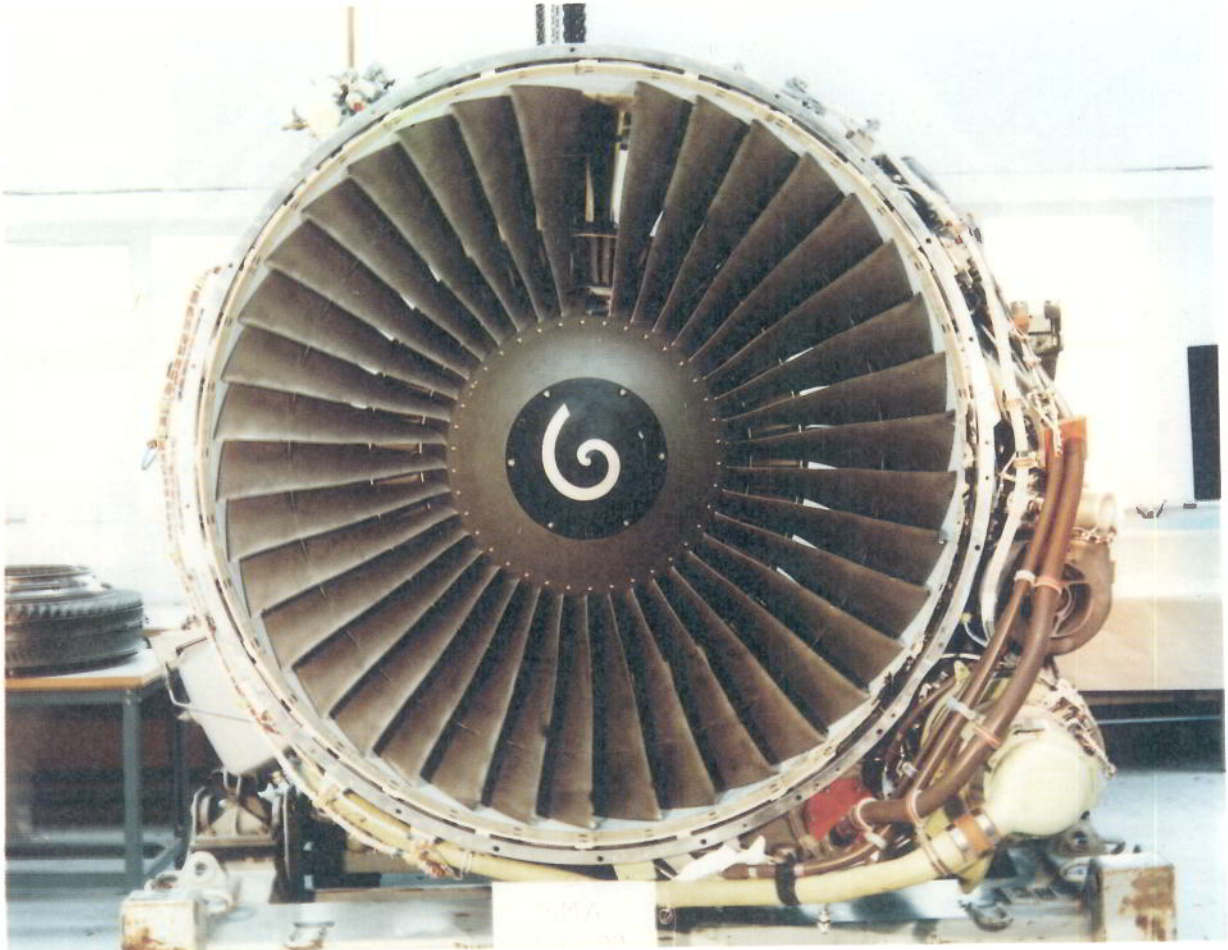
Figure 4(b)

View on front of fan of G-OBMG after in-flight fan blade outer panel separation showing the nearly total absence of leading edge damage on all the remaining blades.

The blade which suffered outer panel separation has been removed from the 12 o'clock position.

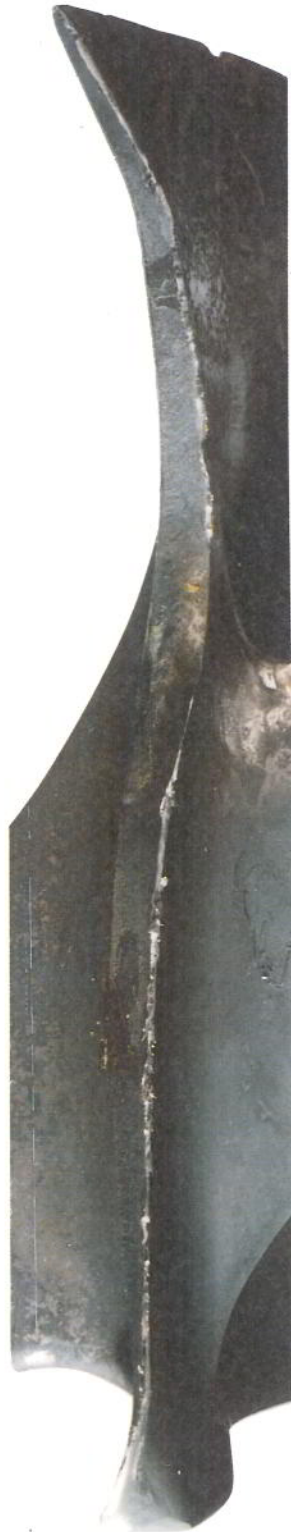
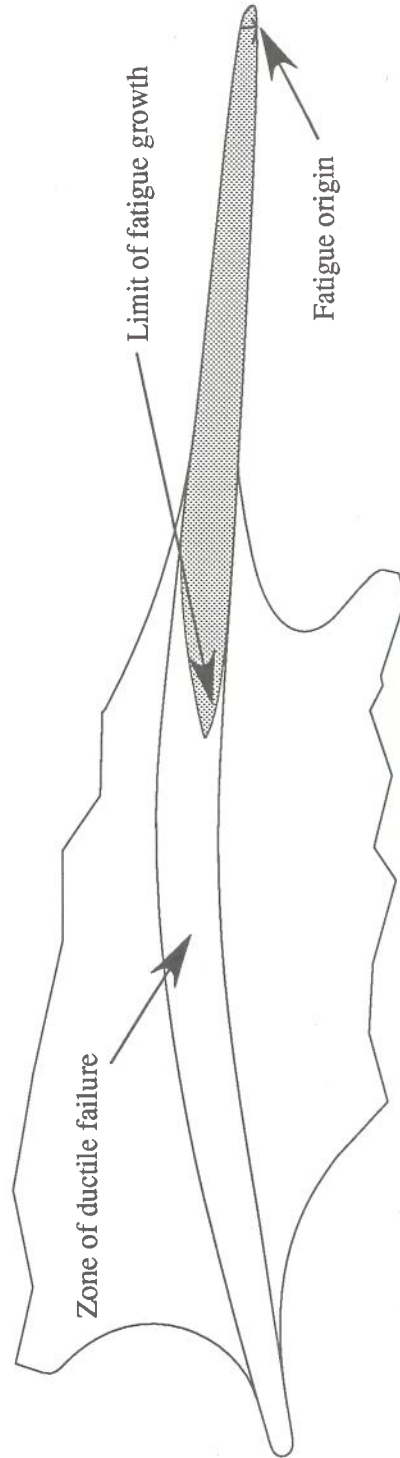
Appendix 1 Fig 6

Features of fan blade fracture from G-OBME

Inspection of the fan assembly of the No.1 (left) engine showed extensive damage had occurred to the titanium alloy blades, with many associated damage-induced overstressing failures. One fan blade was found to have fractured outboard of the "mid-span shrouds", due to a progressive fatigue failure originating near the leading edge of this blade, adjacent the pressure face. This failure had released the outer "panel" (approximately 4 inches) of this blade. The cause of this fatigue failure, which was the only instance of fatigue fracture found amongst the fan blades, is being pursued.

3. The Civil Aviation Authority, in conjunction with the engine manufacturer, consider instituting inspection procedures for the examination of the fan stage of CFM 56 engines to ensure the early detection of damage that could lead to the failure of a blade.
4. The Civil Aviation Authority review the advice given in the Boeing 737-400 Maintenance Manual concerning the excessive generation of heat during blending operations with power grinding and blending tools.

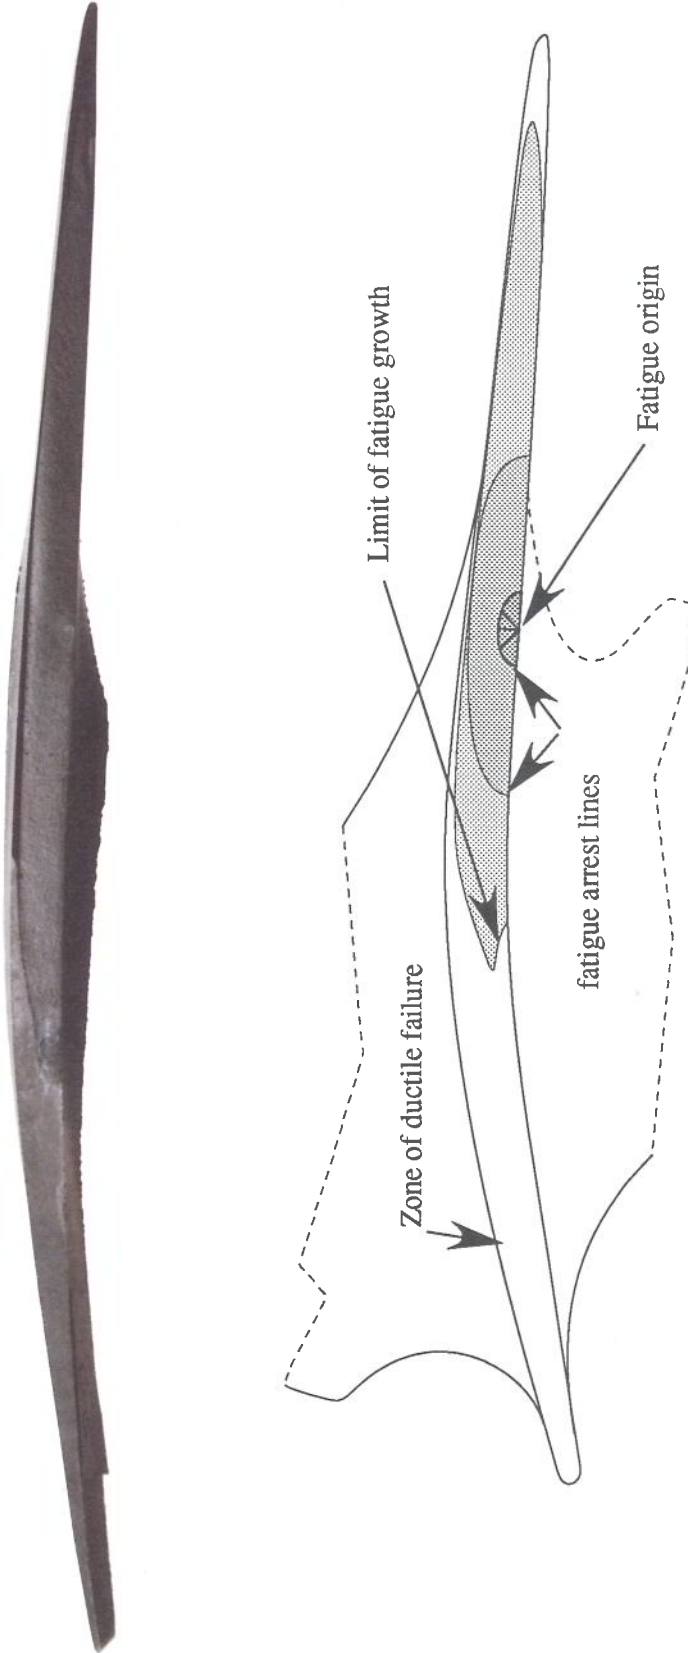
Appendix 1 Fig 7

Features of fan blade fracture from G-BNNL

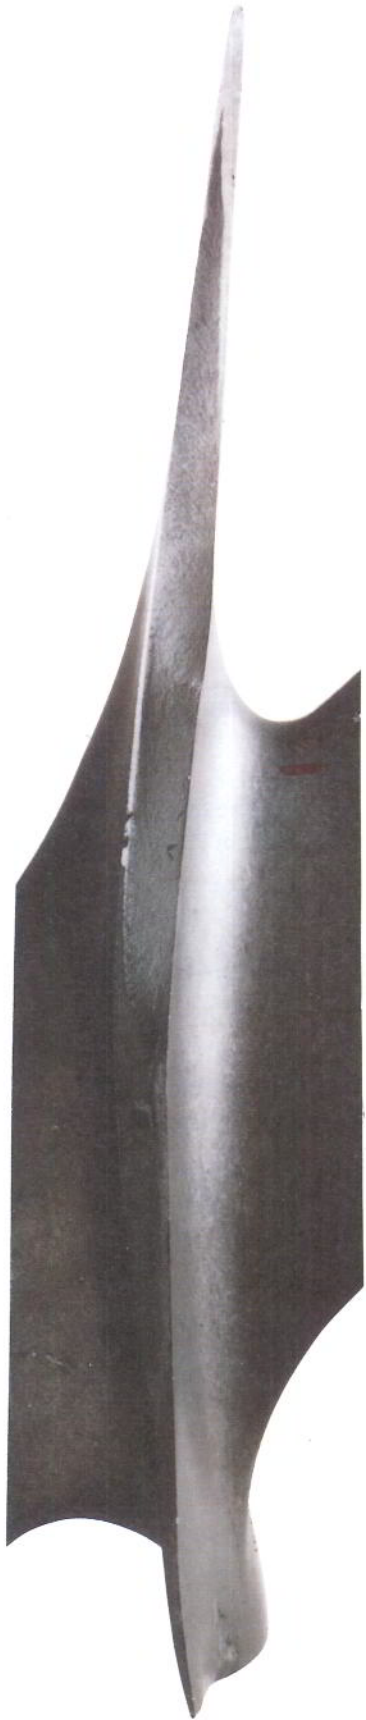
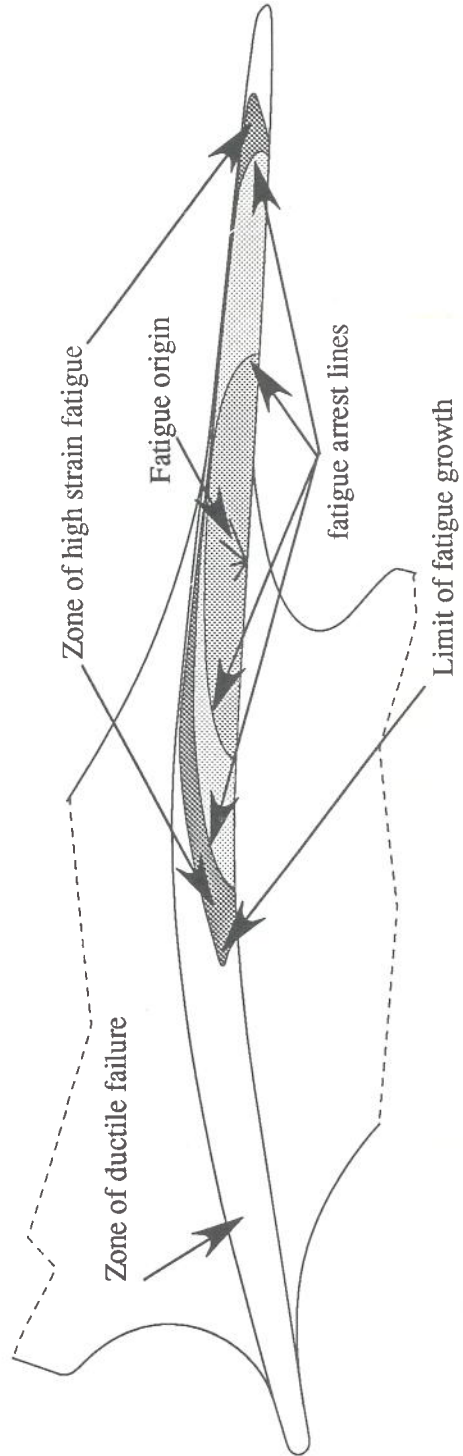
Appendix 1 Fig 8

Features of fan blade fracture from G-OBMG

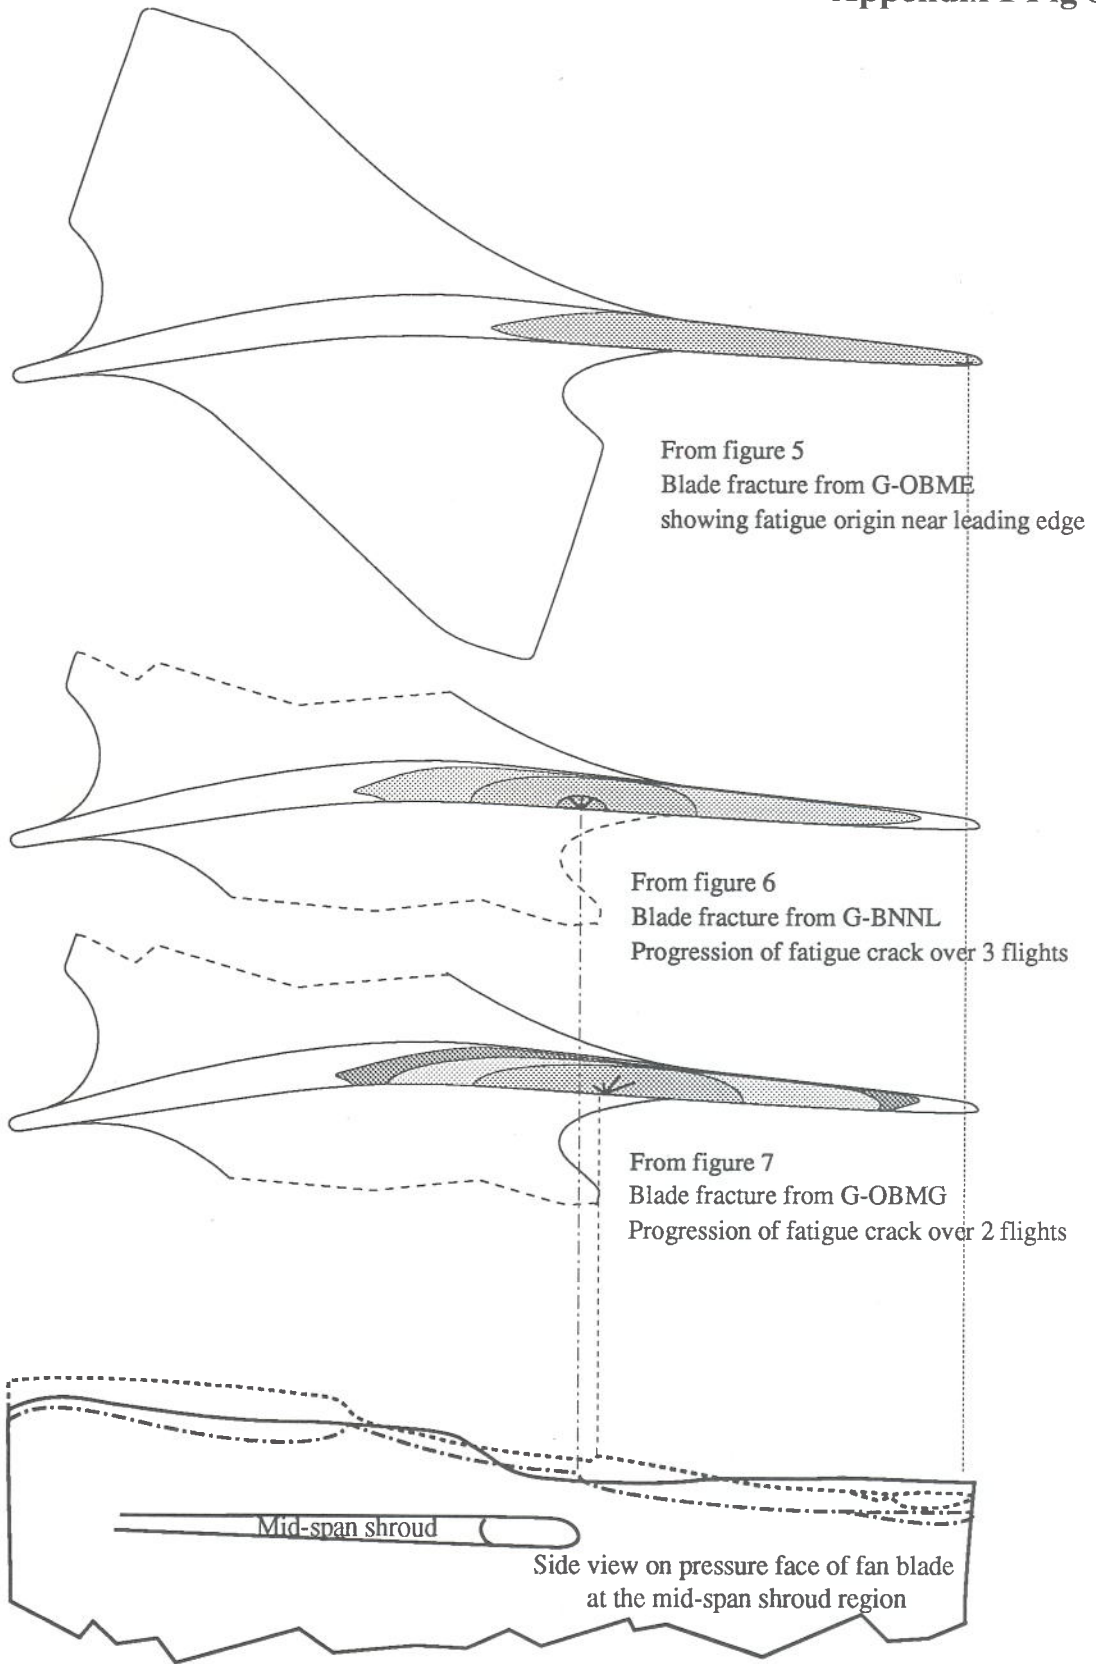
Comparison of fracture lines on 3 fan blades

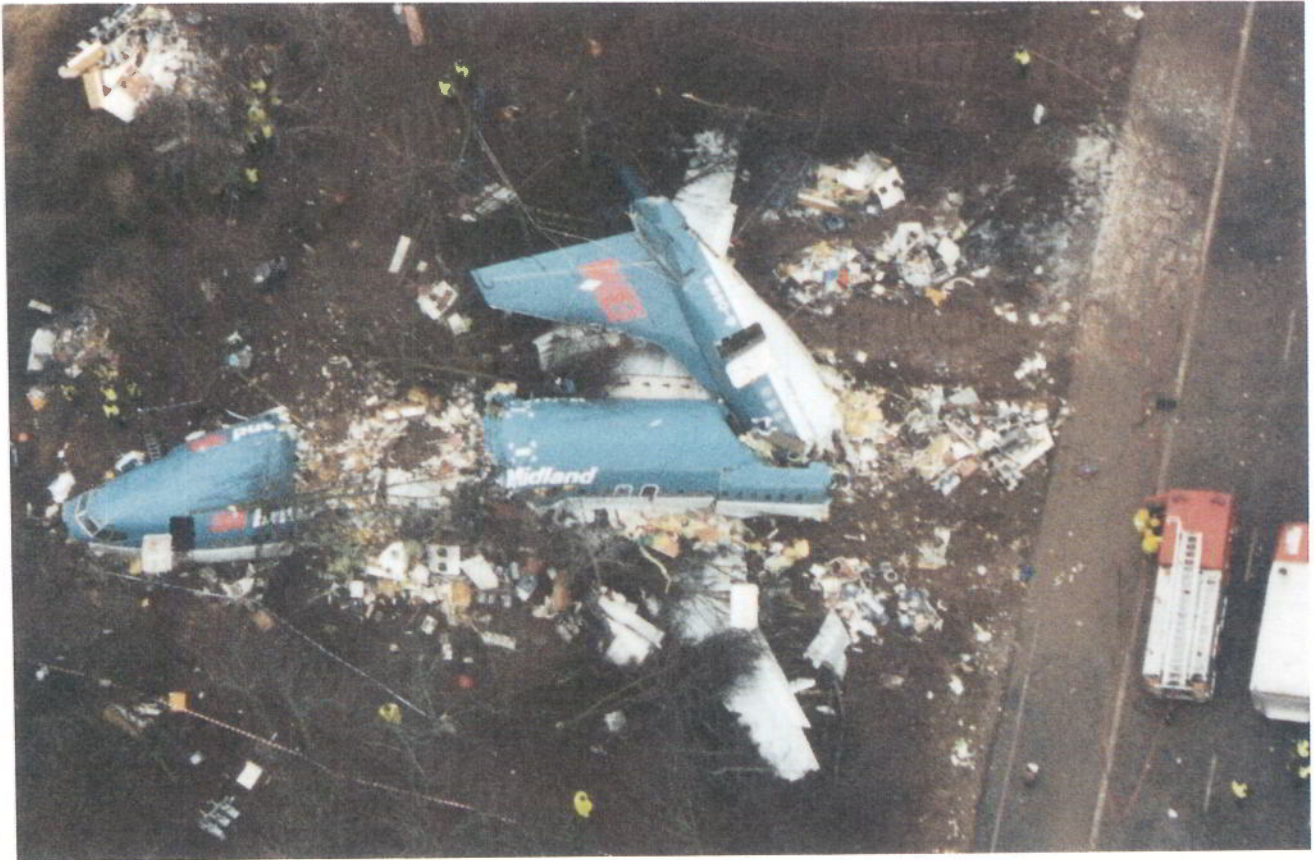
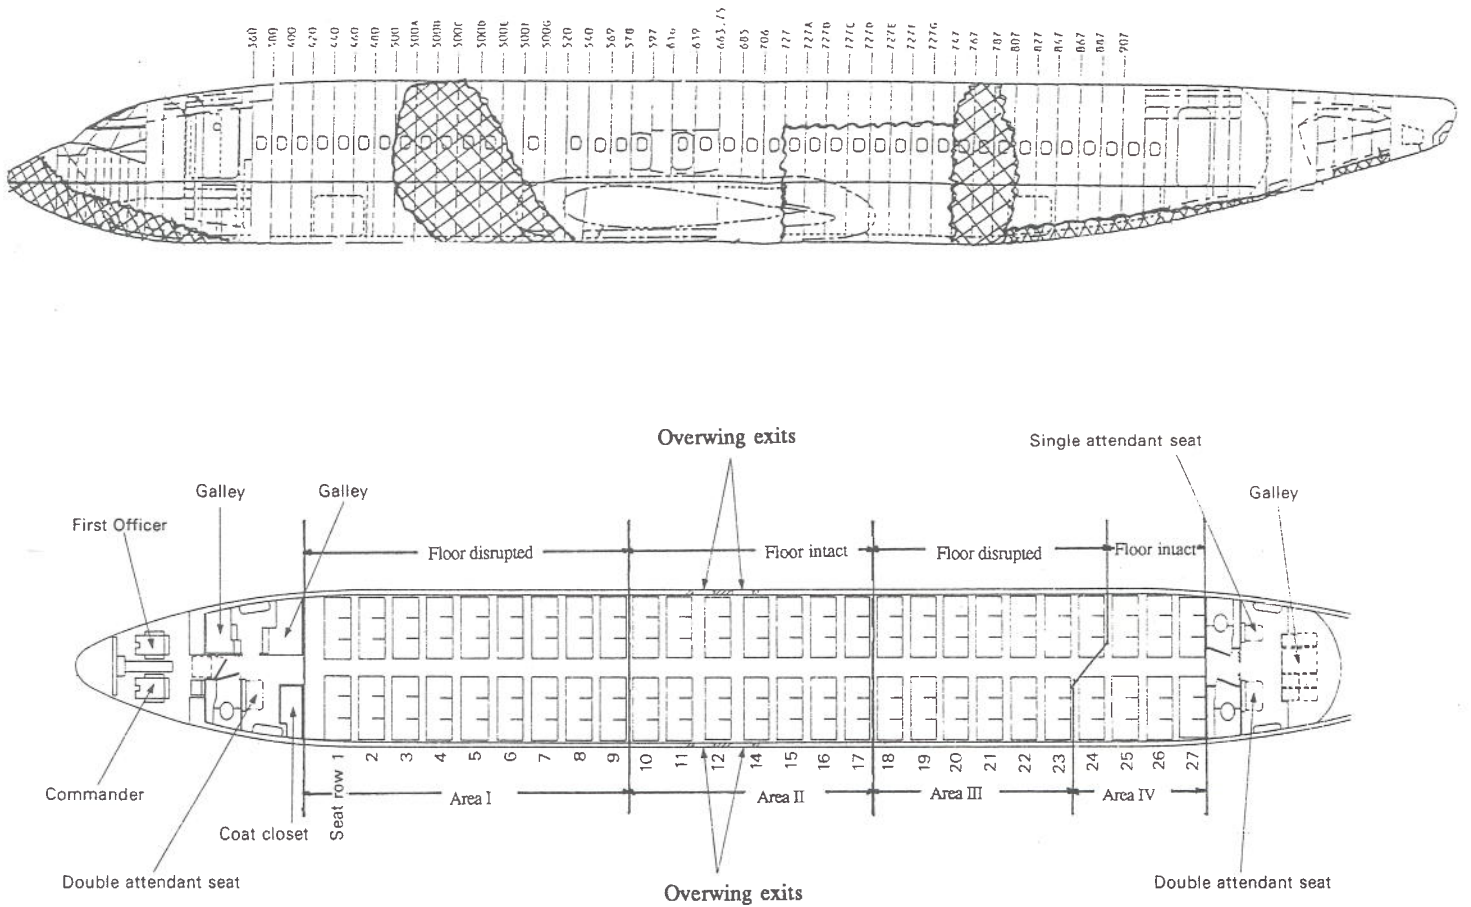
Appendix 3, figure 7 - Structural disruption

Area of cabin (fig. 7)	Triple Seats		Rear legs			Front legs							Seat backs		
	Row Nos. in area	Triples	Attachment to track			Attachment to front seat spar				'U' - strap deformation				Attachment to seat	
			Identified	Attached	Detached	Identified	Fully attached	Partially attached	Detached	Identified	Pristine	Deformed	Collapsed	Attached	Detached
I	1-9	18	33	27(82%)	6(18%)	35	17(49%)	12(34%)	6(17%)	35	4(11%)	18(51%)	13(37%)	46(85%)	8(15%)
II	10-17	14	28	28(100%)	0(0%)	28	23(82%)	5(18%)	0(0%)	27	5(19%)	2(7%)	20(74%)	56	0
III	18-23L/24R	13	25	18(72%)	7(28%)	24	7(29%)	13(54%)	4(16%)	24	5(21%)	14(58%)	5(21%)	(Fuselage buckle) 1 20 (Other) 17	
IV	24L/25R-27	7	14	14(100%)	0(0%)	14	14(100%)	0(0%)	0(0%)	14	13(93%)	1(7%)	0(0%)	14	0

Examination of the fuselage showed that two major structural failures had occurred in the impact, one slightly forward of the wing leading-edge and one aft of the wing trailing-edge. These had respectively resulted in the fuselage nose section becoming detached from the centre section and the tail section buckling over, and to the right of, the centre section. The forward fuselage had therefore sustained a high degree of disruption in the passenger cabin, with floor structure, seats and furnishings becoming detached; similar damage had occurred around the aft fuselage failure. The floor structure and seating were much less disrupted in the centre (*ie* over-wing) section of the cabin and in the inverted tail section.
