Air Accidents Investigation Branch

**Report on the serious incident to
Boeing 777-236, G-VIIR
at Robert L Bradshaw
International Airport
St Kitts, West Indies
on 26 September 2009**

Air Accidents Investigation Branch**Aircraft Accident Report No: 4/2010 (EW/C2009/09/04)**

Aircraft Type and Model: Boeing 777-236

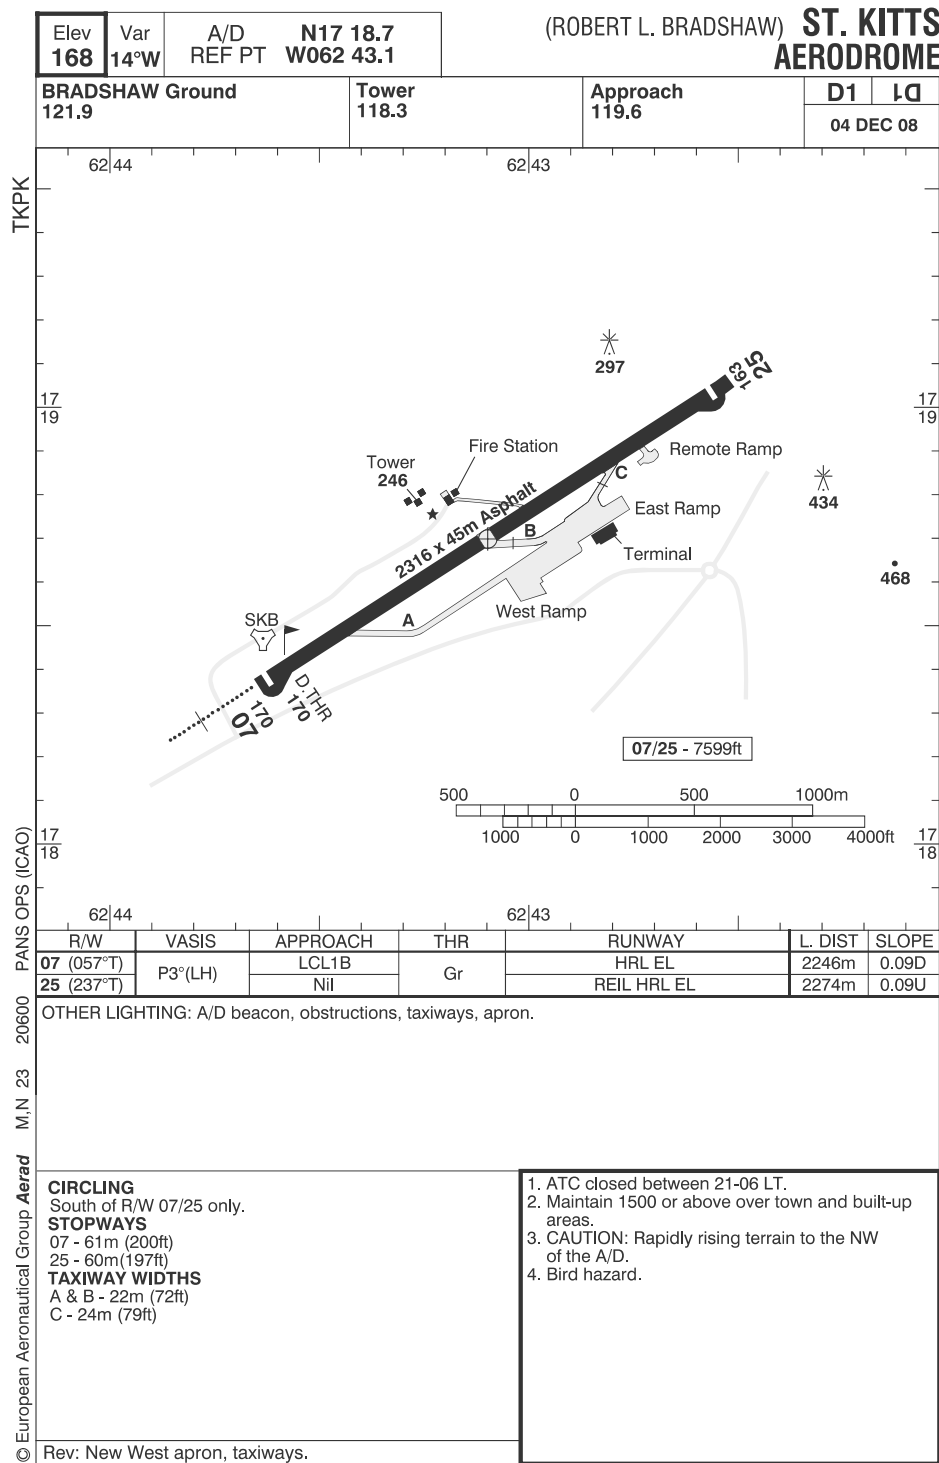
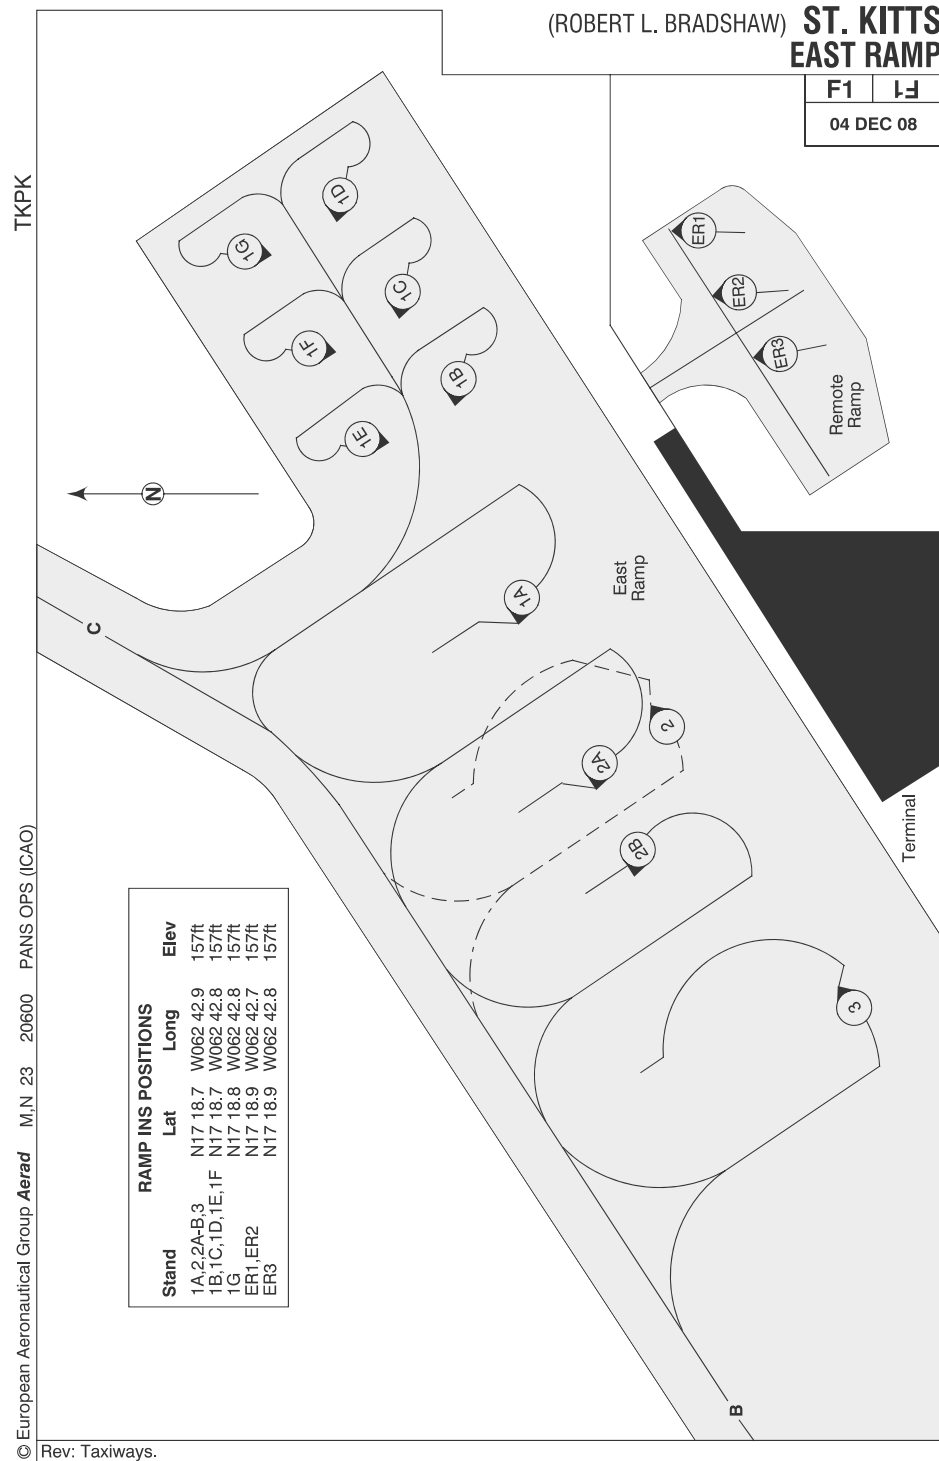
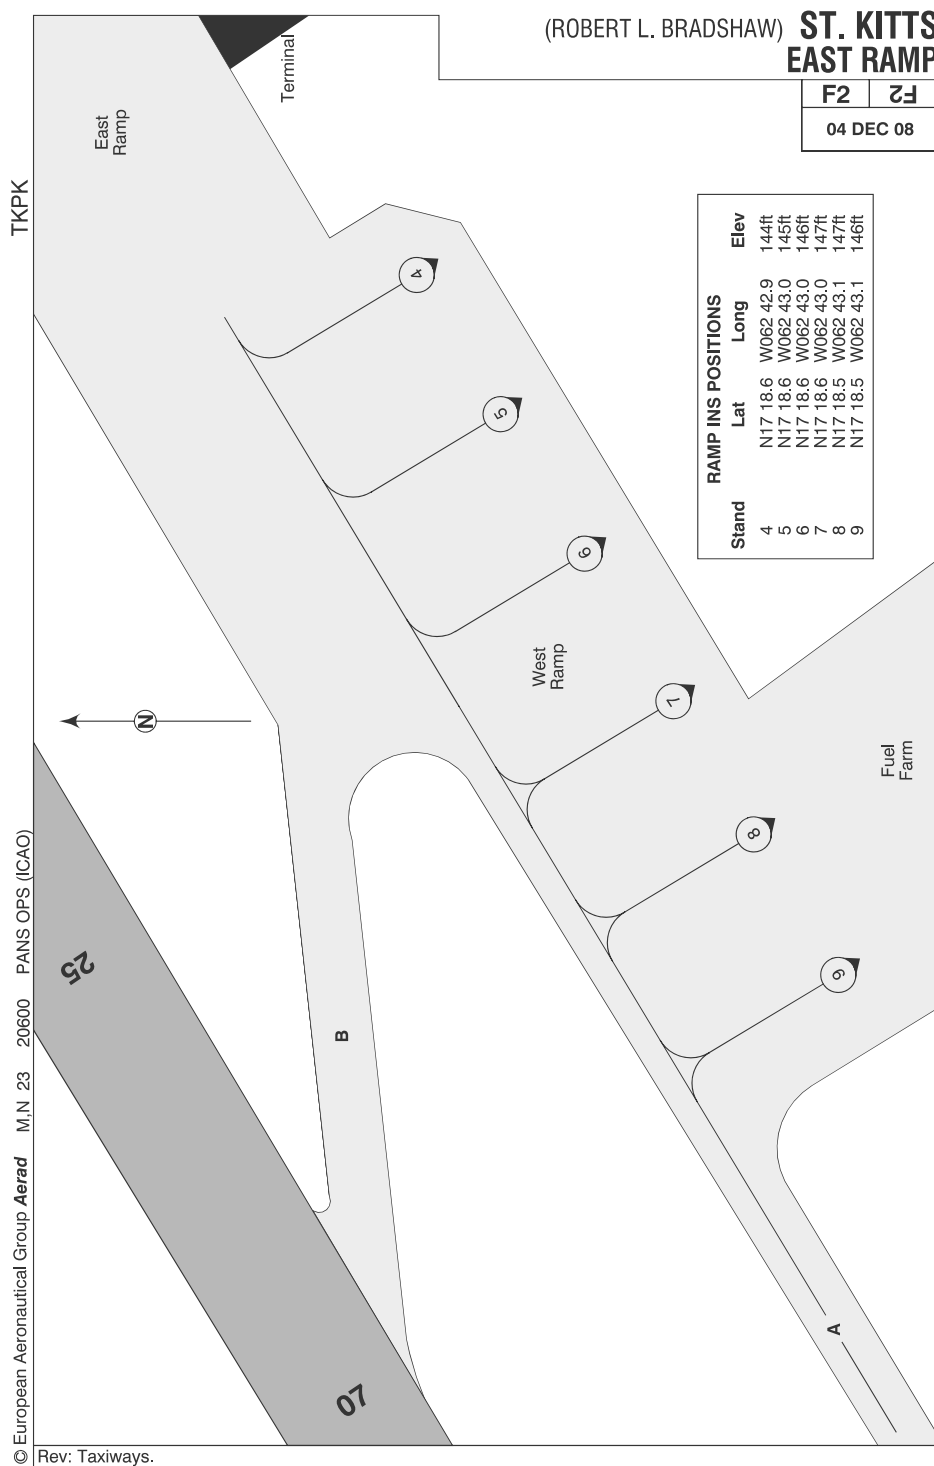
Figure 1
Aerodrome Charts

After an uneventful start the co-pilot called for taxi at 2059 hrs, 6 minutes ahead of schedule. Figure 1 shows a copy of the charts used by the crew.

The co-pilot commenced a right turn through 135° away from the terminal because no taxiway markings were present to guide the aircraft from the ramp in front of the terminal. As he did so he identified a taxiway centreline at the rear of the ramp and assumed it to be Taxiway Alpha. The aircraft continued on this taxiway to Holding Point Bravo, during which time the commander completed the flight controls check and the Before Take-off checklist. By the time the commander looked up and orientated himself, the aircraft was approaching Holding Point Bravo.

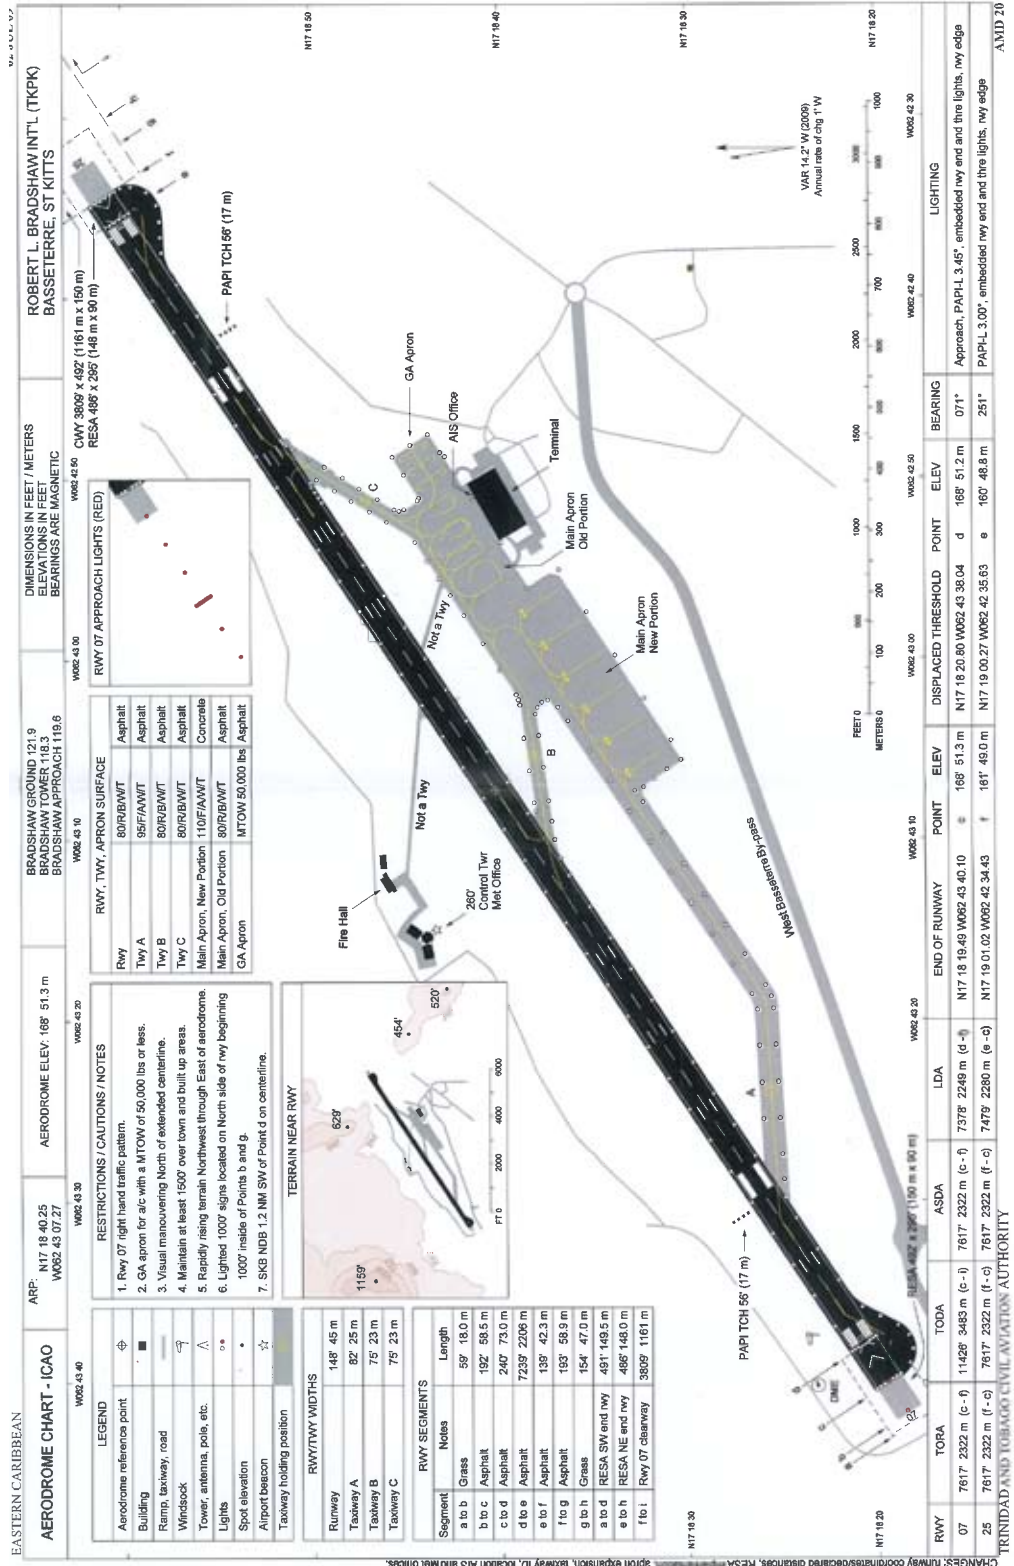
Figure 2

During its visit to SKB the AAIB found that, as mentioned in the 2006 ASSI inspection, there were no holding point signs. Additionally there were no taxiway signs and the taxiway centreline linking the rear of the Main Apron Old Portion to the rear of the Main Apron New Portion, as shown in the ECAIP, was not present.

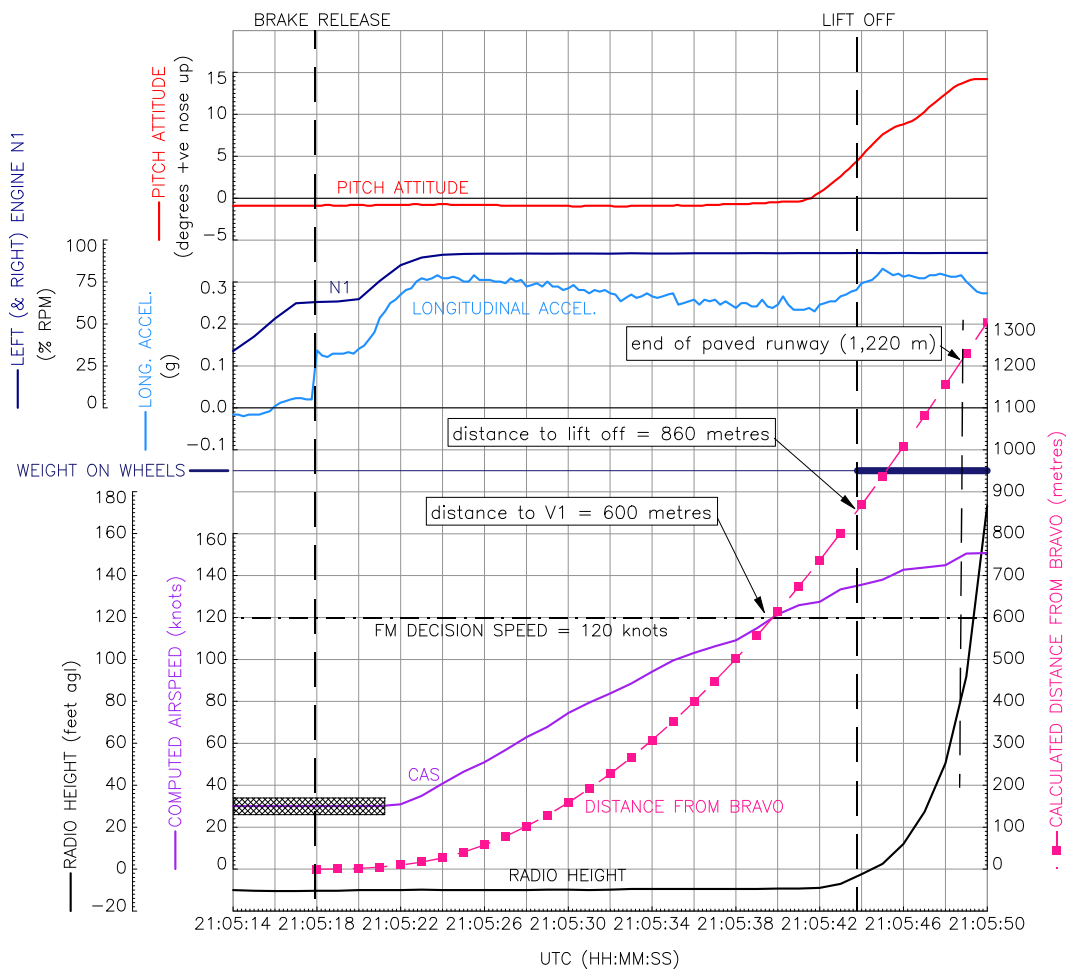
Intersection Bravo on Runway 07 is not authorised, for Boeing 777 takeoffs, by this aircraft's operator. The aircraft had taken off with a Takeoff Run Available (TORA)¹ of 1,220 m; the performance calculations were based on a TORA of 1,915 m.

Salient parameters from the QAR recordings are presented in Figure 3, which starts with the aircraft lined up on the runway at Bravo with the thrust beginning to increase just prior to brake release. Figure 3 also shows the distance travelled along the runway from brake release, which was calculated from groundspeed.
