Accidents Investigation Branch

Department of Transport

**Report on the accident to
De Havilland DHC-5D Buffalo C-GCTC
at the Royal Aircraft Establishment,
Farnborough, Hampshire
on 4 September 1984**

Aircraft Accident Report No. 6/85
(EW/E24)

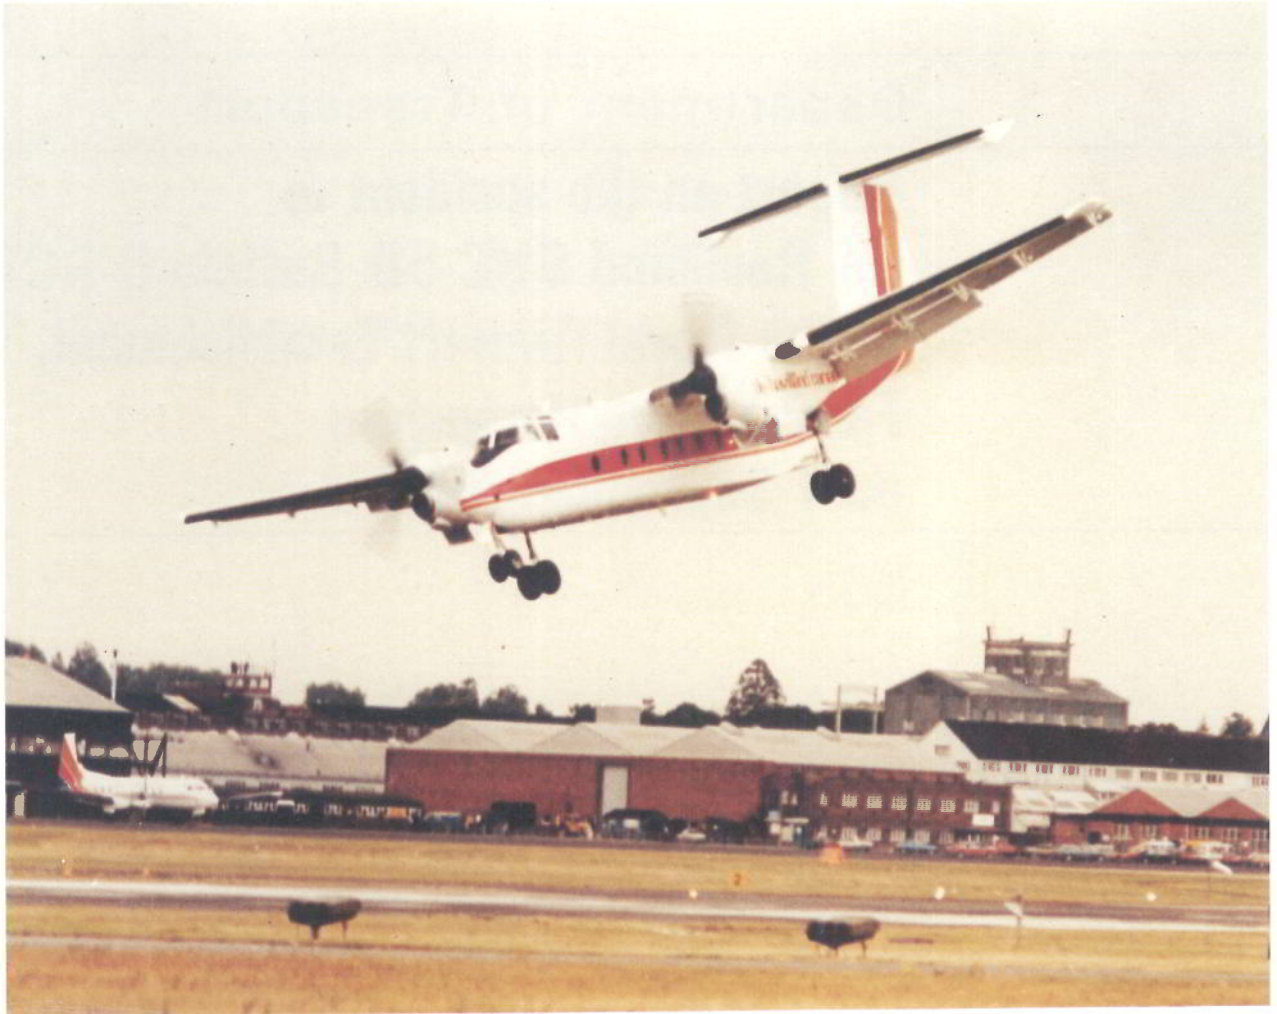
DHC-5D BUFFALO C-GCTC SHORTLY BEFORE IMPACT

On the final approach, shortly after the bank had been reversed, and at an estimated height of 450 feet agl, the nose of the aircraft was observed to drop significantly, resulting in a marked increase in the rate of descent. At this time the co-pilot recalls that he felt a shudder through the airframe and that he checked the airspeed, which was indicating 85 knots. The steep rate of descent appeared to reduce momentarily, before the nose dropped again and the aircraft continued in a steep side-slipping and descending turn to the right, passing slightly south of the runway centre line. At approximately 2 seconds before touch down, as the aircraft continued its turn back towards the centre line, bank angle and rate of descent were observed to reduce. As the aircraft crossed the runway threshold, and co-incident with the apparent slight reduction in the rate of descent, there was a sudden increase in engine noise as power was applied, but the commander was unable to prevent a very heavy landing. On touch down the nose landing gear collapsed, both wings failed and the propellers, on contact with the runway, disintegrated; the resulting debris, flung over a wide area, caused damage to three aircraft in the static display area and to four private motor vehicles. A flash fire, which started as the wings failed, died out before the aircraft came to rest. The occupants escaped without injury, but one spectator was slightly injured by flying debris. The accident occurred at 1517.51 hrs, after a flight lasting 1 minute and 48 seconds.

The accident resulted from an error of judgment by the aircraft commander. Unfavourable weather conditions, a transitory handling problem whilst flying outside the tested flight regime and the pressure on the commander to complete his flying sequence, were probably contributing factors.

- 4.1 It is recommended that organisers of air displays ensure that only the minimum safe number of operating crew be carried on board those aircraft taking part in the display which are to undertake other than routine manoeuvres such as would be judged acceptable in normal passenger carrying operations.
