ACCIDENT

Aircraft Type and Registration:	AS355F2 Twin Squirrel, G-SEWP
No & Type of Engines:	2 Allison 250-C20F turboshaft engines
Constructor's Serial No:	5480
Year of Manufacture:	1991
Date & Time (UTC):	28 October 2010 at 0950 hrs
Location:	31 nm south of Belfast Aldergrove Airport, Northern Ireland
Type of Flight:	Commercial Air Transport (Passenger)
Persons on Board:	Crew - 1 Passengers - 3
Injuries:	Crew - 1 (Minor) Passengers - 3 (Minor)
Nature of Damage:	Aircraft destroyed
Commander's Licence:	Commercial Pilot's Licence (Helicopter)
Commander's Age:	42 years
Commander's Flying Experience:	2,045 hours (of which 185 were on type) Last 90 days - 47 hours Last 28 days - 21 hours
Information Source:	AAIB Field Investigation

Synopsis

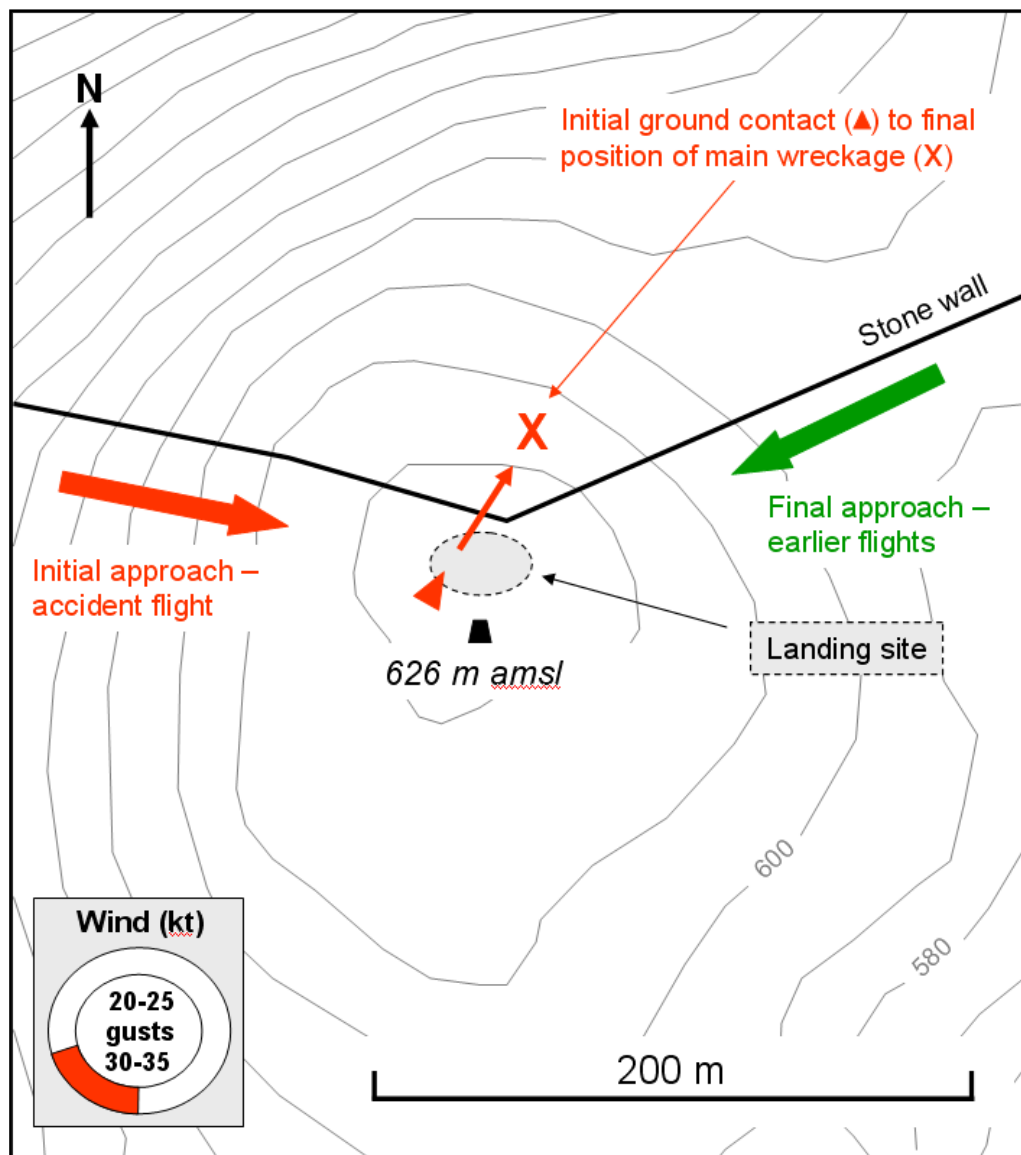
Figure 1

The four previous approaches had been made from the north-east, approximately into wind. Whilst at the summit on the previous flight the pilot thought that the wind had backed and reduced in strength. On the accident flight, because of the possible drop-off at the alternative site, the helicopter approached the hilltop from a westerly direction. It overflew the landing site and started a right turn back towards it (Figure 1).

Sketch of accident location
