ACCIDENT

| Aircraft Type and Registration: | Aerospatiale SA.341G Gazelle, HA-LFB | |
| Date & Time (UTC): | 8 March 2011 at 1907 hrs | |
| Location: | Near Honister Slate Mine, Keswick, Cumbria | |

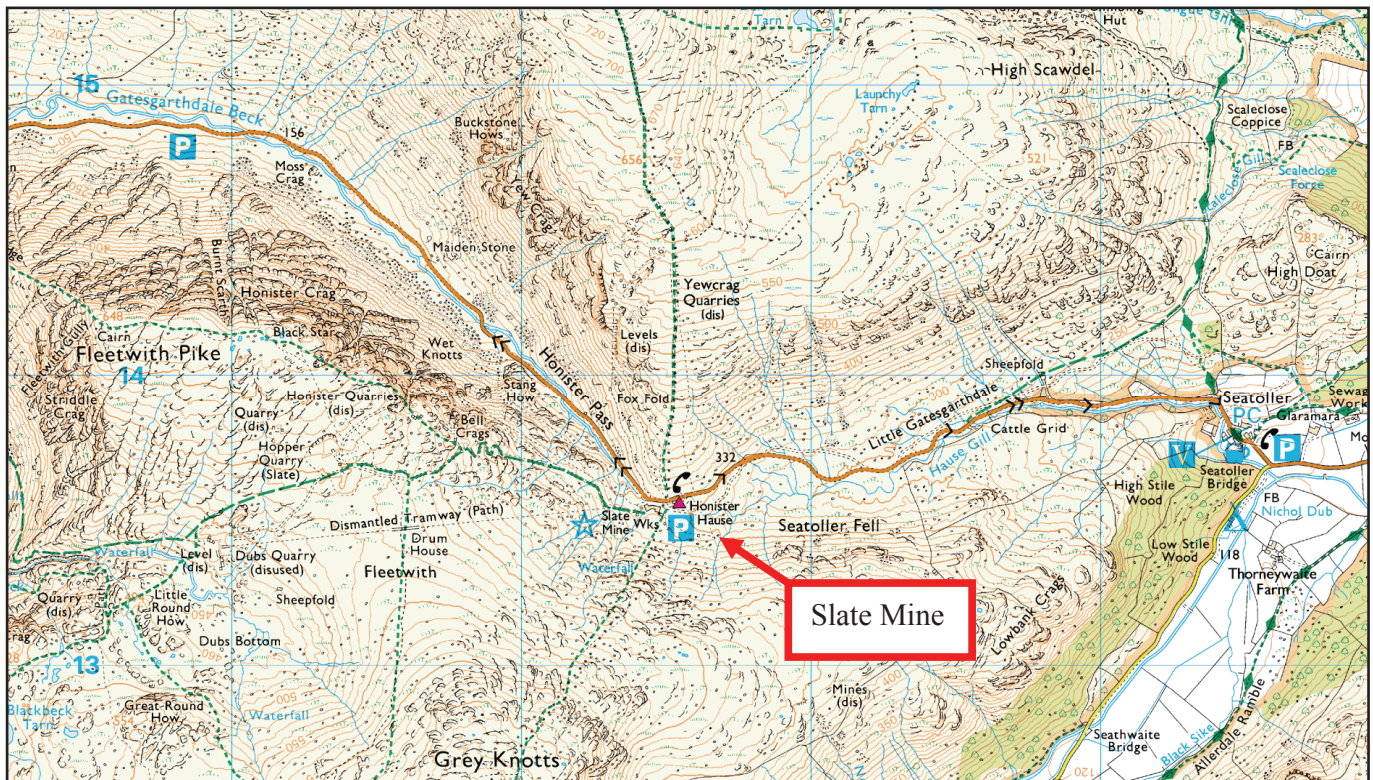
Figure 1

The mine is located at a saddle in the Honister Pass (Figure 1). To the west of the mine, the Honister Pass extends north-west towards Buttermere and Crummock Water; to the east, the Pass extends towards Seatoller, where it joins a valley orientated approximately north-south, descending to the north to meet the southern end of Derwent Water.

The area around the slate mine

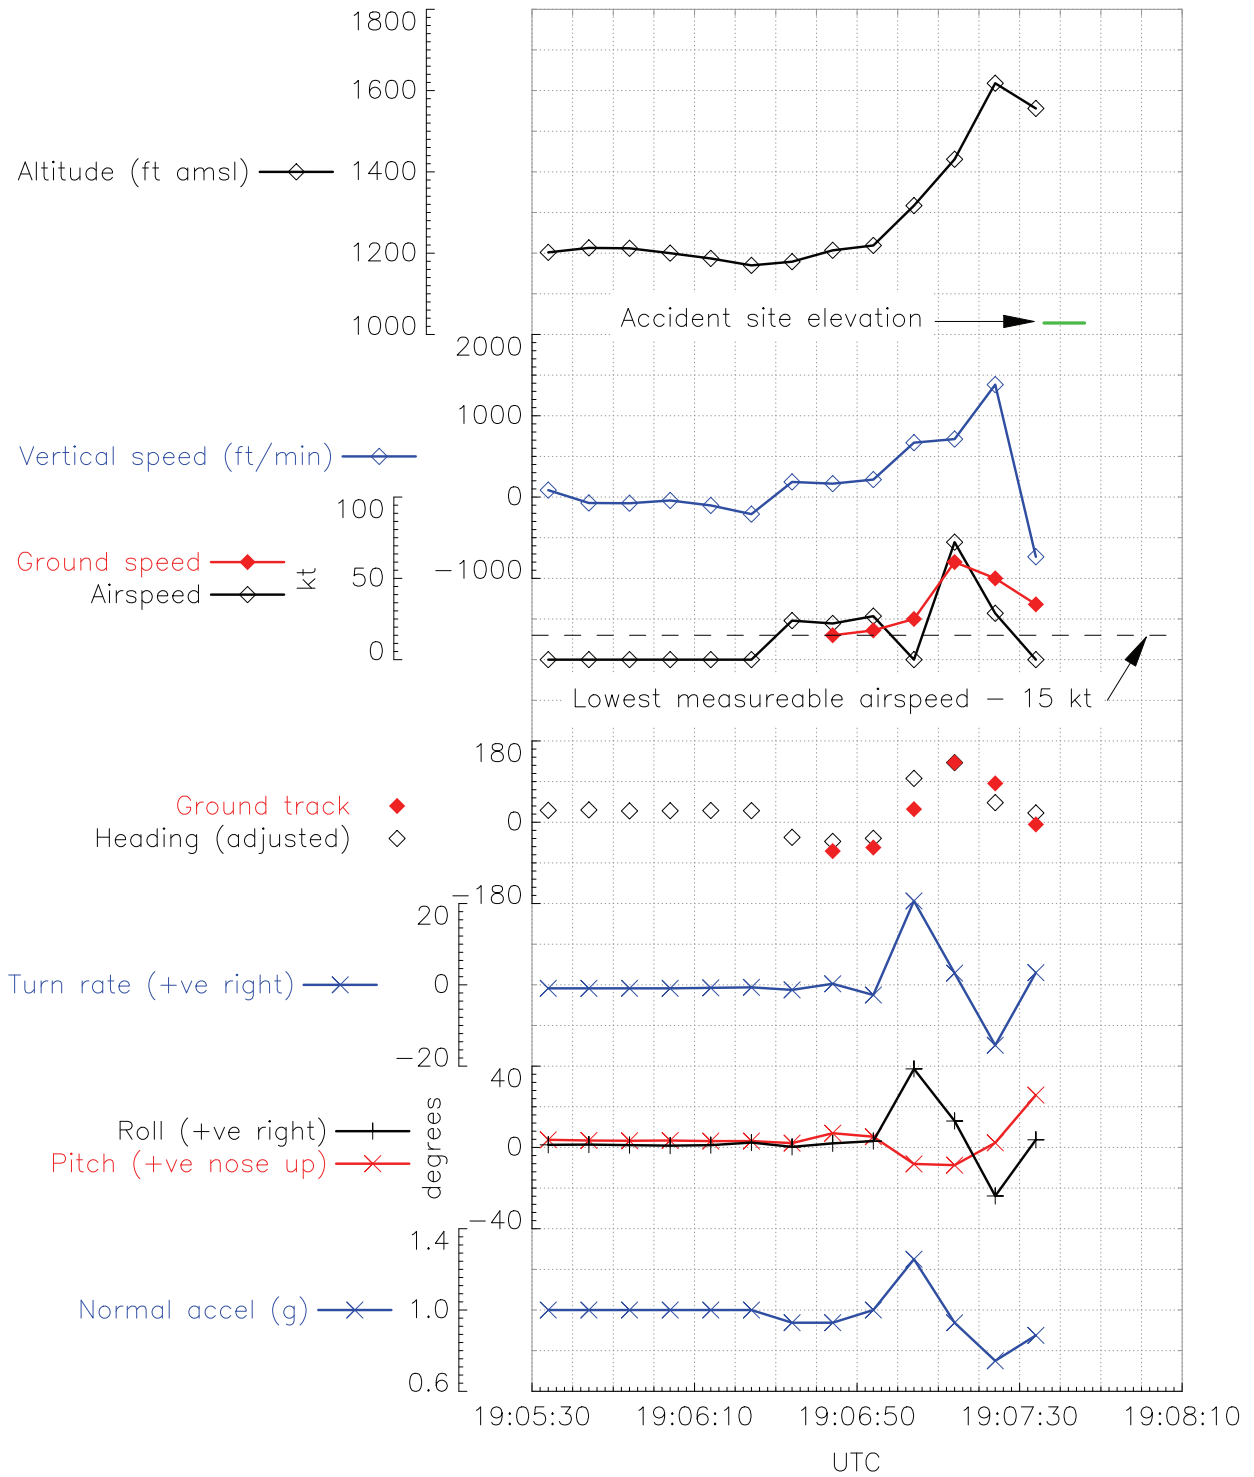
Figure 2
EFIS recorded data

Figures 2 and 3 show data from the EFIS recordings. The recordings started at 1905:34 hrs with the helicopter stationary at the takeoff location and with a heading of approximately 025°(T). The barometric altitude varied whilst still on the ground during the helicopter start up, as would be expected. The CCTV showed the various lights and beacons becoming active. The helicopter took off at 1906:25 hrs and turned to head north-west with an airspeed of approximately 25 kt, climbing slowly. The helicopter then carried out a climbing turn and headed south-east towards the southern side of the eastern valley. The helicopter reached its highest recorded altitude in a left turn away from the valley side. The next and final recorded point, at 1907:34 hrs, placed the

helicopter nearer the north side of the valley with no valid airspeed (ie below 15 kt), a ground speed of 34 kt, a track of 355°(T), a heading of approximately 20°(T), a descent rate recorded as -735 ft/min, 25.75° of nose-up pitch, 3.75° of right roll and a turn rate of 3°/s to the right. This implies a slow rotation to the right with little roll and a nose-up attitude, low airspeed, forward ground speed and in a descent.

The final recorded point had no valid airspeed (less than 15 kt), 25.75° of nose-up pitch and a calculated height of approximately 550 ft agl. A review of the previous flights showed that, with one exception, each occasion the pitch was recorded as greater than 20° nose-up was associated with a flare before landing. The one exception was associated with flight involving a number of high pitch and roll manoeuvres at speed. The highest nose-up pitch angle recorded with a calculated height of 500 ft agl or higher, during previous flights, was 8.75°

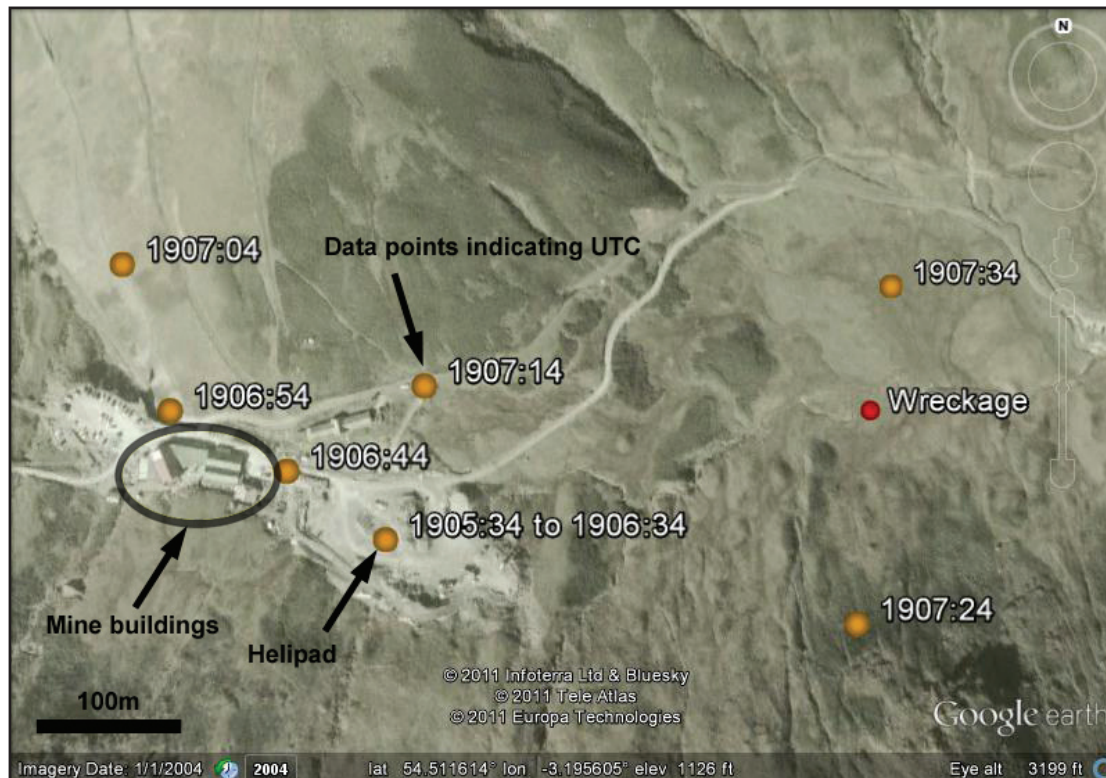
Figure 3

Recorded GPS positions during the accident flight

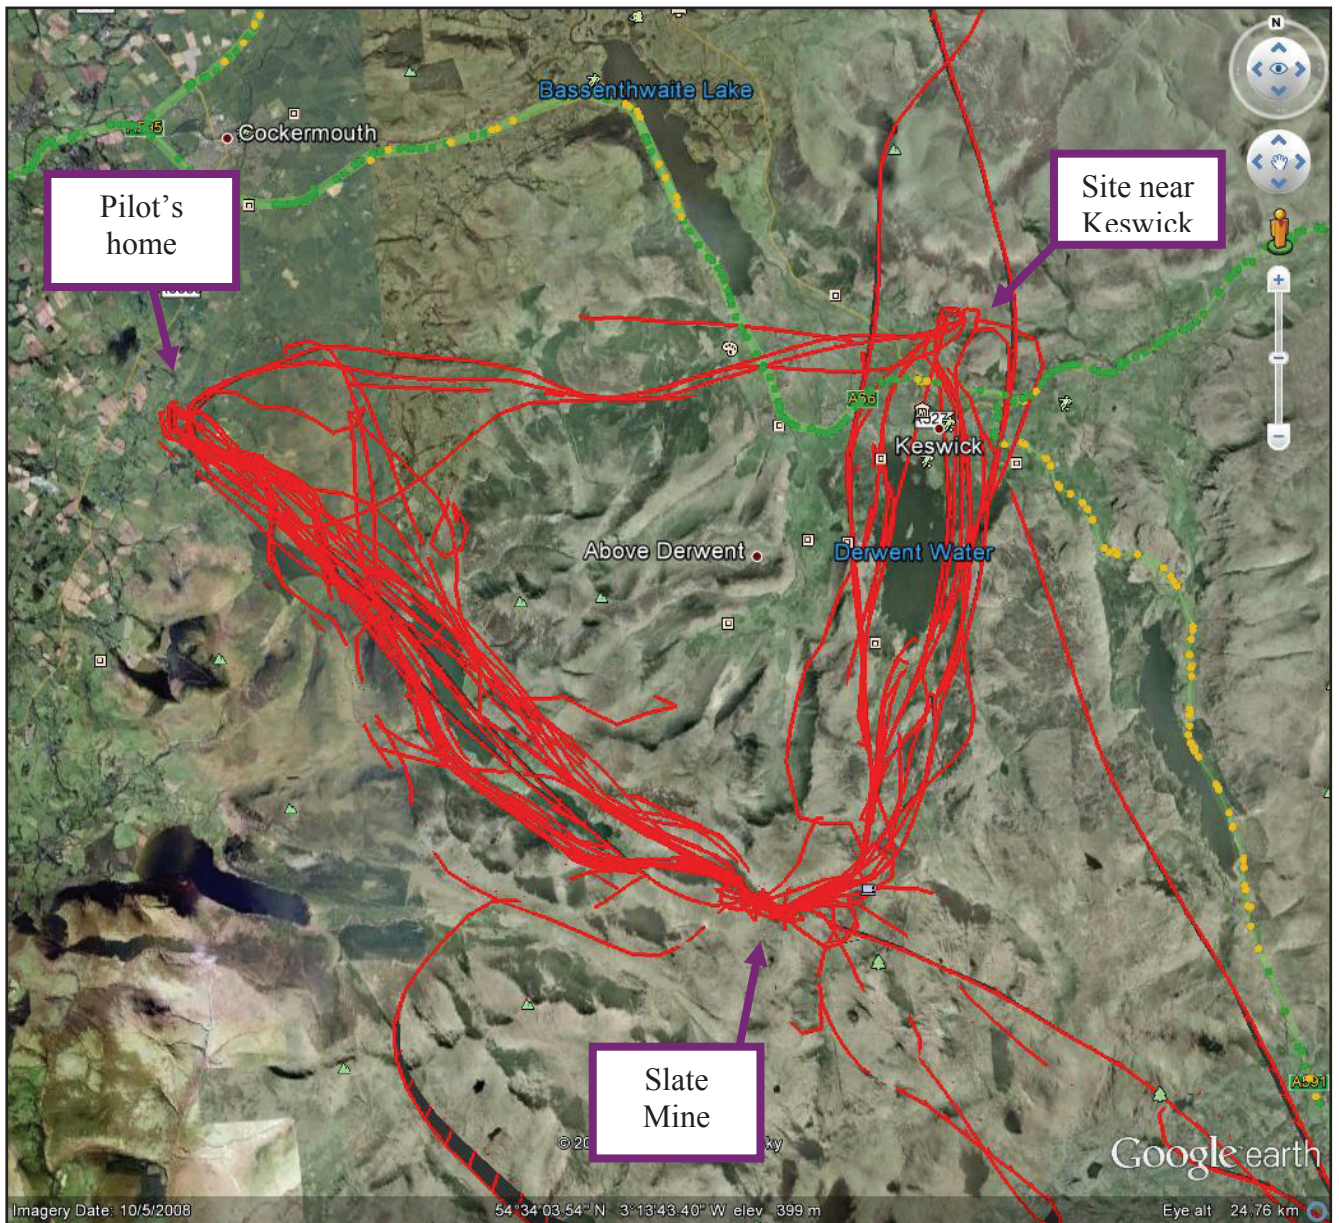
Figure 4

The pilot's flying frequently took him between three sites in the Lake District: his home, south of Cockermouth; the mine at Honister, and another site north of Keswick. This is illustrated by the GPS recordings of his recent flights (Figure 4)

The pilot habitually flew more or less directly between these locations, although the tracks varied. The route from the slate mine directly to his home involved crossing the Honister Pass, and then following Buttermere and Crummock Water before reaching low-lying ground near his home. This route is through relatively deep and steep-sided valleys among high ground rising to a maximum of 2,792 ft. His route from the mine to the site near Keswick is down the valley towards Seatoller and then following falling ground into a wider valley towards Derwent Water and Keswick itself. From

The pilot's usual routes within the Lake District (GPS tracks shown in red)
