SERIOUS INCIDENT

Aircraft Type and Registration:	Airbus A319-111, G-EZFI	
No & Type of Engines:	2 CFM56-5B5/3 turbofan engines	
Year of Manufacture:	2009	
Date & Time (UTC):	6 January 2011 at 1955 hrs	
Location:	Belfast International Airport	
Type of Flight:	Commercial Air Transport (Passenger)	
Persons on Board:	Crew - 6	Passengers - 46
Injuries:	Crew - None	Passengers - 1 (Minor)
Nature of Damage:	None	
Commander's Licence:	Airline Transport Pilot's Licence	
Commander's Age:	39 years	
Commander's Flying Experience:	8,408 hours (of which 2,892 were on type) Last 90 days - 172 hours Last 28 days - 41 hours	
Information Source:	AAIB Field Investigation

Synopsis

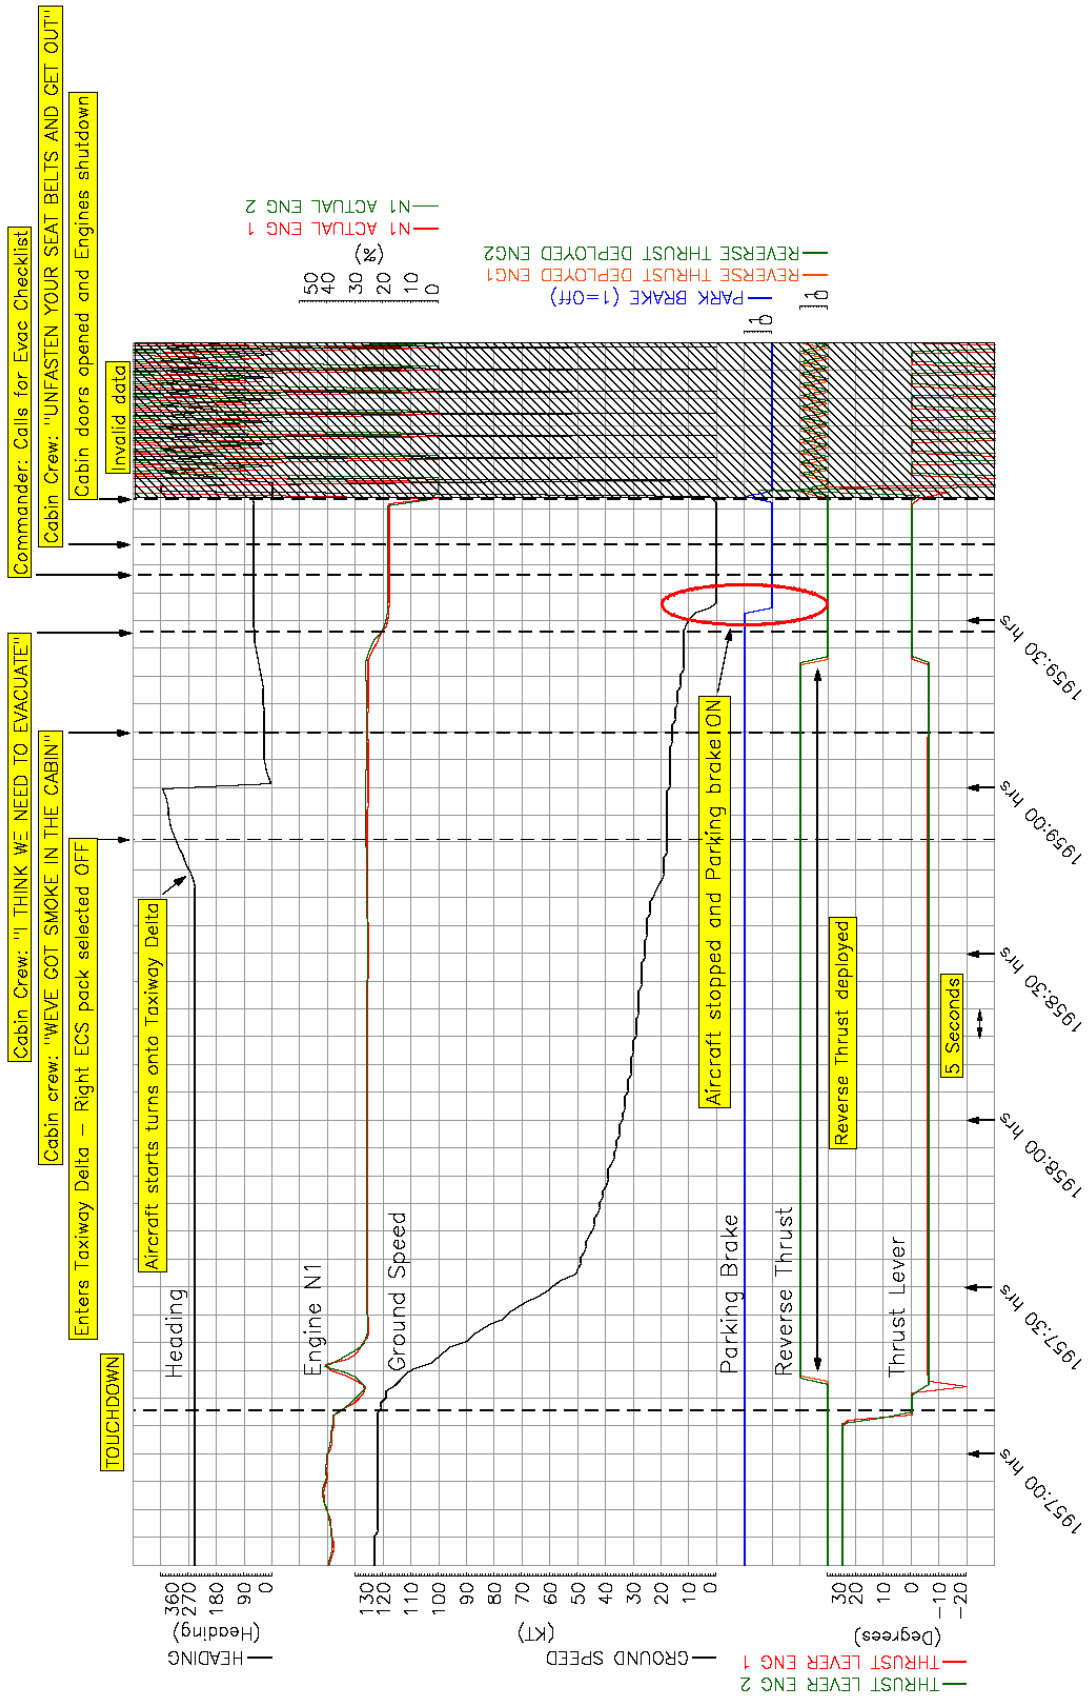
A record of the incident was available from the FDR and CVR. Figure 2 is a plot of salient parameters from the FDR during the landing and taxi in. Both recordings stopped shortly after the engines were shut down.

Recorded data for the landing and taxiing phases
