SERIOUS INCIDENT

Aircraft Type and Registration:	Airbus A319-131, G-EUPO
No & Type of Engines:	2 International Aero Engine V2522-A5 turbofan engines
Year of Manufacture:	2000 (Serial No: 1279)
Date & Time (UTC):	17 December 2010 at 1320 hrs
Location:	On approach to London Heathrow
Type of Flight:	Commercial Air Transport (Passenger)
Persons on Board:	Crew - 6 Passengers - 122
Injuries:	Crew - None Passengers - None
Nature of Damage:	None
Commander's Licence:	Airline Transport Pilot's Licence
Commander's Age:	50 years
Commander's Flying Experience:	16,080 hours (of which 1,221 were on type) Last 90 days - 208 hours Last 28 days - 58 hours
Information Source:	Field Investigation

Synopsis

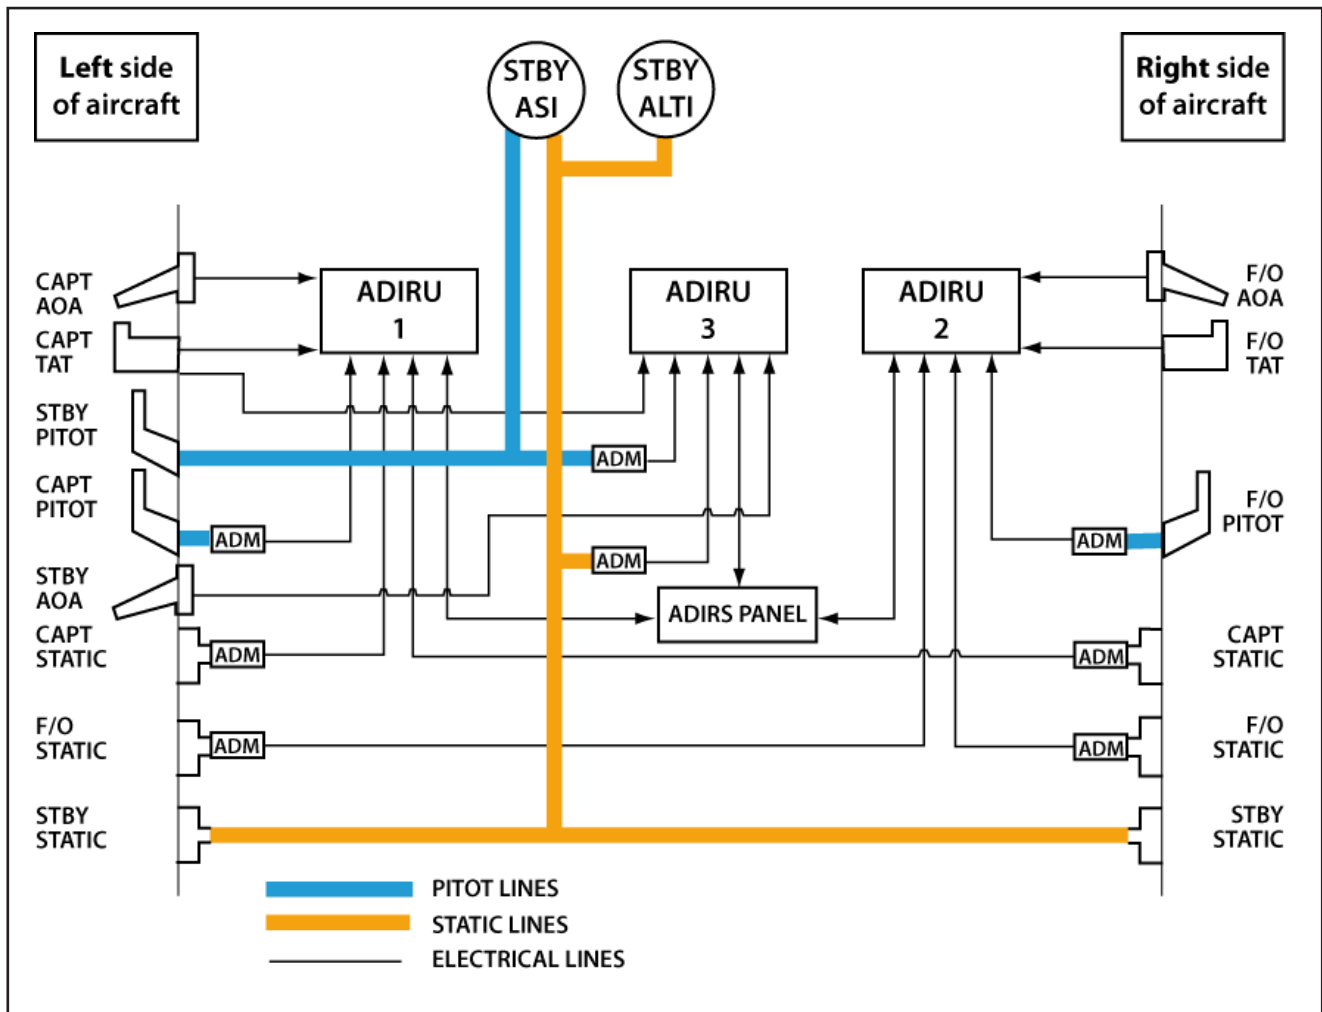
Figure 1
Air data system

The air data is provided to the ADIRU from three pitot probes, six static pressure probes, three Angle of Attack (AOA) sensors and two Total Air Temperature (TAT) probes (Figure 1). The data from the AOA and TAT probes is provided directly to the ADIRU as an electrical signal,

whereas air pressure from the pitot and static probes is first converted at an Air Data Module (ADM) into an electrical signal. Air pressure is provided directly to the stby airspeed indicator and altimeter from static and pitot probes that are also linked by two ADMs to ADIRU 3. The pitot head probes, static ports, AOA probes and TAT probes are electrically heated by three independent Probe Heat Computers (PHC) that automatically control and monitor the electrical power to the Capt, F/O and stby probes.

data from ADIRU 3 dropping below 30 kt. The stby ASI and ADIRU 3, which was now supplying the Capt PFD, were both using air pressure information from the stby pitot and static probes. The recording on the DAR and the indications reported on the Capt PFD and stby ASI were consistent with possible icing of the stby pitot probe.

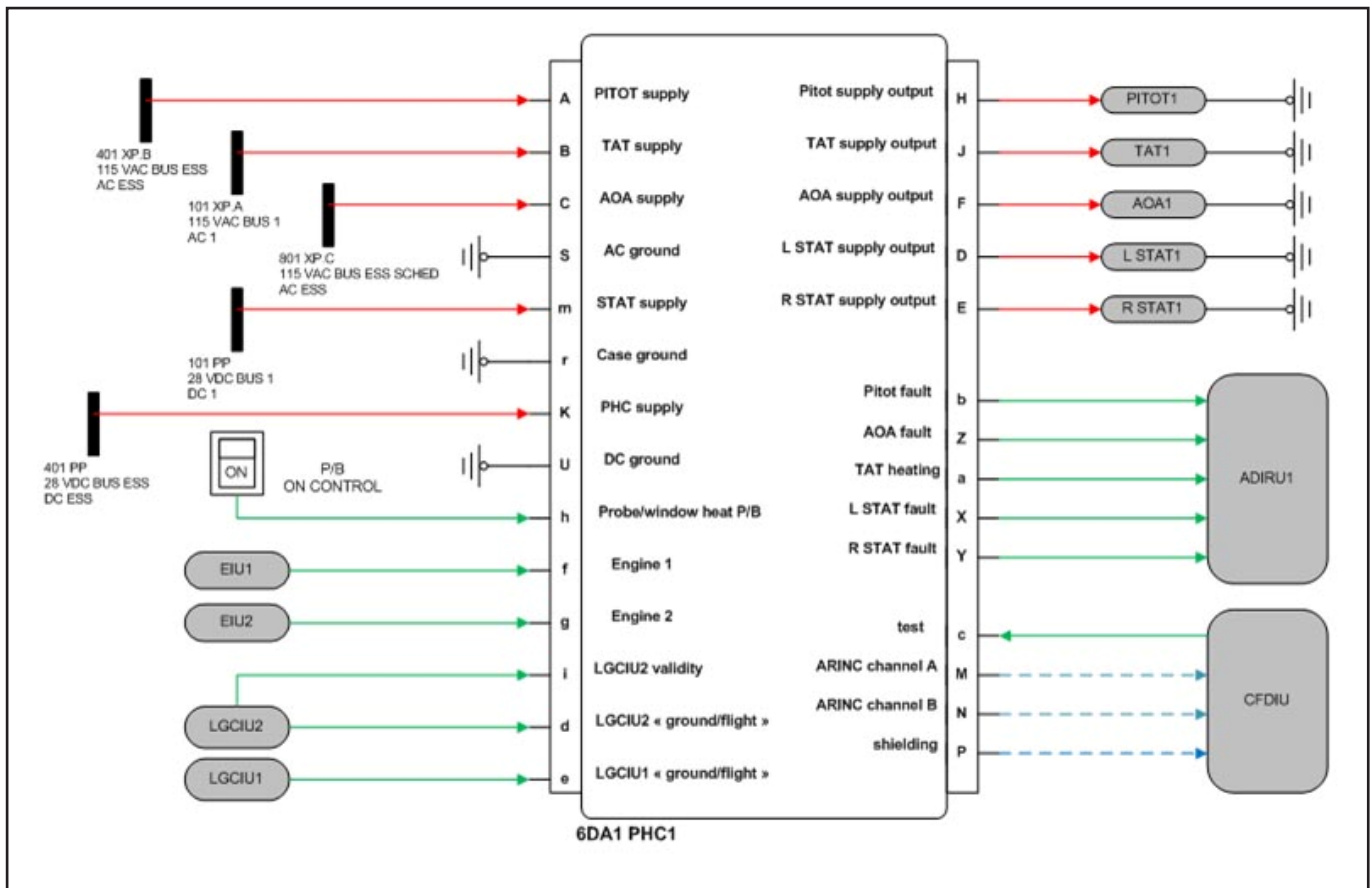
Figure 2

The three PHC monitor and control the electrical power to the heating elements in the probes, ports and AOA sensors. If the electrical current consumption is outside limits, ECAM warnings are generated by the FWS, using discrete signals sent by the PHC through the ADIRU (Figure 2). BITE messages are generated directly by the PHC and recorded in NVM as well as being sent to the CFDIU on two ARINC channels (data buses). In the event that the data communication between the PHC and CFDIU is lost, ECAM warnings will still be displayed if the discrete outputs from the PHC are still available, but the associated BITE fault message will not be recorded by the CFDIU.

According to the PFR, the ECAM cautions ANTI ICE CAPT TAT and ANTI ICE CAPT R STAT were both associated with the failure message NO PHC 1 DATA that was generated by the CFDS. This message only indicated that the CFDS was not receiving any data from PHC 1 and was not an indication of the serviceability state of the PHC. Post-flight testing of PHC 1 did not identify any BITE messages or faults that could have resulted in these warnings.

Approximately seven minutes later, the ECAM caution ANTI ICE STBY R STAT was displayed and, according to the PFR, was associated with the failure message NO PHC3 DATA, generated by the CFDS. This also indicated that the CFDS was not receiving any data from PHC 3. Post-flight testing of PHC 3 did not identify any BITE messages or faults that could have resulted in this warning. At this time, there was no degradation of the airspeed outputs from ADIRU 1, ADIRU 2 and ADIRU 3 recorded on the DAR, indicating that there was no ice accumulation on the probes and the air data system was serviceable.

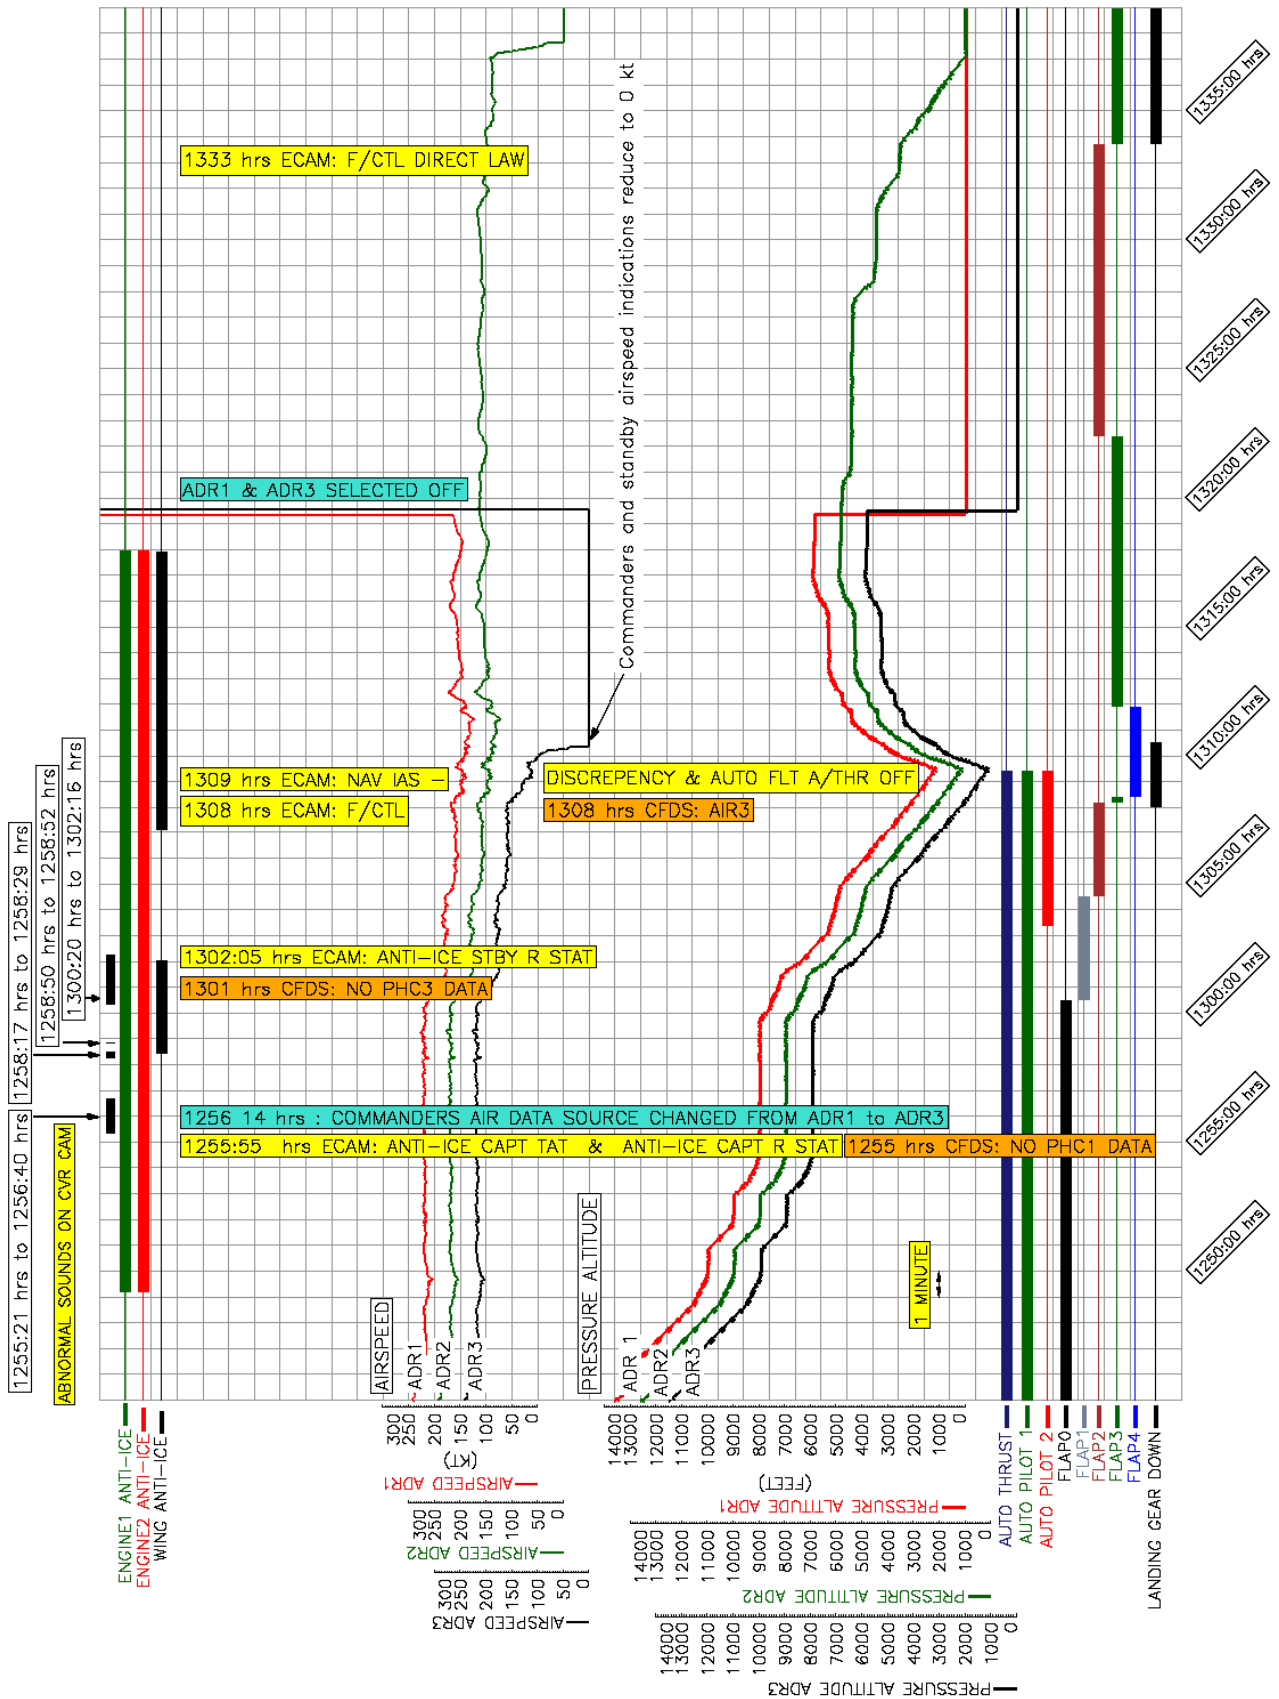
Figure 3

1214 hrs and ending shortly after the aircraft had been shut down at Luton Airport. Salient parameters during the approach into London Heathrow and the landing at Luton are contained in Figure 3.

Approximately six minutes later, the PFR shows the ECAM message MAINTENANCE STATUS F/CTL, the associated failure message ADR 3 was generated by EFCS 2 and confirmed by EFCS 1 and the AFS. This message indicated that EFCS 1, EFCS 2 and the AFS had identified that there was a discrepancy between the airspeed outputs from ADIRU 1, ADIRU 2 and ADIRU 3. Data from the DFDR showed the airspeed output of ADIRU 3 reducing, with the airspeed output from ADIRU 1 and ADIRU 2 remaining within two knots of each other at about 140 kt. A NAV IAS DISCREPANCY warning was generated by the FWC which indicated that there was a discrepancy between the airspeed displayed on the Capt and F/O PFDs. At the same time the crew reported that the speed displayed on the Capt PFD decayed to around 50 to 60 KIAS and the stby ASI fell simultaneously to 0 KIAS. Less than two minutes had elapsed between the initial discrepancy being detected and the airspeed output from ADIRU 3 decaying to 0 kt. About the same time the PFR records the failure message DMC 1: NO ADC3 DATA; this would have been generated as a result of the air speed
