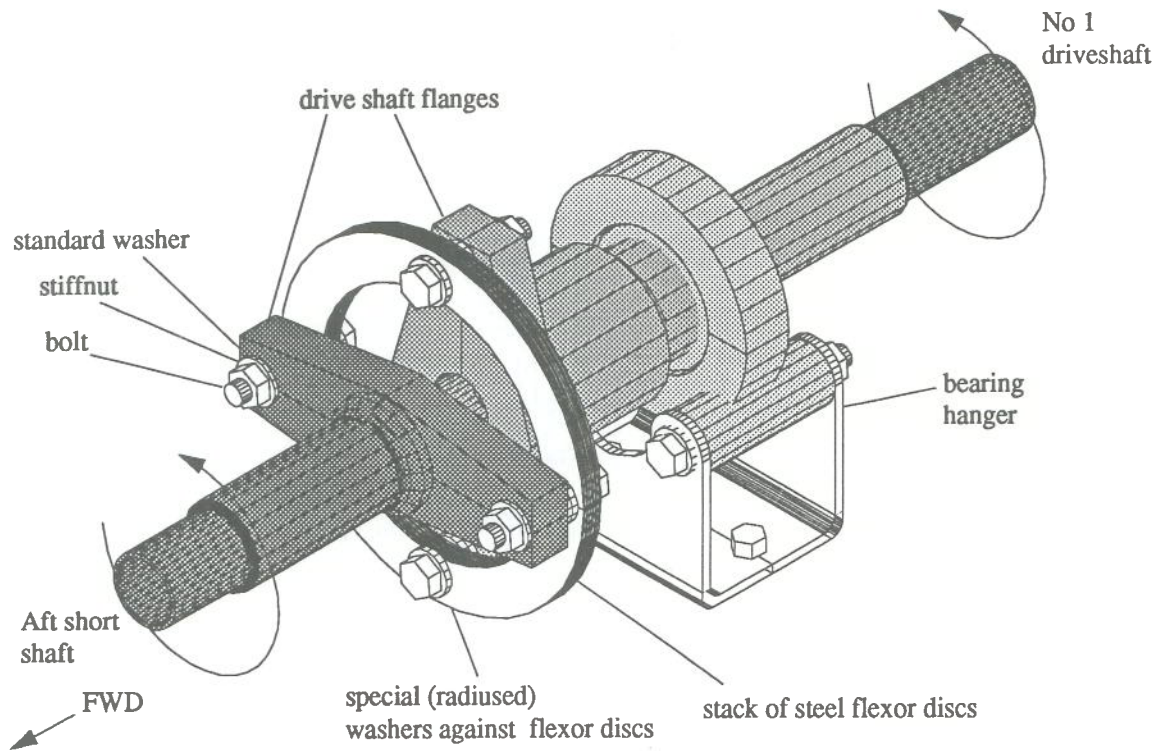
Figure 1

The top fuselage skins and the oil cooler cowling were heavily damaged in the vicinity of the Thomas coupling at the rear of the *aft short shaft*. [The Thomas couplings comprise a stack of thin stainless steel discs to which the drive shaft flanges are connected, each by means of two bolts secured by self-locking nuts, see figure 1. Special washers with rounded corners are used at the interfaces with the thin flexor discs to avoid damaging the discs.] The damage consisted of multiple contact marks and penetrations of both the top fuselage skin and the oil cooler cowling, consistent with 'flailing' of a partially disconnected coupling against the inside of the cowling and the top of the fuselage. This

evidence comprised the sole indication of tail rotor shaft rotation, and strongly suggested that a disconnection of the coupling at the rear of the *aft short shaft* had occurred during flight, with consequent loss of drive to the tail rotor.

Thomas coupling arrangement at junction of aft short shaft and No 1 drive shaft

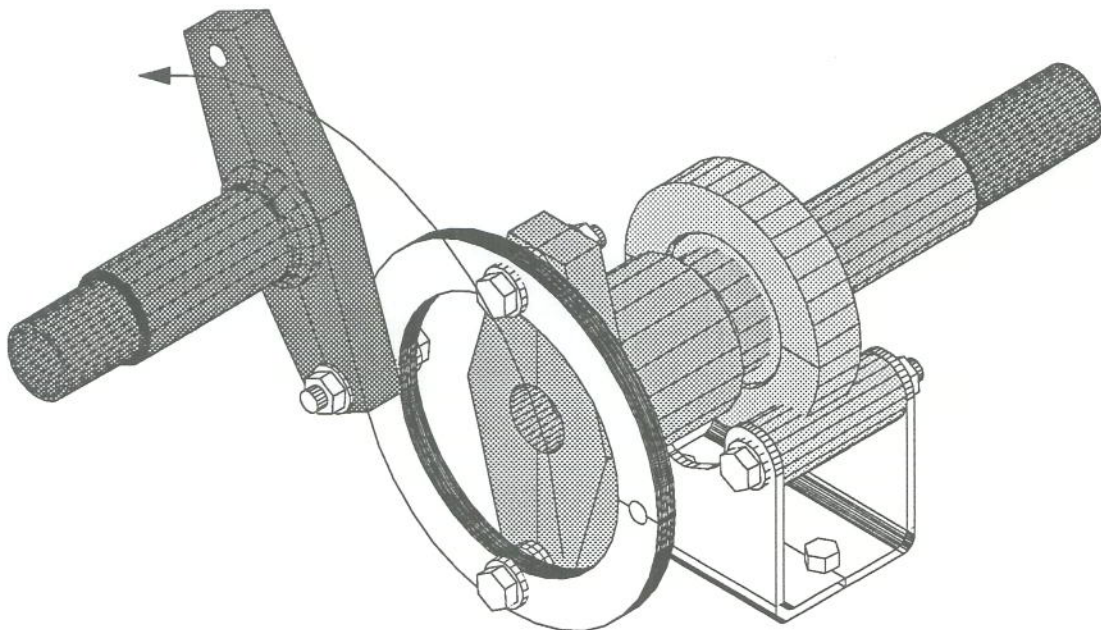
Figure 2

The relative motion of the shafts during the whirling phase would have generated binding and frictional loads which would have tended very rapidly to unscrew the nut on the remaining bolt. (The drive shaft rotates at approximately 6000 RPM and the time taken for the second nut to be spun off by this means is likely to have been a matter of a few seconds, at most, after the first bolt came out.)

Bruise marks on the fuselage top skins and other localised damage suggested that the *aft short shaft* had bowed outwards due to centrifugal loading as it whirled about the remaining bolt, prior to the second nut coming off, causing the shaft to fracture at approximately the mid position. The rear section of the shaft then appears to have become jammed partially underneath the coupling, with one of the flanges penetrating through the fuselage top skin, until it was released in the impact. The forward half of the broken shaft was not found and it is likely that this was thrown out of the hole in the cowling whilst the aircraft was still in flight.

Showing whirling motion of aft short shaft about remaining bolt, following loss of first bolt

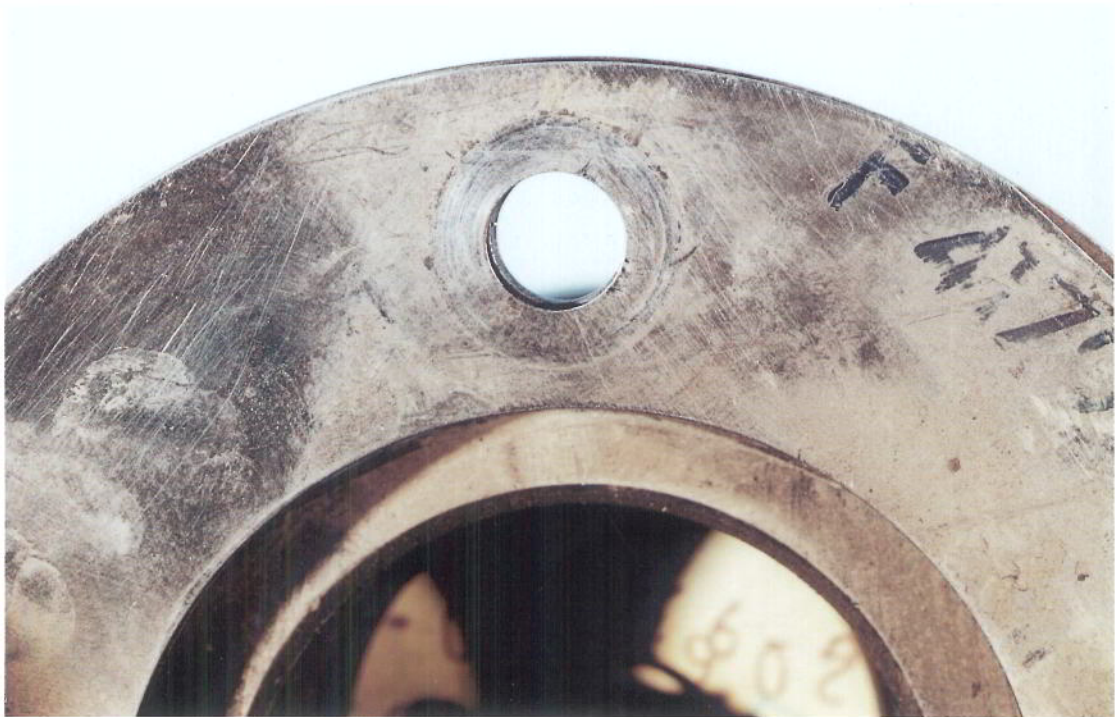
The *aft short shaft* drive flange was completely disconnected from the coupling and both connecting bolts and nuts were missing. In addition, one of the sets of connecting bolt holes was essentially undamaged whereas the other set of holes was heavily bruised and enlarged (see Plates 1a and 1b). This evidence, together with the *flailing* type damage to the fuselage top skins and the oil cooler cowling immediately adjacent to the coupling, indicated that one of the bolts joining the *aft short shaft* to the coupling had come out shortly before the impact, causing the *aft short shaft* to rotate about the other remaining bolt as shown in figure 2, rather than both shafts rotating in unison. As a consequence, the drive to the tail rotor had been lost and the forward shaft section had whirled in a conical motion inside the cowling, cutting into and through the top skins of the fuselage and the oil cooler cowling. This process was almost certainly the source of the noise heard by witnesses on the ground.

Plate 1a
Undamaged bolt hole through flexor plate stack from Thomas Coupling

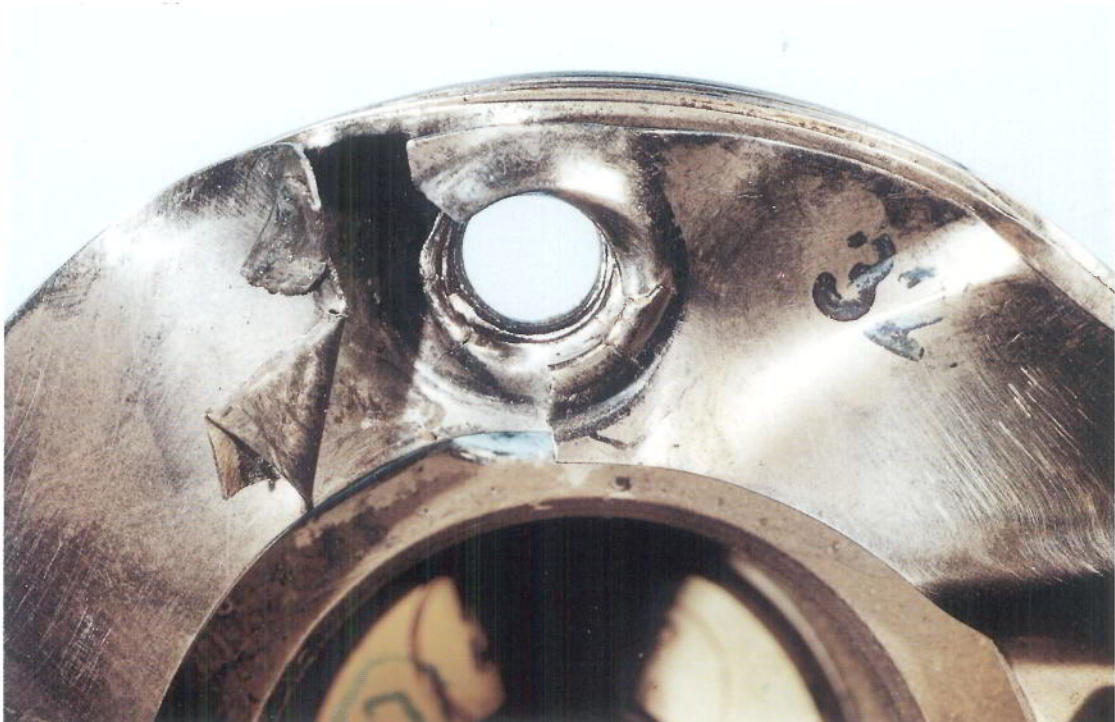
Of the washers found inside the cowling, one had a special rounded edge as used on the Thomas couplings, and was completely undamaged, and the other was a standard washer of the type fitted under the nuts on the coupling. The latter had been deformed in a manner which matched the raised lip of the *damaged* hole on the connecting flange, indicating that this washer had been fitted under the nut which was the second to come undone, after the shaft had partially disconnected and had started to whirl.

Plate 1b
Damaged bolt hole in flexor plate stack

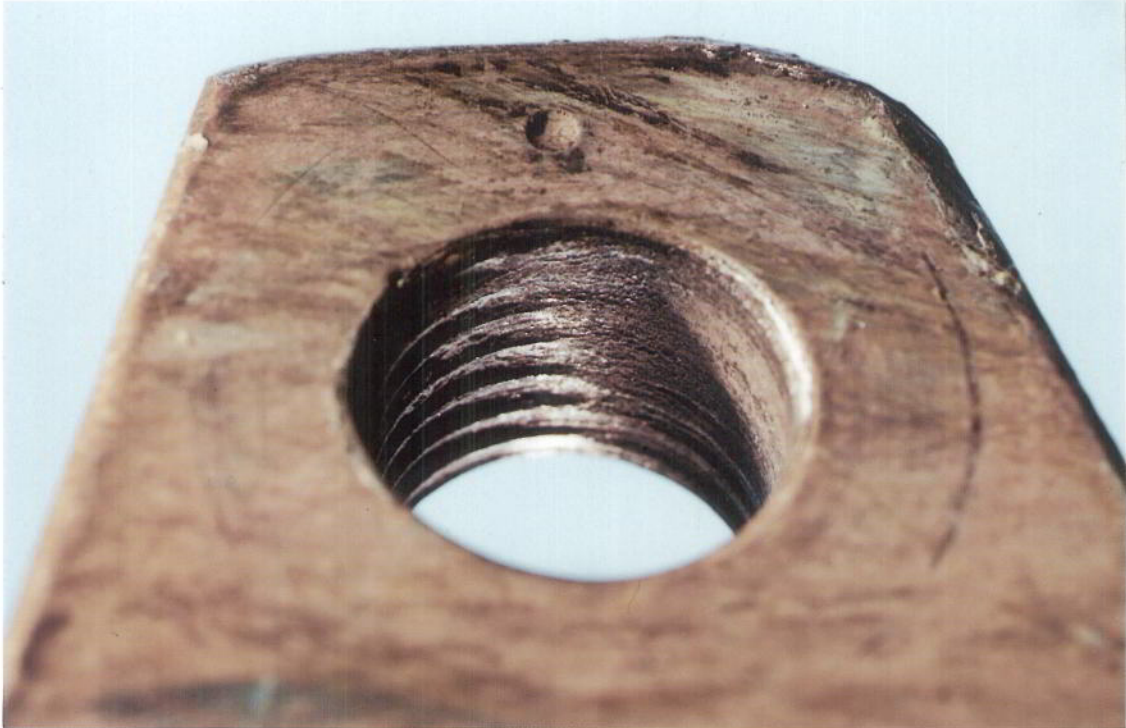
Plate 2

Close examination of the *undamaged* bolt hole in the connecting flange revealed a helical thread form which had been worn into the side of the hole, consistent with long term fretting, under load, of the bolt whilst in a partially retracted state (Plate 2).

The bolt recovered from inside the cowling was of the same type as the missing bolts from the Thomas coupling. Inspection under high magnification showed that the threads were essentially undamaged and the bolt appeared to be in good overall condition. An accumulation of compacted fretting deposits filled the thread grooves, consistent with the wear grooves observed in connecting flange (Plate 2), and it was thus apparent that this was the bolt which had initially migrated out of the coupling.

The migration of the bolt out of the coupling had apparently taken place progressively over a period of time, as evidenced by the thread form which had been worn into the side of the bolt hole as the bolt progressively withdrew.

Close up of thread form worn into bolt hole in connecting flange as bolt progressively migrated out over time (view onto aft face of flange)

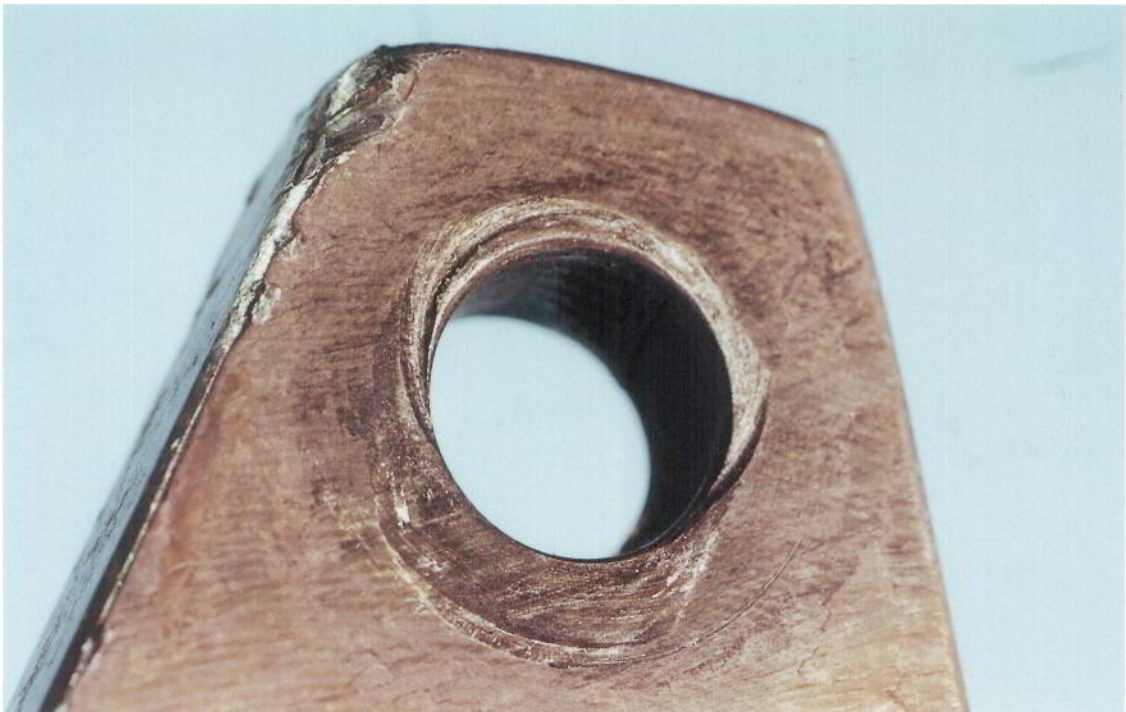
Plate 3

Under magnification, crescent-shaped surface indentations (see Plate 3) could be seen on the *aft short shaft* connecting flange in the area around the undamaged bolt hole, ie. in the region which would normally be situated beneath the nut and washer. These marks did not extend around the complete circumference and were not typical of marks produced in normal circumstances by an intact washer, or by an intact nut without a washer.

To date, it has not been possible to determine the reason why the nut initially separated from the bolt on the Thomas coupling, nor to satisfactorily explain the peculiar marks and indentations on the coupling flange at the interface with the nut/washer. However, the marks are not consistent with those which would be expected from an intact washer and/or nut, or from a complete absence of either. This evidence, together with the relative absence of fretting debris on the flexor plates from G-OSUE compared with those from other Thomas couplings on which a nut is known to have progressively

worked loose, raise the possibility that the nut had cracked or failed, or partially failed, producing a sudden release of clamping pressure rather than the nut having progressively backed-off.

Close up of curious surface features on drive flange in area under nut/washer from bolt which migrated out (view onto forward face of flange)
