**SERIOUS INCIDENT**

<b>Aircraft Type and Registration:</b>	Boeing 737-73V, G-EZJK	
<b>No &amp; Type of Engines:</b>	2 CFM56-7B20 turbofan engines	
<b>Year of Manufacture:</b>	2002	
<b>Date &amp; Time (UTC):</b>	12 January 2009 at 1545 hrs	
<b>Location:</b>	West of Norwich, Norfolk	
<b>Type of Flight:</b>	Private	
<b>Persons on Board:</b>	Crew - 2	Passengers <sup>1</sup> - 2 (engineer observers)
<b>Injuries:</b>	Crew - None	Passengers - None
<b>Nature of Damage:</b>	None	
<b>Commander's Licence:</b>	Airline Transport Pilot's Licence	
<b>Commander's Age:</b>	43 years	
<b>Commander's Flying Experience:</b>	10,716 hours (of which 7,719 were on type) Last 90 days - 56 hours Last 28 days - 9 hours	
<b>Information Source:</b>	AAIB Field Investigation

**Synopsis**

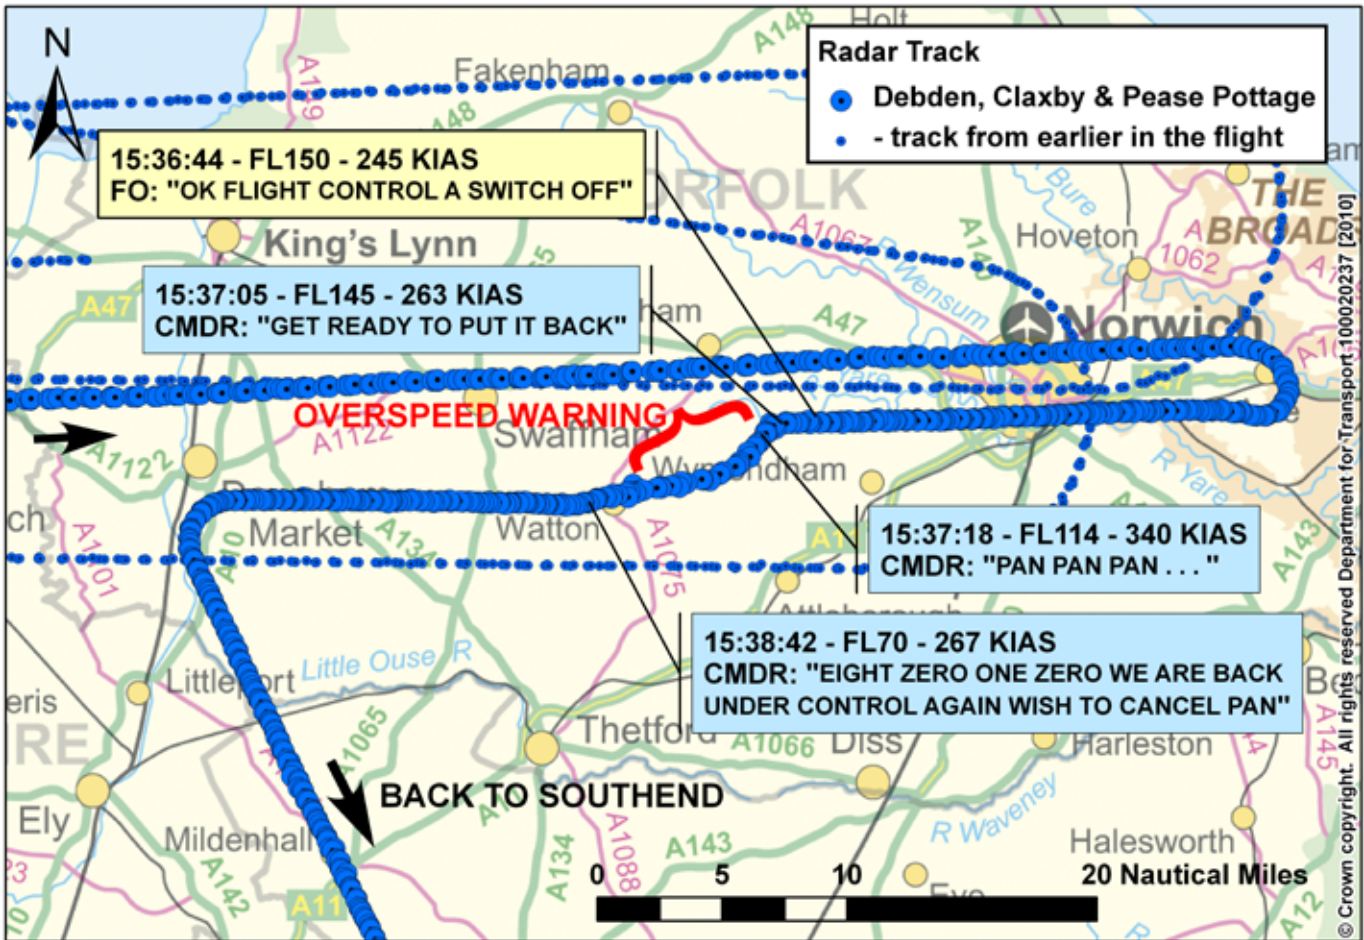
Mode S Secondary Surveillance Radar (SSR) data was also recorded for the incident flight, providing information about time and position of the aircraft, and a number of aircraft airborne parameters that matched those recorded on the FDR. Figure 1 shows part of the aircraft's track derived from the radar, annotated with extracts of speech recorded on the CVR.

G-EZJK radar track with extracts from CVR

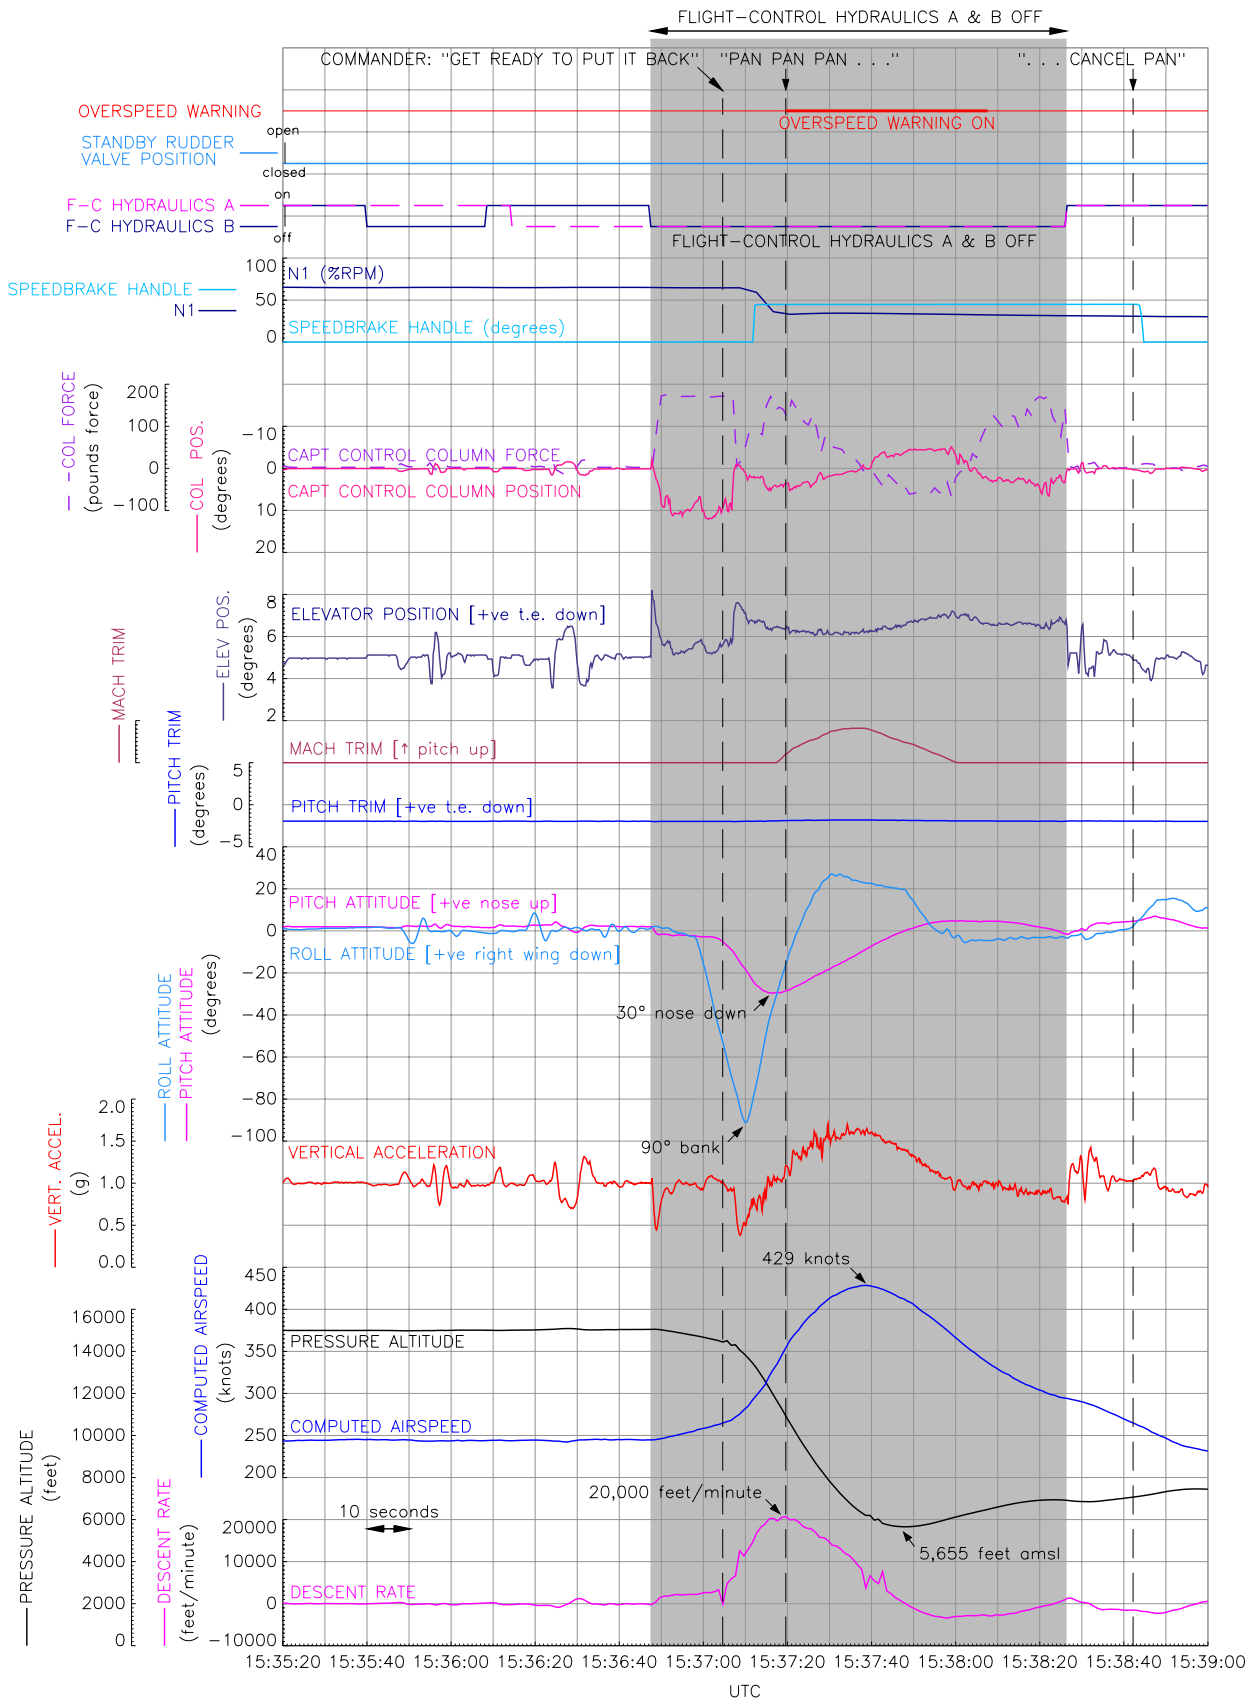
Figure 2

A time history of salient parameters from the FDR for the incident is shown at Figure 2.

The graphical presentation starts just after the aircraft was trimmed, at FL150, at a computed airspeed of 245 kt, the STAB TRIM MAIN ELECT and AUTO PILOT TRIM switches were selected to their CUTOUT positions, and SPOILER A and B switches were selected to OFF. In this trimmed condition (with zero stick force) the elevator position was about 5° trailing edge down.

With the FLT CONTROL A switch still in the OFF position, the co-pilot asked the commander if he was ready for the FLT CONTROL B switch to be selected OFF (putting the aircraft in manual reversion). The commander replied "YES GO AHEAD". The hydraulics to the B system were turned off (time 15:36:47). The elevator position rapidly moved to just over 8° trailing edge down (an increase in 3° trailing edge down from the trimmed position), and the aircraft pitched from 2° nose up to 2° nose-down. The commander immediately pulled back on the control

The aircraft’s descent rate increased considerably, reaching a maximum of 20,000 ft/min as it descended through about FL110. At this point the bank angle was reducing through 40°, the pitch attitude was 30° nose-down, and the airspeed was 320 kt (Mach 0.60) but still accelerating. As the aircraft’s descent rate started to reduce, the commander made a PAN call (time 15:37:20). This call coincided with the sounding of the aural overspeed warning which remained active for the next 48 seconds.

The maximum recorded airspeed during the recovery was 429 kt (Mach 0.719). The maximum recorded vertical acceleration was 1.6 g and the minimum recorded altitude was 5,655 ft amsl. The Mach trim was in operation above Mach 0.615 making pitch-up commands to the elevator in addition to deflections demanded by the commander’s control column inputs.

Salient FDR Parameters for the serious incident to G-EZJK

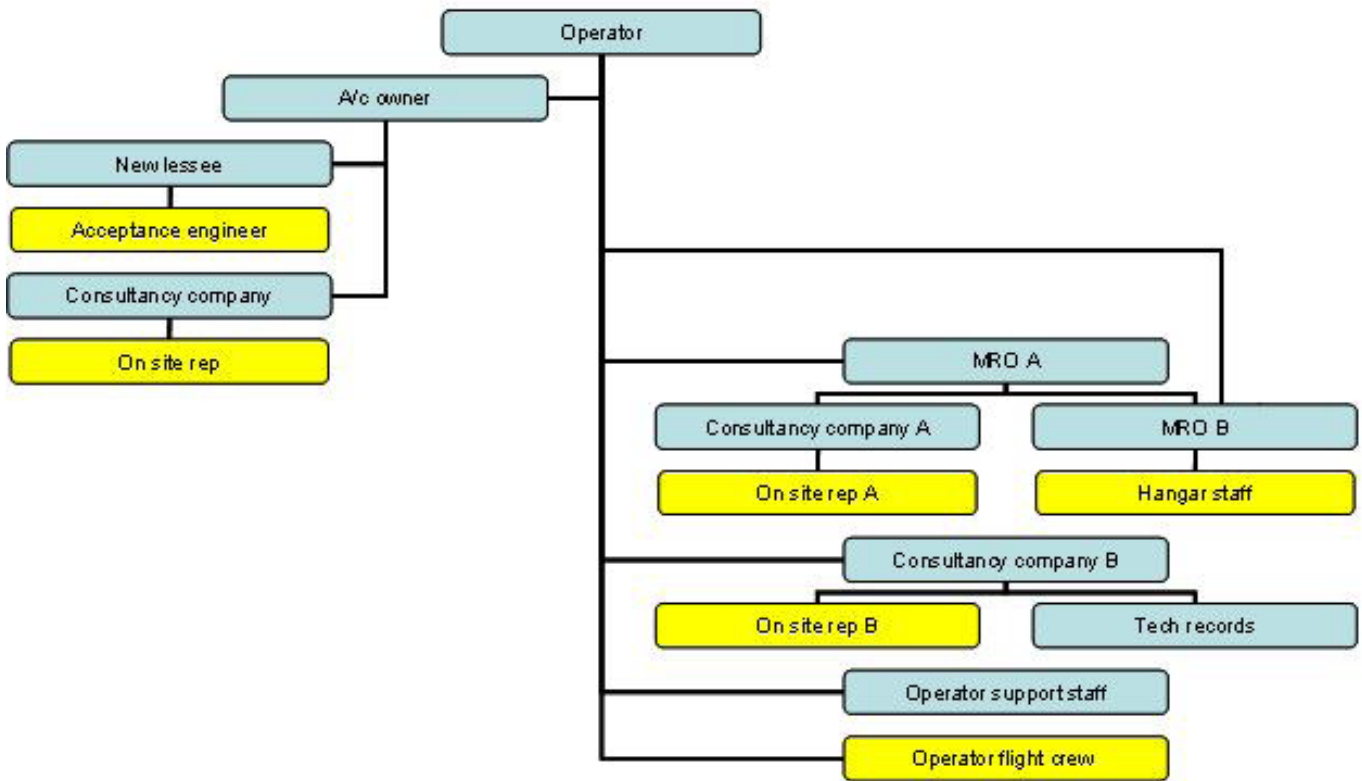
**Figure 9**

Chart of parties involved in aircraft hand-back (direct involvement in the incident is highlighted in yellow.)

#### **Safety Recommendation 2010-072**

It is recommended that the European Aviation Safety Agency review the regulations and guidance in OPS 1, Part M and Part 145 to ensure they adequately address complex, multi-tier, sub-contract maintenance and operational arrangements. The need for assessment of the overall organisational structure, interfaces, procedures, roles, responsibilities and qualifications/competency of key personnel across all sub-contract levels within such arrangements should be highlighted.

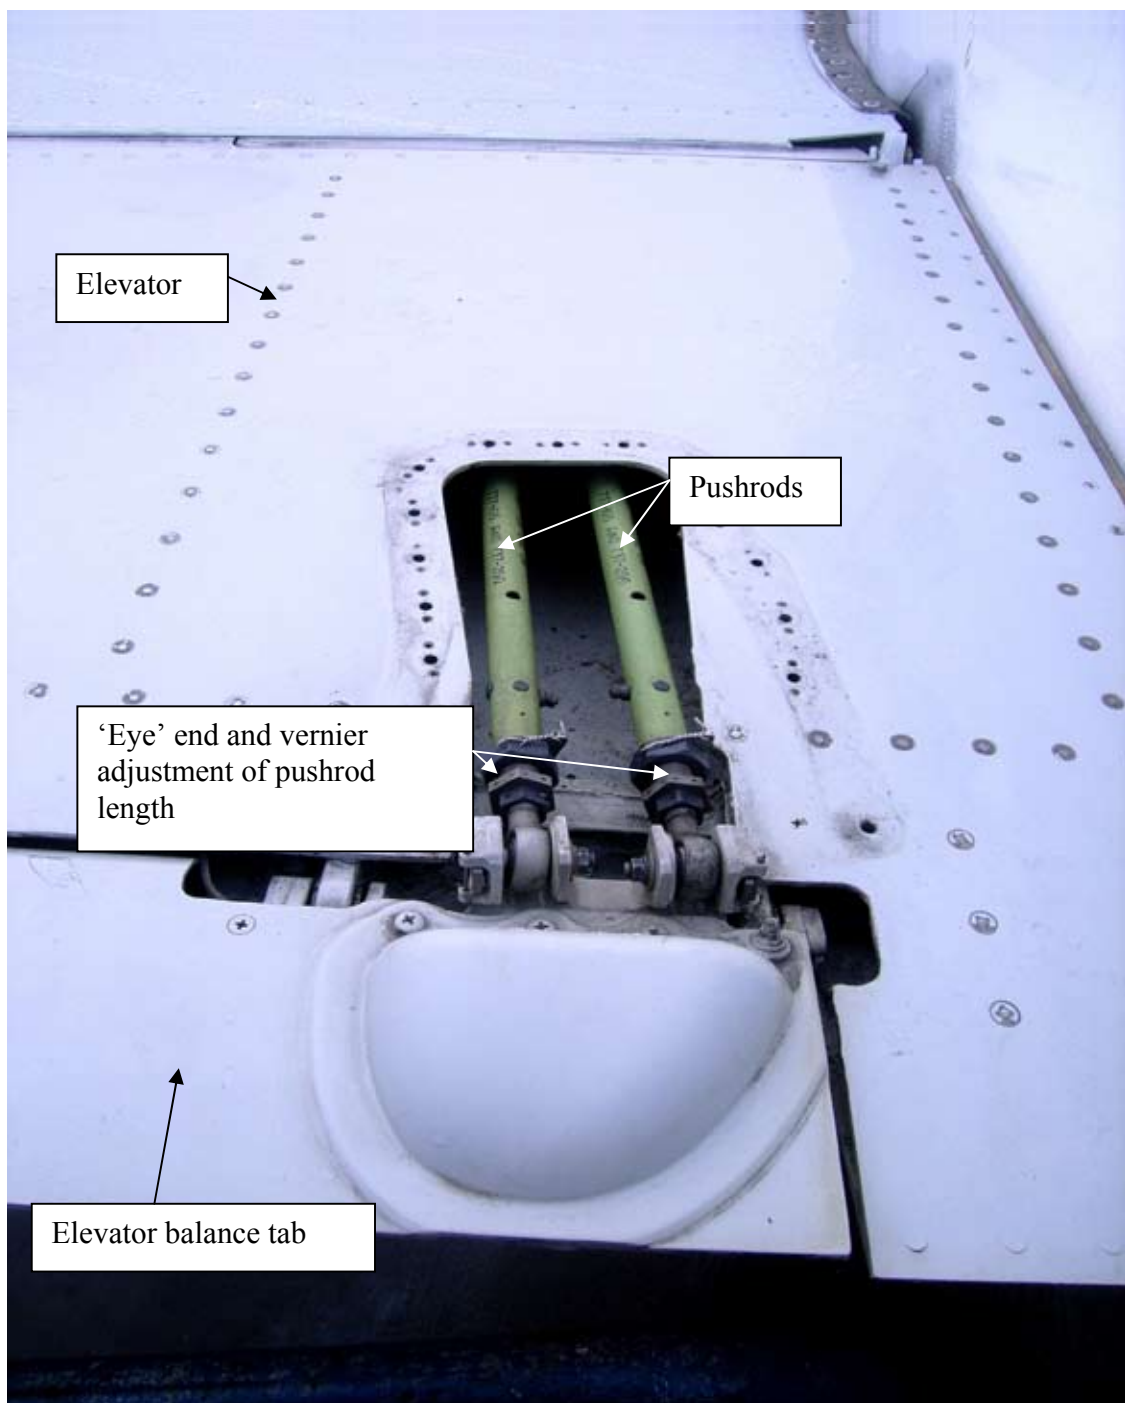
**Figure 10**

The B737-700 is fitted with tabs on the trailing edges of the elevator control surfaces. These act as balance tabs to reduce the control forces required to move the elevators and are critical for manual control of the aircraft in the event of a double hydraulic system failure. Two control rods link each tab to the elevator control

Based on the pilot's report, a 0.05 inch trailing edge down adjustment of the tab was required to achieve neutral trim (although the aircraft was within AMM limits). A review of the adjustment task completed by MRO B staff, as a consequence of the information provided in the customer work request, showed that they calculated an adjustment of 0.105 inch trailing edge up was necessary to achieve neutral trim. The AMM recommends that the tab is only rigged to the nearest 0.01 inch. They noted that a half turn adjustment of the rod 'eye' end gave a 0.1 inch adjustment in the tab trailing edge position, and so elected to round down to this figure to avoid the need to adjust the vernier bushing. A duplicate inspection of the task was completed in line with requirements, but this did not identify any issues. However, the difference between the required and actual adjustment of the tab trailing edge position was roughly equivalent to applying 18 nose-down turns of the trim wheel to a balanced aircraft.

Elevator tab pushrods

**Safety Recommendation 2010-074**

It is recommended that Boeing develop an Aircraft Maintenance Manual procedure to identify mis-rigging of the B737 elevator tab control system and amend the Aircraft Maintenance Manual tab adjustment procedure to limit the amount of trim adjustment on any one maintenance input.
