ACCIDENT

Aircraft Type and Registration:	Boeing 767-324, G-OOBK	
No & Type of Engines:	2 General Electric CO CF6-80C2B7F turbofan engines	
Year of Manufacture:	1995	
Date & Time (UTC):	3 October 2010 at 0536 hrs	
Location:	Bristol Airport	
Type of Flight:	Commercial Air Transport (Passenger)	
Persons on Board:	Crew - 12	Passengers - 258
Injuries:	Crew - None	Passengers - None
Nature of Damage:	Significant structural damage to fuselage crown skins	
Commander's Licence:	Airline Transport Pilot's Licence	
Commander's Age:	49 years	
Commander's Flying Experience:	14,433 hours (of which 1,355 were on type) Last 90 days - 225 hours Last 28 days - 92 hours	
Information Source:	AAIB Field Investigation

Synopsis

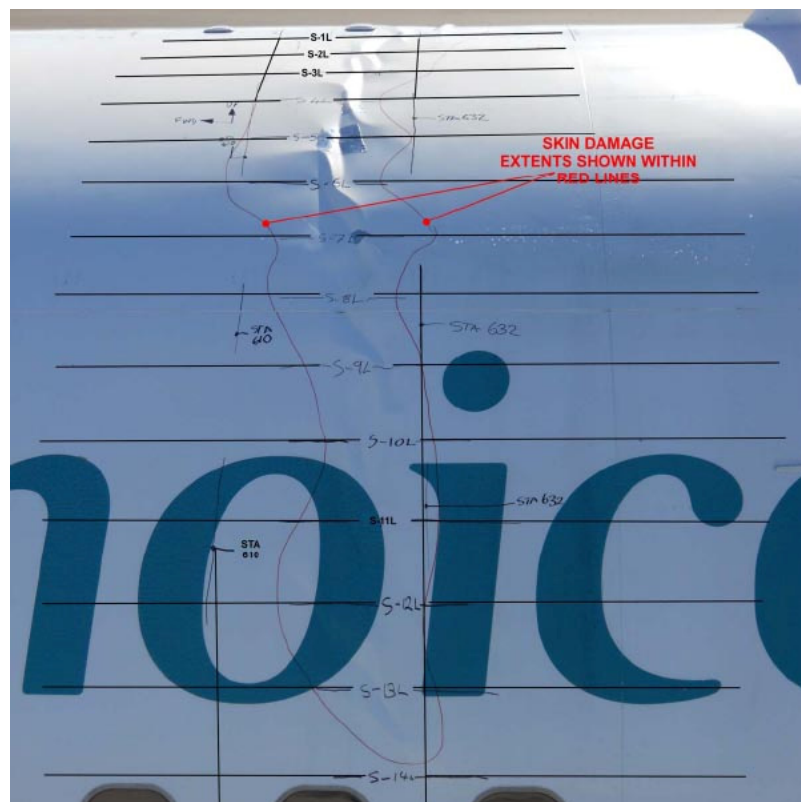
Figure 5

Phase one hard landing inspections were carried out by the Operator in accordance with AMM 05-51-01. The most significant damage was to the crown skins between frames STA 610 and STA 632 and stringers 14 L and 14 R. See Figure 5.

All the stringers in this area were cracked, bent or deformed and the skin was creased and wrinkled. Five frame segments were twisted and deformed, and the frame segment at STA 632 was cracked between stringer 13L and 14L. The intercostal was buckled at STA 645, stringer 1R. See Figure 6.

Buckling of skin between STA 610 and STA 632

After reviewing the flight data, the aircraft manufacturer determined that the damage to the aircraft was consistent with the aircraft either landing on the nose wheel or the nose wheel making contact with the runway following a rapid de-rotation.

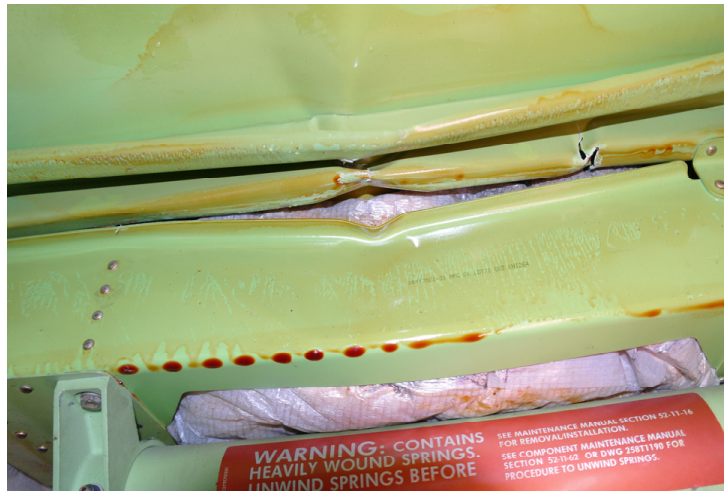
Figure 6

Buckling of intercostal and cracking of frame

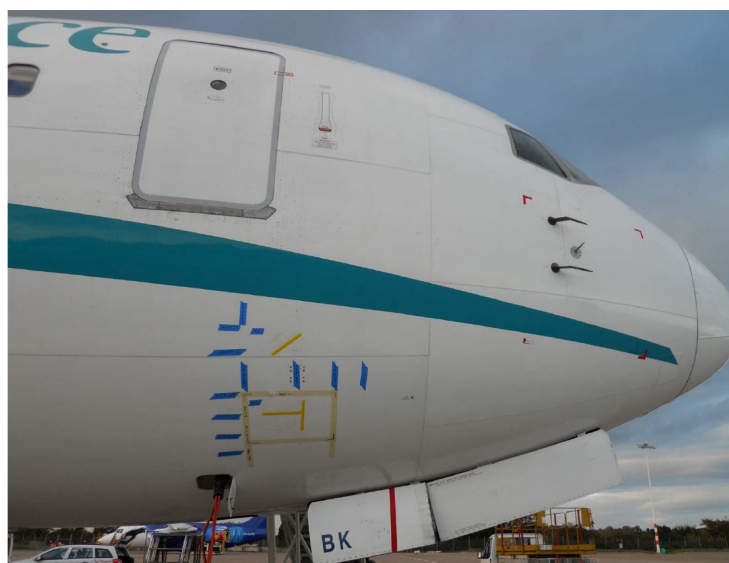
Figure 7

There was light creasing in the skin above and below the nose jacking point, though it was not possible to establish if this damage had occurred during this

landing. The skin in the area of the nose landing gear was also found to be wrinkled between STA 276 and 303, stringer 28R to 30R, and stringer 25R-26R. See Figure 7. There was evidence of an oil leak from the lower seal on the nose oleo and the trunnion bushings showed signs of having been displaced.

Damage adjacent to nose jacking point

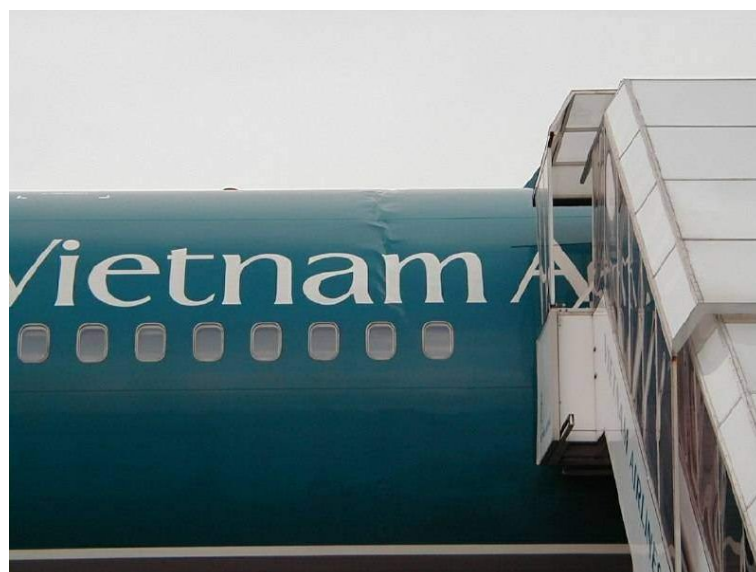
Figure 8

On the 19 September 2000, when the aircraft was previously registered as S7-RGV and operated by another airline, it sustained similar damage to the upper crown skins. It was not possible to establish the circumstances of this accident. The repair was carried out by a team from Boeing. See Figure 8. The maintenance records revealed that since the operator had taken delivery of the aircraft in December 2004 and there had only been one other report of a hard landing that occurred on 16 March 2010.

Previous damage to the crown skins
