**INCIDENT**

<b>Aircraft Type and Registration:</b>	DHC-8-402 Dash 8, G-JEDR	
<b>No &amp; Type of Engines:</b>	2 Pratt & Whitney Canada PW150A turboprop engines	
<b>Year of Manufacture:</b>	2003	
<b>Date &amp; Time (UTC):</b>	3 March 2011 at 1255 hrs	
<b>Location:</b>	Exeter Airport	
<b>Type of Flight:</b>	Commercial Air Transport (Passenger)	
<b>Persons on Board:</b>	Crew - 4	Passengers - 39
<b>Injuries:</b>	Crew - None	Passengers - None
<b>Nature of Damage:</b>	Right main landing gear inboard wheel detached	
<b>Commander's Licence:</b>	Airline Transport Pilot's Licence	
<b>Commander's Age:</b>	58 years	
<b>Commander's Flying Experience:</b>	6,778 hours (of which 3,417 were on type) Last 90 days - 103 hours Last 28 days - 24 hours	
<b>Information Source:</b>	AAIB Field Investigation

**Synopsis**

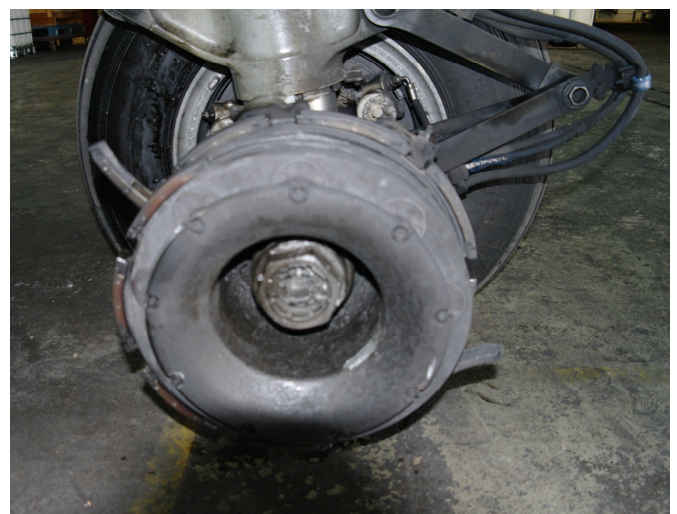
**Figure 1**  
Wheel axle as found

The detached main wheel and bearing debris found on the runway were recovered for AAIB inspection. Initial examination of the aircraft revealed that the wheel nut was still in position on the axle with its locking devices correctly installed. The brake unit was loose on the axle and had sustained damage to the heat pack, Figure 1. The wheel nut and brake unit were then removed from the axle along with the remains of the failed wheel bearings. The axle had light scoring to its bearing surfaces and there was minor flailing damage to components close to the brake unit.

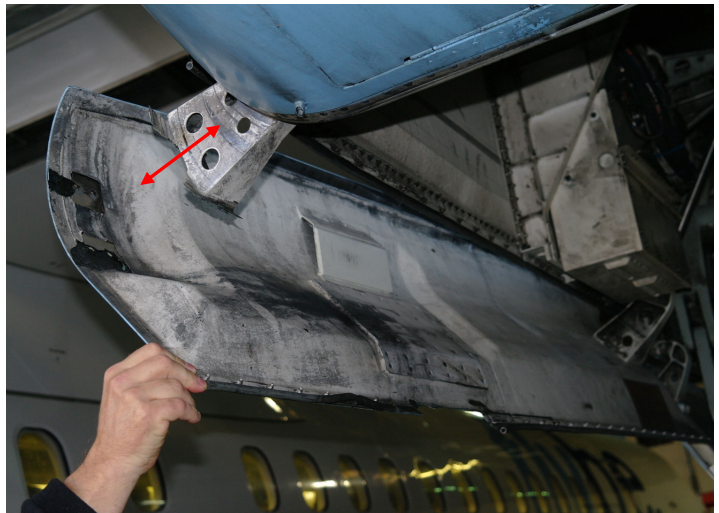
**Figure 2**

The right main landing gear inboard door showed evidence of contact with the rotating wheel assembly and its rear hinge attachment had been torn away from the door. The door remained attached to the aircraft by the other hinge and operating linkage, Figure 2. The nacelle above the door was slightly damaged by the door.

Inboard main gear door showing detached hinge

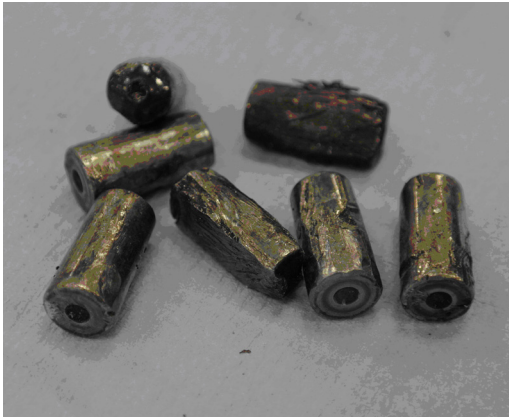
**Figure 5**

The remains of the wheel bearings and the wheel were examined with representatives of the bearing manufacturer, the wheel manufacturer and the operator present. There was evidence of sufficient grease of the correct type. The seven recovered rollers, Figure 5, were examined and these showed there was minimal heat generation and the roller bodies and spherical thrust large end showed minimal wear or distress prior to the incident. As these rollers were found on the runway, it cannot be certain which bearing these came from as the same part number roller is used in both bearings.

Recovered bearing rollers showing signs of mechanical rather than heat damage

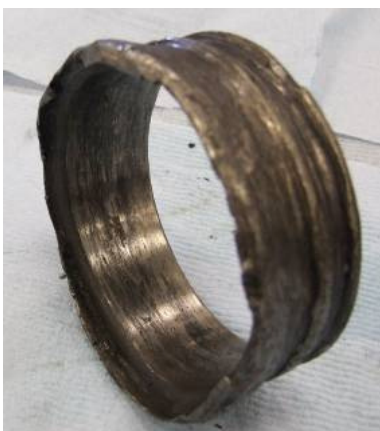
**Figure 6**

Both inboard and outboard bearings had suffered significant damage. The outboard bearing (closest to the wheel nut) showed that it had failed first and its cone thrust rib had been pushed flat by the forces of the failure, Figure 6, allowing the wheel to detach. The outboard bearing appeared to have suffered a cage trapping episode, where the cage became trapped between the rotating cup and the rollers, instantaneously locking the bearing and causing catastrophic failure. The inboard bearing suffered consequential, low temperature damage as the spinning wheel became unsupported by the severely damaged outboard bearing.

Outer bearing cone, showing deformed thrust rib

It is most likely that the outer wheel bearing suffered a trapped cage which caused it to fail catastrophically. Consequential damage deformed the outer bearing cone, allowing the inboard wheel of the right main landing gear to detach from its axle during landing gear retraction. It was not possible to determine the cause of the trapped cage.

The bearing manufacturer's representative has reiterated to its quality and production departments the need for the cage on these part number bearings to be 'close' to the low end of the manufacturing tolerance to ensure the maximum possible cage-to-cup clearance exists from new.

The wheel manufacturer has reviewed the bearing inspection section of the Component Maintenance Manual for the wheel to ensure that all the inspections

recommended by the bearing manufacturer are included. They have also recommended to the aircraft manufacturer that the roller bearing and cage assembly is replaced at each tyre change.

1. All engineers involved in the repair and overhaul of wheels and their associated wheel bearings will receive the bearing manufacturer's inspection requirements and techniques training.
2. The bearing manufacturer's Aircraft Landing Wheel Bearing Maintenance Manual will be available in their wheel and brake workshop as a reference document for the inspection process.
3. All new bearings received from suppliers will be fully inspected.

The operator is also considering the introduction of a fixed operating life for these bearings rather than the 'on-condition' basis used at present.
