AAIB Bulletin No: 7/95

Ref: EW/C95/5/5

Aircraft Type and Registration: De Havilland Canada DHC-8-311 Dash 8, G-BRYJ

Location: Jersey Airport

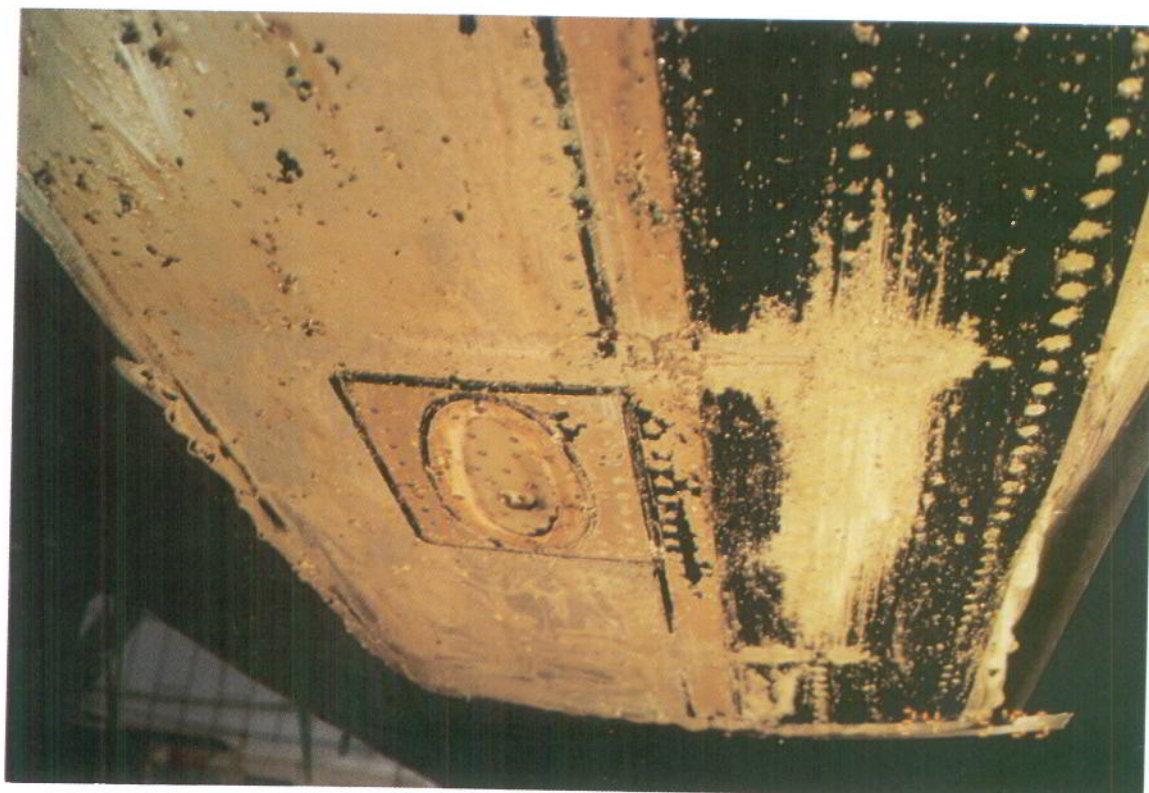
A photograph of the damage is also appended, although it should be noted that at the time of the AAIB inspection, the damaged area had been treated with paint stripper in preparation for the structural repair. The damage would definitely have appeared more superficial when it was inspected immediately after the sectors flown. In particular, it was apparent that the paint quality was such that it was difficult to discern the rivet lines, and in consequence, the locations of the frames and stringers. Inspection of the fuselage interior in the affected area revealed no evidence of damage.

The fuselage skin panels in this area consisted of two alloy sheets bonded together. These in turn were conventionally riveted to the frames and stringers. The left and right panels butted together on the aircraft centreline, the join being covered by internal and external butt straps. The inner strap was considerably wider than the outer, which had been abraded away where it straddled frame No 642.50. The skin either side was also severely abraded, slightly more so on the right-hand side, and the two layers of the skin panel had worn away, exposing the inner butt strap. The skin was scratched as far forward as the next frame, with the damage again being slightly more severe on the right-hand side. The TOUCHED RUNWAY switch mounting plate, mounted to the left of the centreline, and which stood slightly proud of the skin, had been abraded on its rear corners. The frangible disk that covered the switch, together with the external switch components, were missing.

View on underside of G-BRYJ looking forward. Note "touch runway" switch mounting plate to the left of the centreline

(NB. Surface treated with paint stripper at time of photograph)
