No: 8/92

Ref: EW/C92/4/1

**Aircraft Type and Registration:** Grob G115, G-BPKG  
**No & Type of Engines:** 1 Lycoming O-235-H2C piston engine  
**Year of Manufacture:** 1988  
**Date & Time (UTC):** 3 April 1992 at about 0950 hrs  
**Location:** Loch Muick near Ballater, Scotland  
**Type of Flight:** Private (training)  
**Persons on Board:** Crew - 2 Passengers - None  
**Injuries:** Crew - 2 Fatal Passengers - N/A  
**Nature of Damage:** Aircraft destroyed  
**Commander's Licence:** Commercial Pilot's Licence with Instructor Rating  
**Commander's Age:** 35 years  
**Commander's Flying Experience:** 1170 hours (of which 10 were on type)  
Last 90 days 150 hours  
Last 28 days 40 hours  
**Information Source:** AAIB Field Investigation

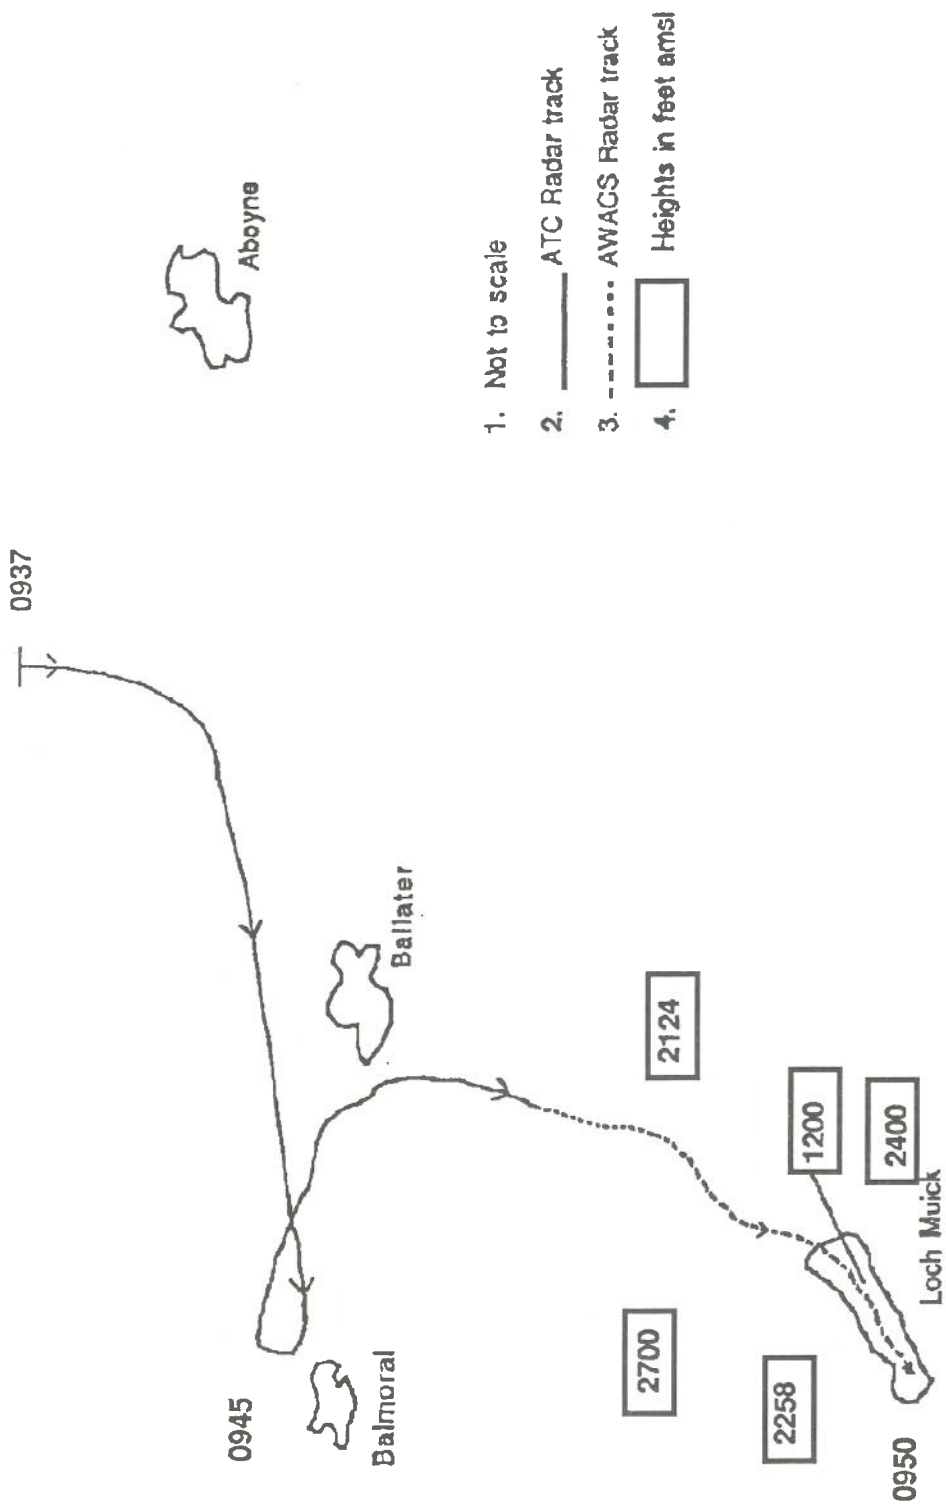
Figure 1

A recording of the aircraft's transponder return displayed on the Aberdeen radar (see Figure 1) indicates that, after the pilot's call at 0937 hrs stating that he would be operating in the Ballater/Aboyne area, the aircraft headed south and then west towards Balmoral where, at 0945 hrs, it turned right towards Ballater. When about one mile west of Ballater, the aircraft turned right into Glen Muick. At 0948 hrs, when two and a half nautical miles south west of Ballater, the aircraft ceased to paint on the Aberdeen radar due to the obscuration generated by the high ground between the radar head and the aircraft. Calculation indicates that the minimum height at which an aircraft can fly in this position and produce a primary radar return on the Aberdeen radar is 2,400 feet. Flight trials indicated that in this position SSR responses could be observed on the Aberdeen radar down to 2,200 feet. Radar data subsequently obtained from an RAF aircraft operating in the North Sea was in good agreement with the Aberdeen data and was available later than 0948 hrs because this radar was not affected by the high ground adjacent to the aircraft's track. This data indicates that the aircraft continued to fly along Glen Muick until contact was lost at 0950 hrs in a position half way along Loch Muick. At about 0940 hrs, a witness located at Birkhall, which position was coincident with the last return from Aberdeen radar, heard an aircraft flying towards Loch Muick. She reported that the engine of the aircraft sounded rough and at one point made a loud 'bang'. She also reported that at the time there was a snow storm in the Glen Muick area.
