ACCIDENT

Aircraft Type and Registration:	Jabiru UL, G-VILA
No & Type of Engines:	1 Jabiru Aircraft Pty 2200A piston engine
Year of Manufacture:	1999 (Serial no: PFA 274A-13364)
Date & Time (UTC):	8 December 2012 at 1119 hrs
Location:	Aldham, near Hadleigh, Suffolk
Type of Flight:	Private
Persons on Board:	Crew - 1 Passengers - None
Injuries:	Crew - 1 (Fatal) Passengers - N/A
Nature of Damage:	Aircraft destroyed
Commander's Licence:	Private Pilot's Licence
Commander's Age:	56 years
Commander's Flying Experience:	634 hours (of which 260 were on type) Last 90 days - 6 hours Last 28 days - 2 hours
Information Source:	AAIB Field Investigation

Synopsis

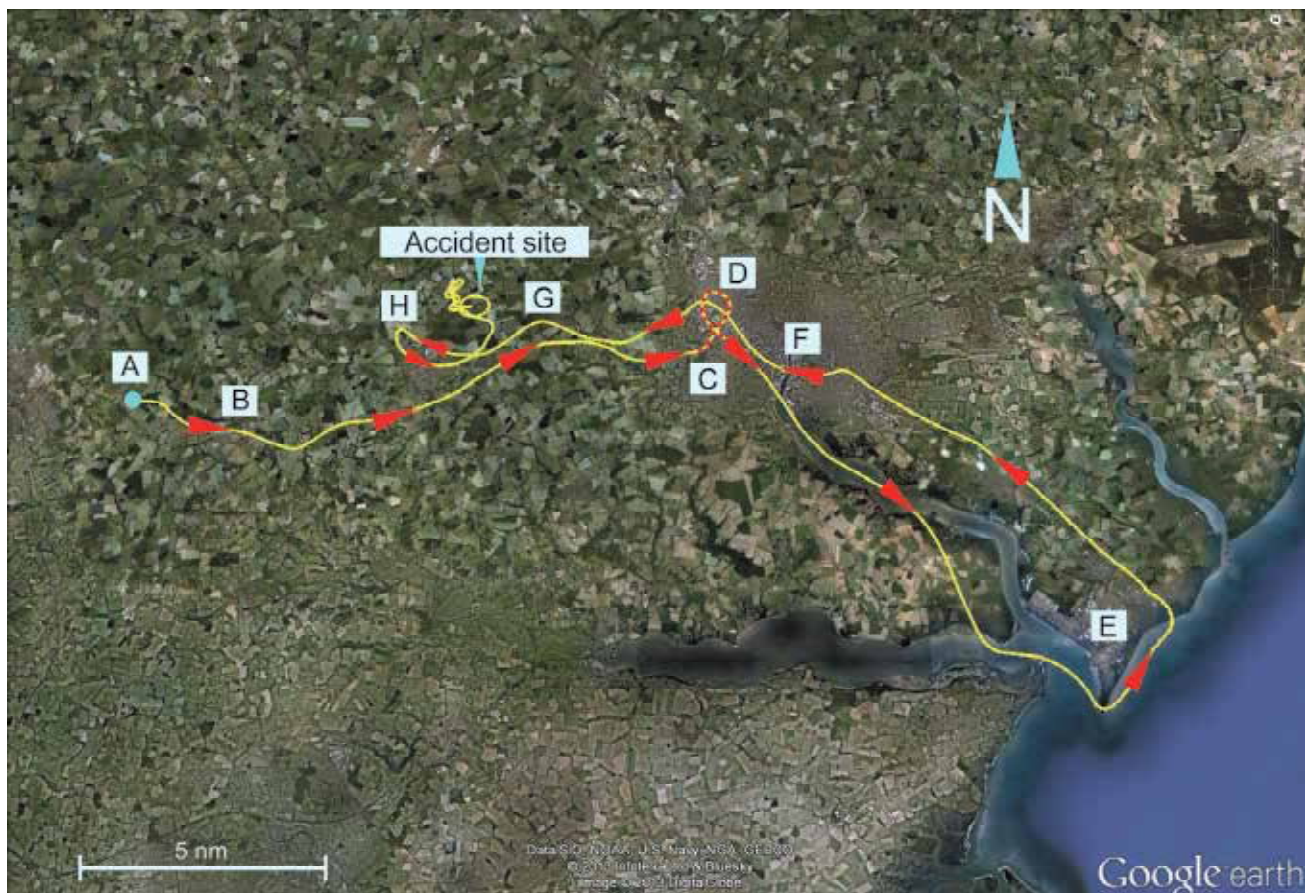
Figure 1

1031 hrs, with the pilot transmitting on the Wattisham frequency that he was climbing to 2,000 ft and had set a QNH of 1025 hPa. The aircraft initially climbed to 700 ft amsl but then descended to about 400 ft (about 200 ft agl) as it approached Boxford (Point B). The aircraft flew to the south of Boxford and then climbed to about 850 ft amsl. Reaching Ipswich (Point C) the pilot flew an orbit near the city (Point D) before tracking towards Felixstowe, 7 nm to the south-east (Point E).

At 1053 hrs, having flown along the coastline at Felixstowe, the aircraft flew over Ipswich, in a north-westerly direction, at between 800 ft and 850 ft amsl (Point F) and tracked towards Newton. A friend of the pilot recognised the aircraft as it passed

over Ipswich and called the pilot's mobile phone. The pilot answered the incoming call at 1105:05 hrs and the call ended at 1106:28 hrs; during the conversation the pilot described his route and commented that there was mist ahead and that he would need to descend to 300 ft. The phone call ended with the pilot saying he would visit his friend's house later in the day. At 1107:04 hrs (Point G) the aircraft started to descend at about 300 ft/min. Having descended to 440 ft (approximately 240 ft agl), the aircraft flew over an industrial area located at the easterly edge of Hadleigh (Point H), following which it started to climb at about 250 ft/min.

Overview of track of G-VILA (Points A to H)

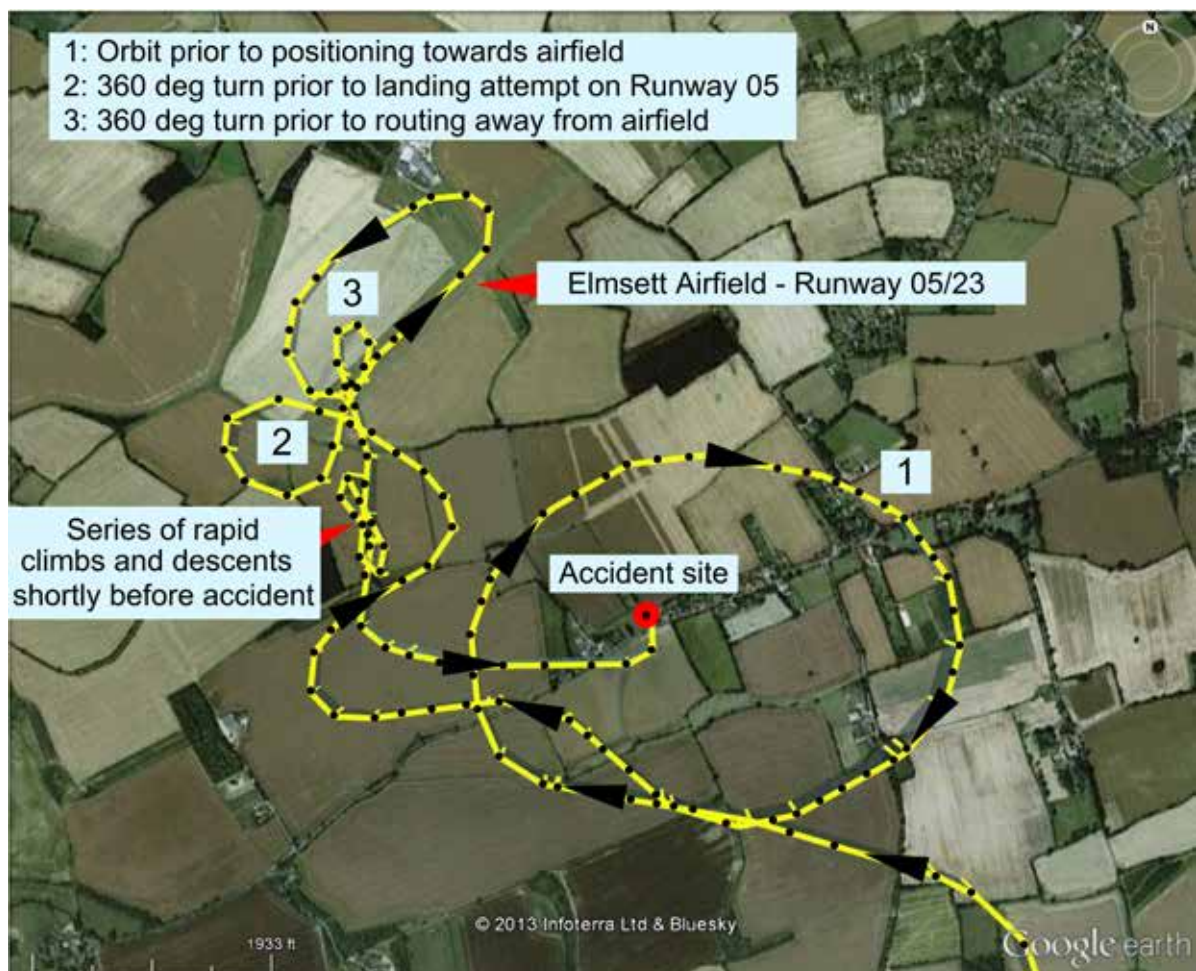
Figure 2 shows the last seven minutes of flight. Approximately 0.5 nm south-east of Elmsett Airfield, the aircraft flew an orbit down to about 260 ft, (Figure 2, Point 1) before making a series of turns ending almost overhead the threshold of Runway 05, at 200 ft aal. The aircraft tracked along the runway centre line, continuing to descend (Point 2). About two-thirds along the runway the aircraft had descended to approximately 50 ft, at a groundspeed of 58 kt. The aircraft then climbed in a left-hand turn, consistent with positioning for a further approach to Runway 05 (Point 3). Reaching the threshold, the aircraft flew a tight left-hand orbit at about 180 ft, and then flew south, away from the runway.

GPS-derived position and altitude of G-VILA - final seven minutes

The aircraft then climbed rapidly before descending to a height of about 150 ft. It climbed again and then descended to 170 ft, whilst making two 180° turns. Coincident with these manoeuvres, an open microphone transmission lasting about 3.5 seconds was recorded on the Wattisham radio frequency. The transmission contained no speech but some breathing, consistent with an inadvertent transmission being made by the pilot of G-VILA. The aircraft then made a left turn towards the east and briefly climbed to a height of about 480 ft, before descending at a rate of 3,300 ft/min, in a left turn. The aircraft impacted the ground a few seconds later (Point 4).

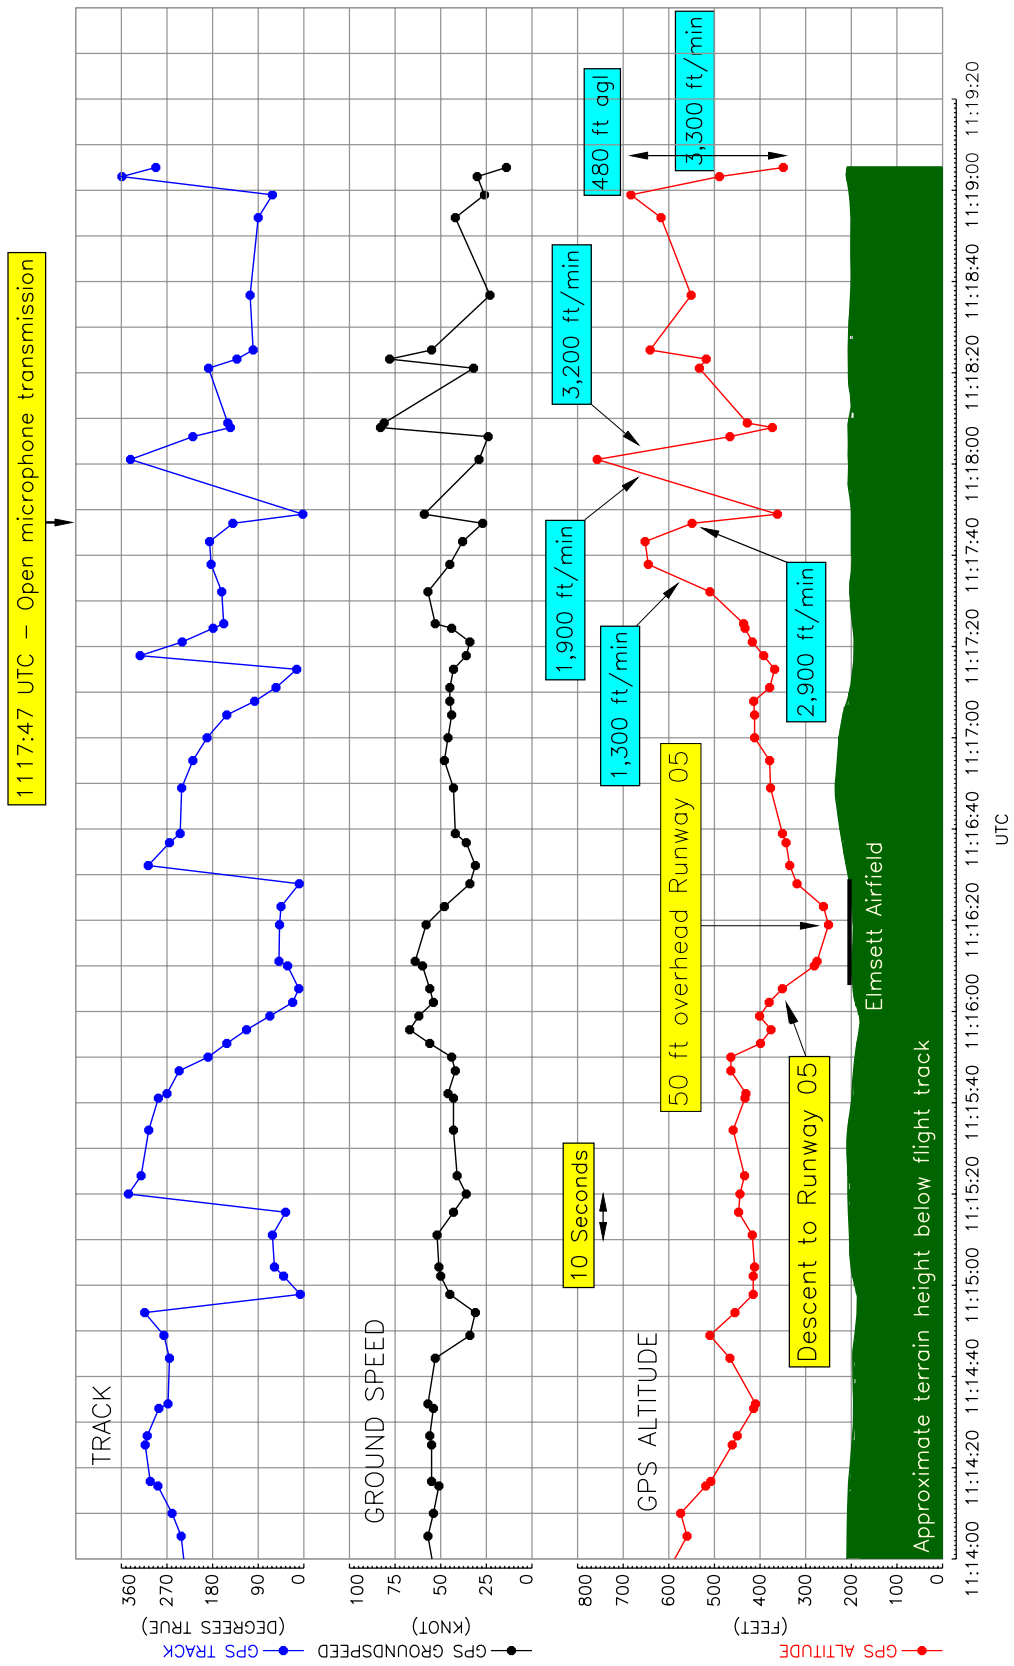
The GPS contained a track log of the accident flight, with aircraft GPS-derived position, track, altitude and groundspeed recorded. The record commenced with the aircraft positioned for takeoff from the easterly strip at 1027 hrs and ended at 1119:05 hrs, shortly before the aircraft impacted the ground. There was a close correlation between the radar and GPS information during the flight, confirming the accuracy of the two information sources. Information from the GPS is shown in Figures 1 to 3; Figure 3 showing the time-history plots.

G-VILA - GPS track, altitude and groundspeed

From the evidence derived from the GPS onboard G-VILA, it is likely that the pilot was attempting to land at Elmsett Airfield. The GPS data from 1116 hrs showed rapid changes in speed, track and altitude, suggestive of an aircraft not fully under control. The description from the eyewitnesses of the aircraft's final manoeuvres suggests that, as the aircraft approached Aldham, the pilot pulled up into a cloud layer and hence his visual references would have been compromised. In the cloud, control of the aircraft was probably lost almost immediately, which resulted in a steep descent and ground impact.

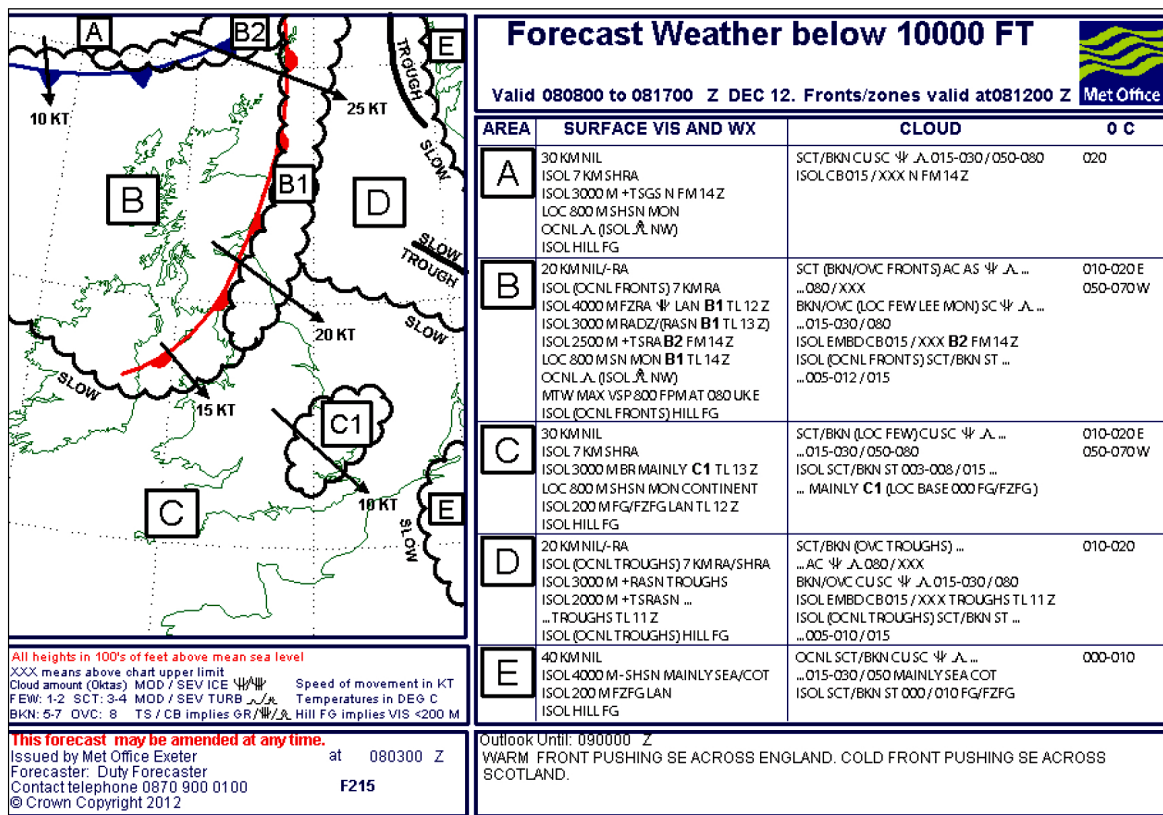
The UK Met Office provided an aftercast of the accident area, along with additional data. On the morning of the accident the forecast available to pilots included Metform F215, (Figure 4) The accident occurred in area C1 for which the Met Office report had the following forecast:

‘30 KM visibility in nil weather, with scattered or broken cloud bases at 1,500 – 3,000 ft

Isolated 7 km visibility in moderate rain showers

Isolated 3,000 m in mist until 1300 UTC with scattered or broken stratus bases 300 – 800 ft

Isolated 200 m in fog or freezing fog until 1200 UTC with associated cloud base at the surface

Isolated hill fog.’

Figure 4
Metform F215

It is not possible to know what weather information the pilot considered before deciding to fly but an extensive area of fog and low cloud was forecast on the Metform F215. The reference, on the Metform F215, to '*isolated*' low cloud and fog meant that up to 25% of the indicated area could be affected. In this case, 25% of area C1 comprised several thousand square miles, and represented a hazard to light aircraft. The SAR commander's estimate of a 20 nm radius of solid fog is corroborated by the satellite data, but still would not have comprised more than 25% of area C1.

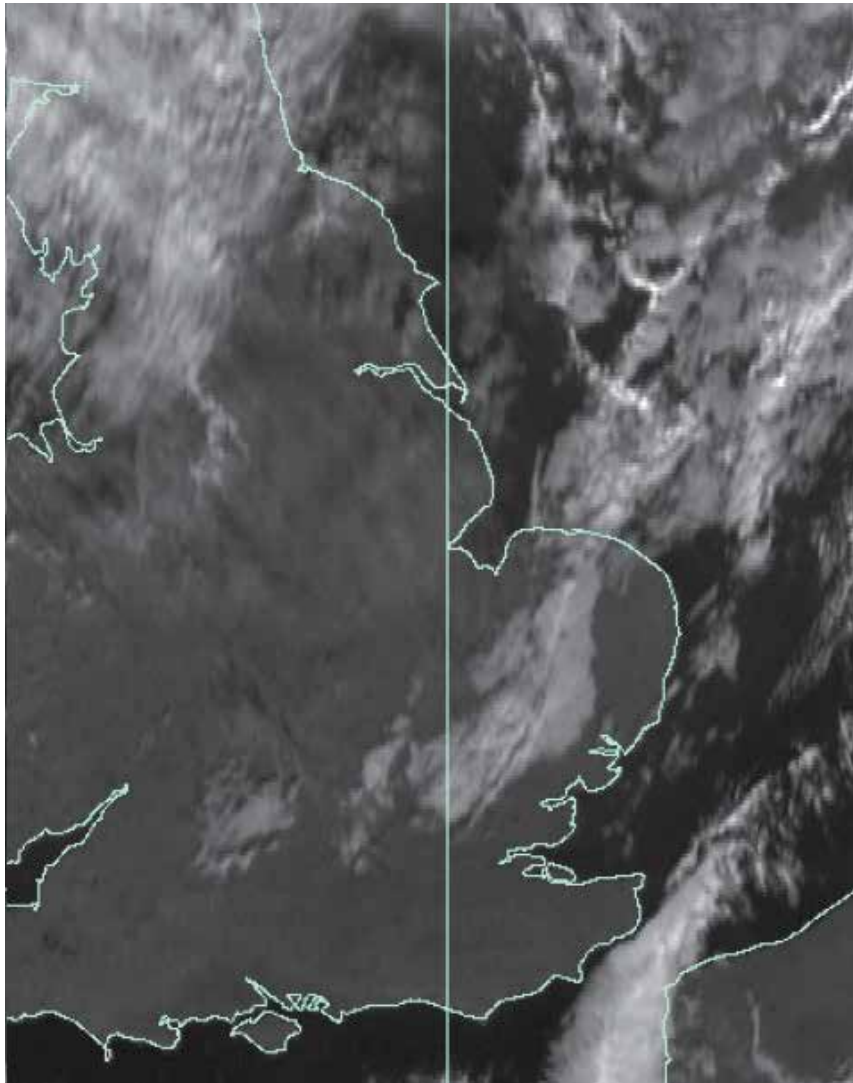
Figure 5

'The weather over England was settled under a ridge of high pressure, however there were some areas of fog and low cloud. Looking at the satellite pictures from that morning much of the fog and low cloud cleared but there was a significant area over East Anglia which did not clear and was moving slowly south east. (Figure 5)

This area of advection fog and low cloud dropped the visibility to (between) 500-4000M. Cloud bases varied between the surface and 400FT.

Visibility outside of the area of cloud was at least 8-10 KM. The visibility and cloud base can vary quite significantly and rapidly within such an area of low cloud. These conditions were forecast on the F215 chart within the area C1.'

Satellite image of visible cloud and fog at 1115 hrs, 8 December 2012
