ACCIDENT

Aircraft Type and Registration:	Piper PA-28-140 Cherokee, G-BBBK	
No & Type of Engines:	1 Lycoming O-320-E3D piston engine	
Year of Manufacture:	1967	
Date & Time (UTC):	3 February 2007 at 1713 hrs	
Location:	In the sea close to Blackpool Beach, Lancashire	
Type of Flight:	Private	
Persons on Board:	Crew - 1	Passengers - 1
Injuries:	Crew - 1 (Fatal)	Passengers - 1 (Fatal)
Nature of Damage:	Aircraft destroyed	
Commander's Licence:	Private Pilot's Licence	
Commander's Age:	26 years	
Commander's Flying Experience:	110 hours (of which 105 were on type) Last 90 days - 4 hours (flown on the day of the accident) Last 28 days - 4 hours (flown on the day of the accident)	
Information Source:	AAIB Field Investigation

Synopsis

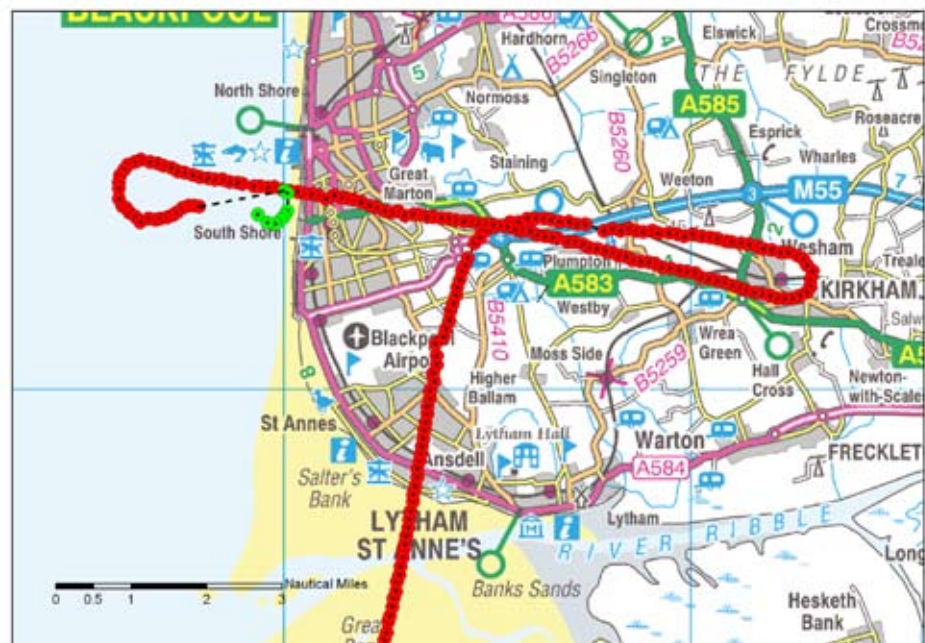
Recorded data from St Annes radar, identified as belonging to the accident aircraft, started at 1638 hrs with the aircraft near Mold, North Wales, when it was tracking to the North. Figure 2 shows this track just as G-BBBK approached Blackpool, and ends when radar contact was finally lost at 1713:18 hrs. Radar contact, however, was briefly lost at 1711:01 hrs (the end of the red track) in Figures 2 and 3, before being re-established 1 minute 39 seconds later (the start of the green track) for a further 38 seconds.

Radar track of G-BBBK positioning to land at Blackpool Airport
