AIRCRAFT ACCIDENT REPORT 3/2005

**Report on the serious incident to
Boeing 757-236, G-CPER
on 7 September 2003**

Air Accidents Investigation Branch

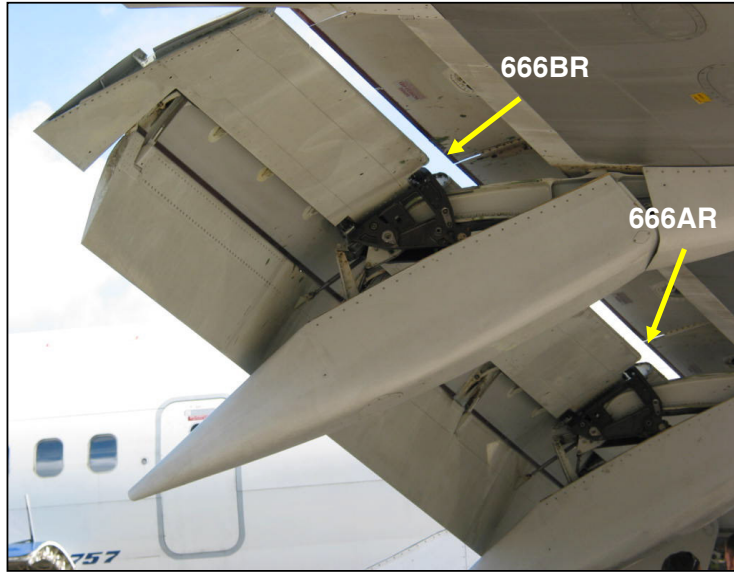
On examining the aircraft with the flaps down, access panels 666AR and 666BR were found to be missing from the outboard flap on the right wing (Figure 1). The panels are approximately 300 mm x 200 mm in size and are installed at the forward attachments for the main flap. Their purpose is to maintain the aerodynamic profile of the flap leading edge.

The panels had not been refitted during the recent maintenance. They were found on a storage rack in Hangar Bay 13 in Technical Block 'D' ('TBD') at

Figure 1
G-CPER R/H Outboard Flap showing locations of missing access panels 666AR and 666BR

After fitting the missing panels, a proving flight was made to verify the integrity of the aircraft before returning it to passenger service. This proved satisfactory, with no reported handling problems with flaps up or down.

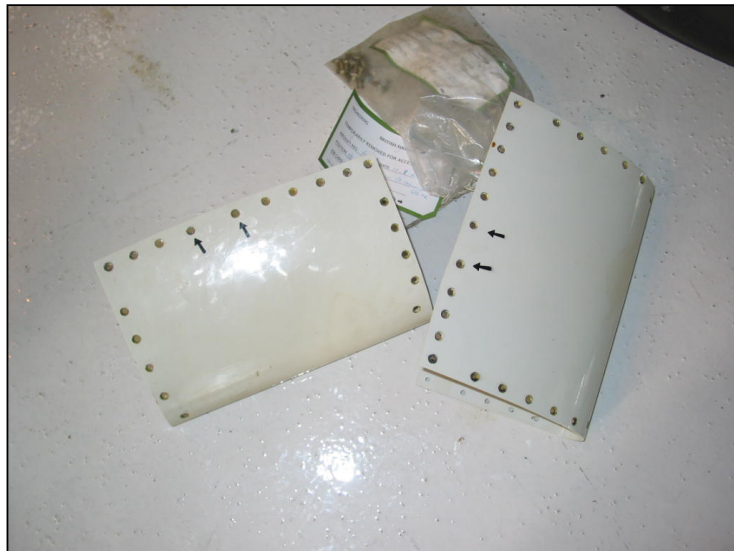
London Heathrow, where the maintenance had been performed. The panels were tagged with 'Temporarily Removed for Access' labels and the attaching screws were found in bags tied to the panels (Figure 2). Examination of the maintenance records showed that the job cards to install the panels had been stamped to certify that the panels had been fitted (Appendix 1). Both job cards had been certified by the same individual. There was no requirement for the panels to be independently inspected after fitting, as they are not considered to be safety critical items.

Figure 2
Flap Panels 666AR and 666BR, found on storage racks in 'TBD' Bay 13 Hangar

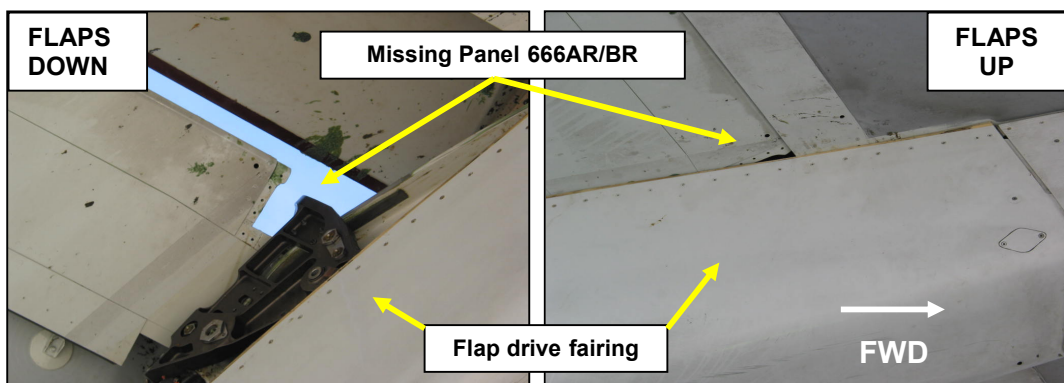
The outboard flap forward attachments to the flap carriages are accessed by removing panels 666AR and 666BR. The panels are secured to the main flap with screws secured by anchor nuts. The panel identification numbers are ink stamped on the inside of the panels. The location of the panels is illustrated in Chapter 06-44-00 of the Boeing 757 Maintenance Manual (Appendix 3). These panels are almost completely hidden by the flap drive fairings when viewed from below and the wing spoiler panels from above, when the flaps are retracted. However, they are clearly visible when the flaps are extended. Figure 3 shows the comparative visibility of the panels with flaps up and flaps down.

Figure 3
Relative visibility of missing flap access panels, flaps down and flaps up

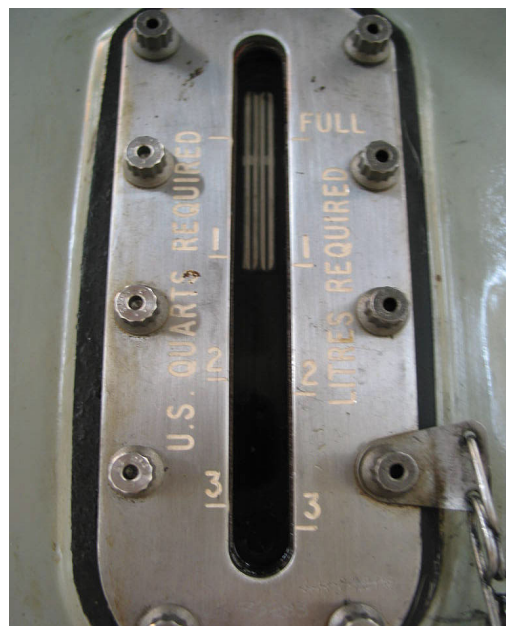
The sight glass is marked with a 'FULL' level (corresponding to approximately 20 litres) and is graduated in litres and US quarts required to top up to the full mark. Thus an oil level corresponding to the '3' on the 'litres' scale means that three litres of oil are required to top up to the 'FULL' mark.

Figure 4
Engine oil tank sight glass

A trial performed on G-CPER's left engine, which was test run prior to strip examination at Rolls-Royce Derby, showed that the oil level on the sight glass decreased by $\frac{3}{4}$ litre over a period of 12 hours after engine shut down.

Most recently the engine oil tanks have been modified by painting green and red bands next to the sight glass to visually differentiate between an acceptable oil level and what is considered to be overfull. The placard on the engine oil servicing door was also replaced with one stating that the maximum engine oil level is the top of the green band. The maximum fill level is now two litres below the 'FULL' graduation on the sight glass, giving a greater margin of protection against overfilling.
