ACCIDENT

Aircraft Type and Registration:	Schempp-Hirth Nimbus-3 glider, G-EENN	
No & Type of Engines:	None	
Year of Manufacture:	1981 (Serial no: 9)	
Date & Time (UTC):	4 September 2012 at 1233 hrs	
Location:	Portmoak Airfield, Scotlandwell, Kinross	
Type of Flight:	Private	
Persons on Board:	Crew - 1	Passengers - None
Injuries:	Crew - 1 (Fatal)	Passengers - N/A
Nature of Damage:	Aircraft destroyed	
Commander's Licence:	FAI Gold C Certificate and 2 Diamonds	
Commander's Age:	49 years	
Commander's Flying Experience:	1,325 hours (of which at least 100 were on type) Last 90 days - 1 hour Last 28 days - 1 hour	
Information Source:	AAIB Field Investigation

Synopsis

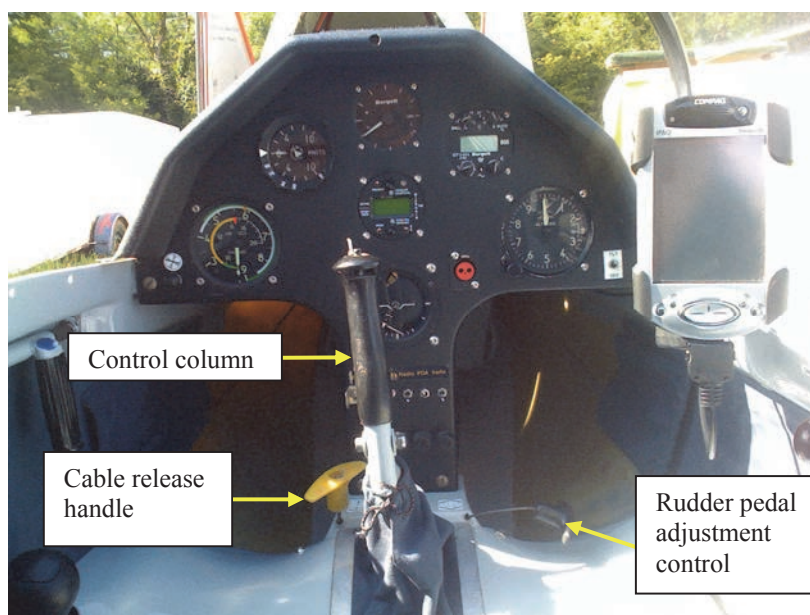
Figure 1

The Nimbus-3 is a single-seat high-performance glider constructed from carbon fibre and fibreglass with a maximum takeoff weight of 750 kg. It has a 25.5 m wing span and conventional flying controls operated by a control column and rudder pedals. It is also equipped with airbrakes, trailing edge flaps and a single-wheel, retractable, main landing gear. The wing tips are angled upwards and rubbing strips are fitted on the lower surface of each wing close to the wing tip. The glider can also carry water ballast in integral tanks fitted inside each wing. In G-EENN the pilot was secured by a four-point harness. For winch launches, the cable is attached to the cable release mechanism situated beneath the cockpit, just in front of the main wheel. On G-EENN the cable was released by the pilot pulling on a yellow coloured 'T' handle located just in front, and to the left, of the control column. A photograph of the cockpit of G-EENN, taken by a previous owner (Figure 1), shows the position of the cable release and rudder pedal adjustment controls.

Photograph of the cockpit in G-EENN taken several years prior to the accident

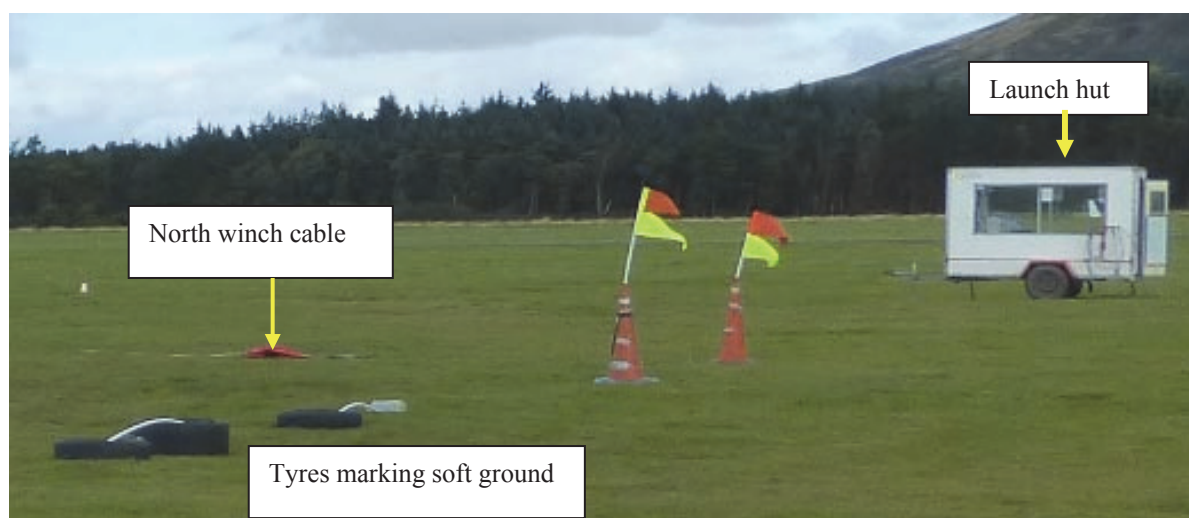
Figure 3

The winch cables were pulled to a position marked by two cones and flags with sufficient space for a glider to be launched from either side of the cones. An area of soft ground adjacent to the cones was marked by two tyres. G-EENN was launched from the southern position using the 'south' cable and from the ground marks it was established that at the start of the launch it was approximately 60 m from the launch hut. After the accident the 'north' cable, which was still in the position where both cables had been delivered, was found to be approximately 30 m north of the position from where G-EENN was launched (Figure 3).

Launch area at time of the accident, looking north-west

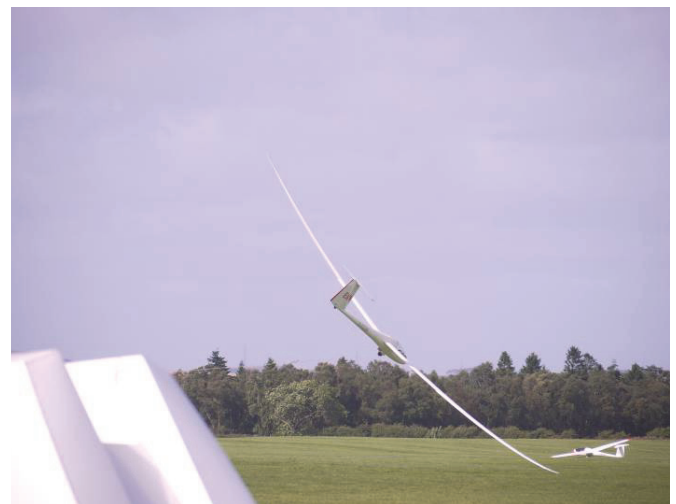
Figure 4

G-EENN, cable just released

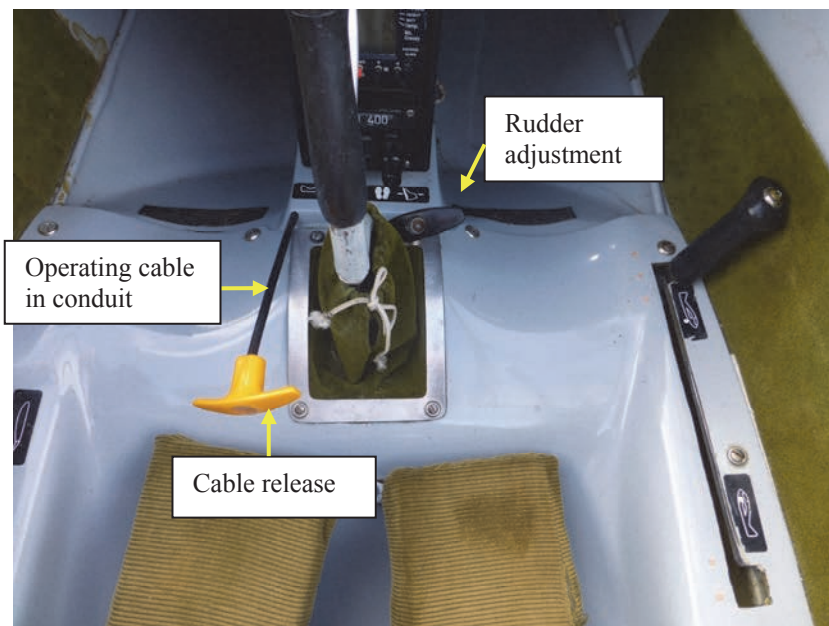
Figure 5

The winch cable release handle fitted to the test glider had a much longer operating cable, which was contained in a black conduit, than the handle fitted on G-EENN (Figure 5). Therefore the tests were carried out using the black rudder pedal adjustment handle, which although situated on the opposite side of the control column, was more representative of the winch cable release handle fitted on G-EENN. The pilot who operated the controls during the tests was approximately six foot tall and of average build.

Cockpit layout in glider used in test

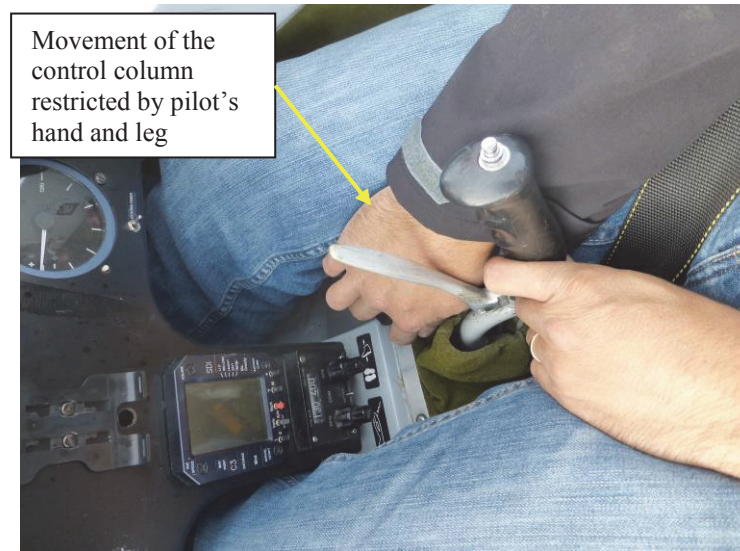
Figure 6

The tests showed that when the pilot kept his hand on the rudder adjustment handle, movement of the control column to the right was restricted by the control column making contact with his right hand, which was constrained by his leg (Figure 6). The maximum distance

that the control column could move corresponded to the aileron surfaces moving approximately 55% of their full range. When the test was repeated using the winch cable release handle equipped with the longer operating cable contained in the black conduit, the control column and ailerons could be moved through their full range of travel.

Movement of control column restricted by pilot's hand

The cable release handle in G-EENN was fitted in a position such that the pilot would probably not have been able to keep his hand on it and still achieve full roll control authority. It is not known whether he was in the habit of keeping his hand on the release during a winch launch, but if not, there was the potential for a critical delay in operating the release handle.

It is recommended that the European Aviation Safety Agency amend the certification standard for Sailplanes and Powered Sailplanes (CS 22) to include the requirement that the cable release mechanisms can be operated at any stage of the launch without restricting the range of movement of any flying control.

It is recommended that the European Aviation Safety Agency require that Type Certificate holders of EASA Type Certificated gliders ensure, where practicable, that the cable release control can be operated at any stage of the launch without restricting the range of movement of any flying control.

It is recommended that the British Gliding Association ensure that, where practicable, the cable release control on EASA Annex II gliders can be operated during any stage of the launch without restricting the range of movement of any flying control.

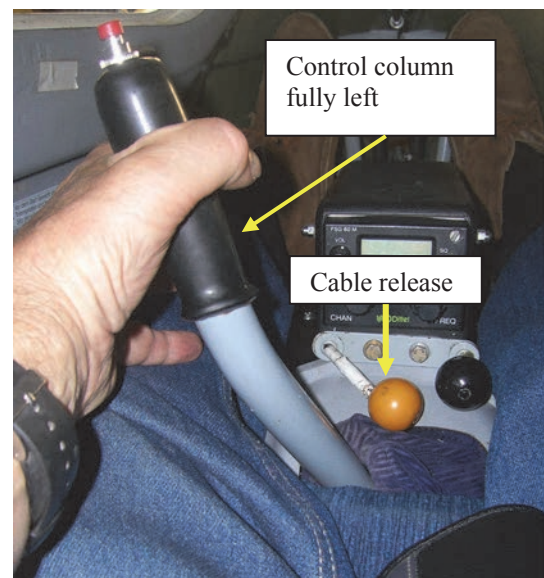
'The application of left aileron would properly have made it difficult to reach the release handle and operate it in the very short time available to regain control of the aircraft....it is possible that he was unable (Pilot) to apply sufficient force to it (release handle) to release the winch cable, especially if he was simultaneously applying full left aileron.'

Figure 7 shows the location of the cable release on a Schleicher ASW 19 glider, which has a similar arrangement to the ASW 20L. The photograph was taken with the control column in the full left position.

Location of cable release on ASW 19 glider

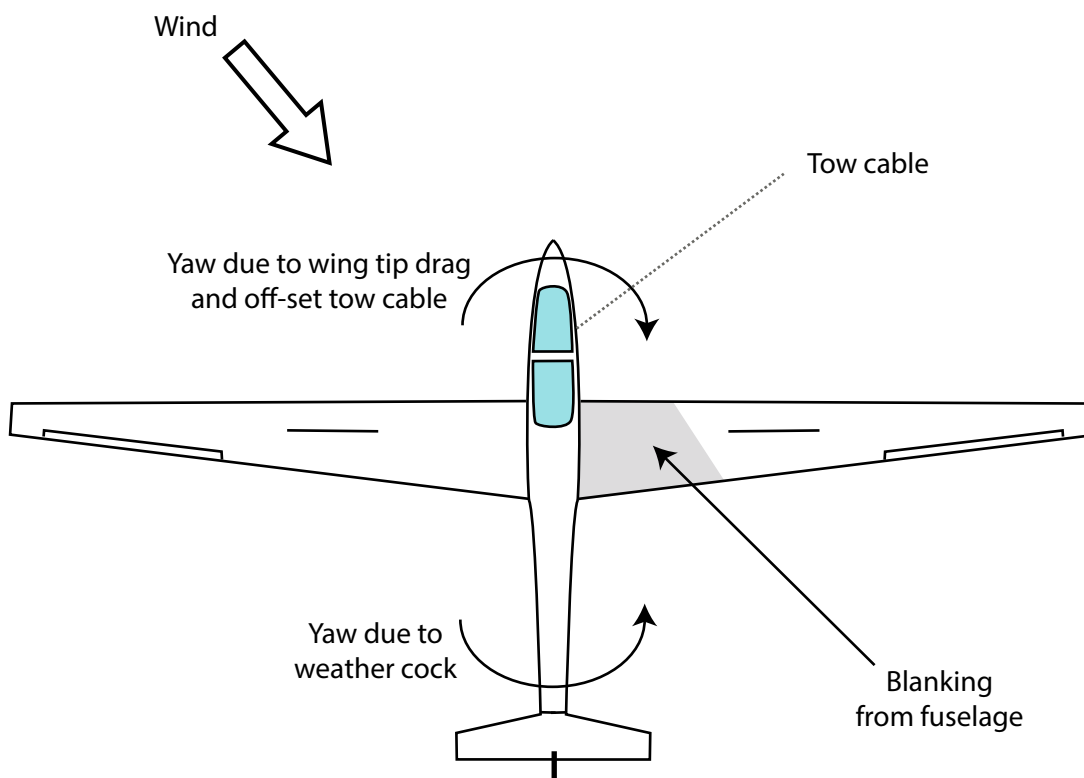
Figure 9

A wing drop accident can be considered in two phases; start of launch and weight-off the main wheel. In this example the release hook is mounted along the longitudinal axis, there is a crosswind from the left, the winch cable is offset to the right and the right wing tip is on the ground (Figure 9).

As the winch cable is wound in, the glider will accelerate along the ground and yaw rapidly to the right, about its main wheel, to align with the direction of the cable. The left wing will produce more lift than the right wing causing a rolling moment to the right. Releasing the cable at this early stage may prevent an accident.

While the crosswind will have the effect of countering the yaw to the right by 'weathercocking' the glider into the direction of the wind, the drag on the right wing tip will increase as the glider's speed increases, which further increases the yawing and rolling moment to the right. There is an increasing risk that the wing tip will dig into the ground and the glider's momentum will cause it to ground loop or cartwheel.

Example of winch launch dynamics

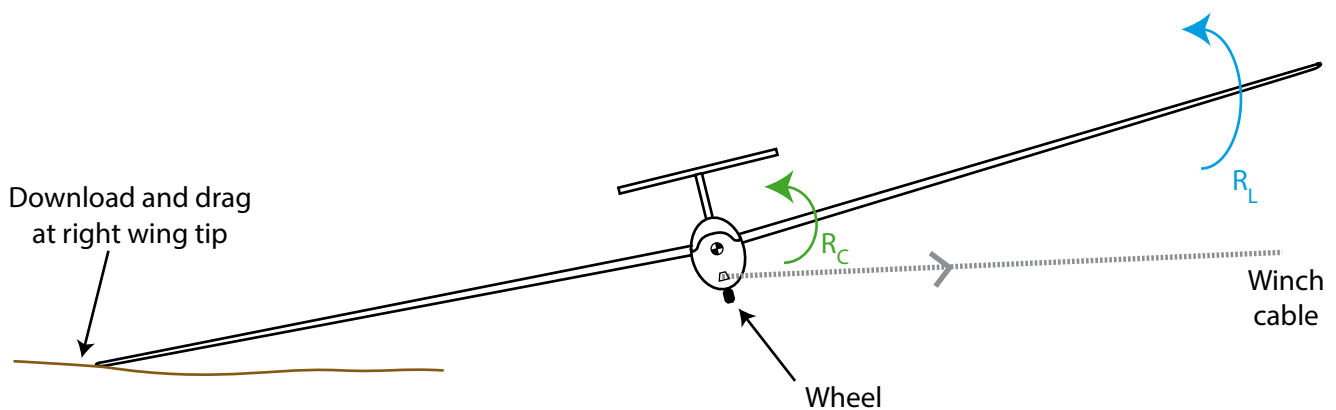
Figure 10

With a modern winch the weight will come off the main wheel approximately three to four seconds after the start of the launch sequence. With the main wheel off the ground, and the winch cable offset from the glider's heading, the force from the winch cable will introduce a rolling moment (R_c) about the glider's C of G (Figure 10).

This rolling moment acts in addition to the aerodynamic effects (R_L), and further increases the down load and drag on the right wing tip. The risk of an accident and injury to the occupants will have substantially increased.

Rolling moment due to offset winch cable

left the ground the pull from the cable acting below the C of G of the glider would have imparted an additional rolling moment to the right.
