PIPER PA24-250 AND 260 SERIES AIRCRAFT ONLY  
RECOMMENDED SPEED LIMITATION

PIPER  
Airworthiness Directive  
Volume I

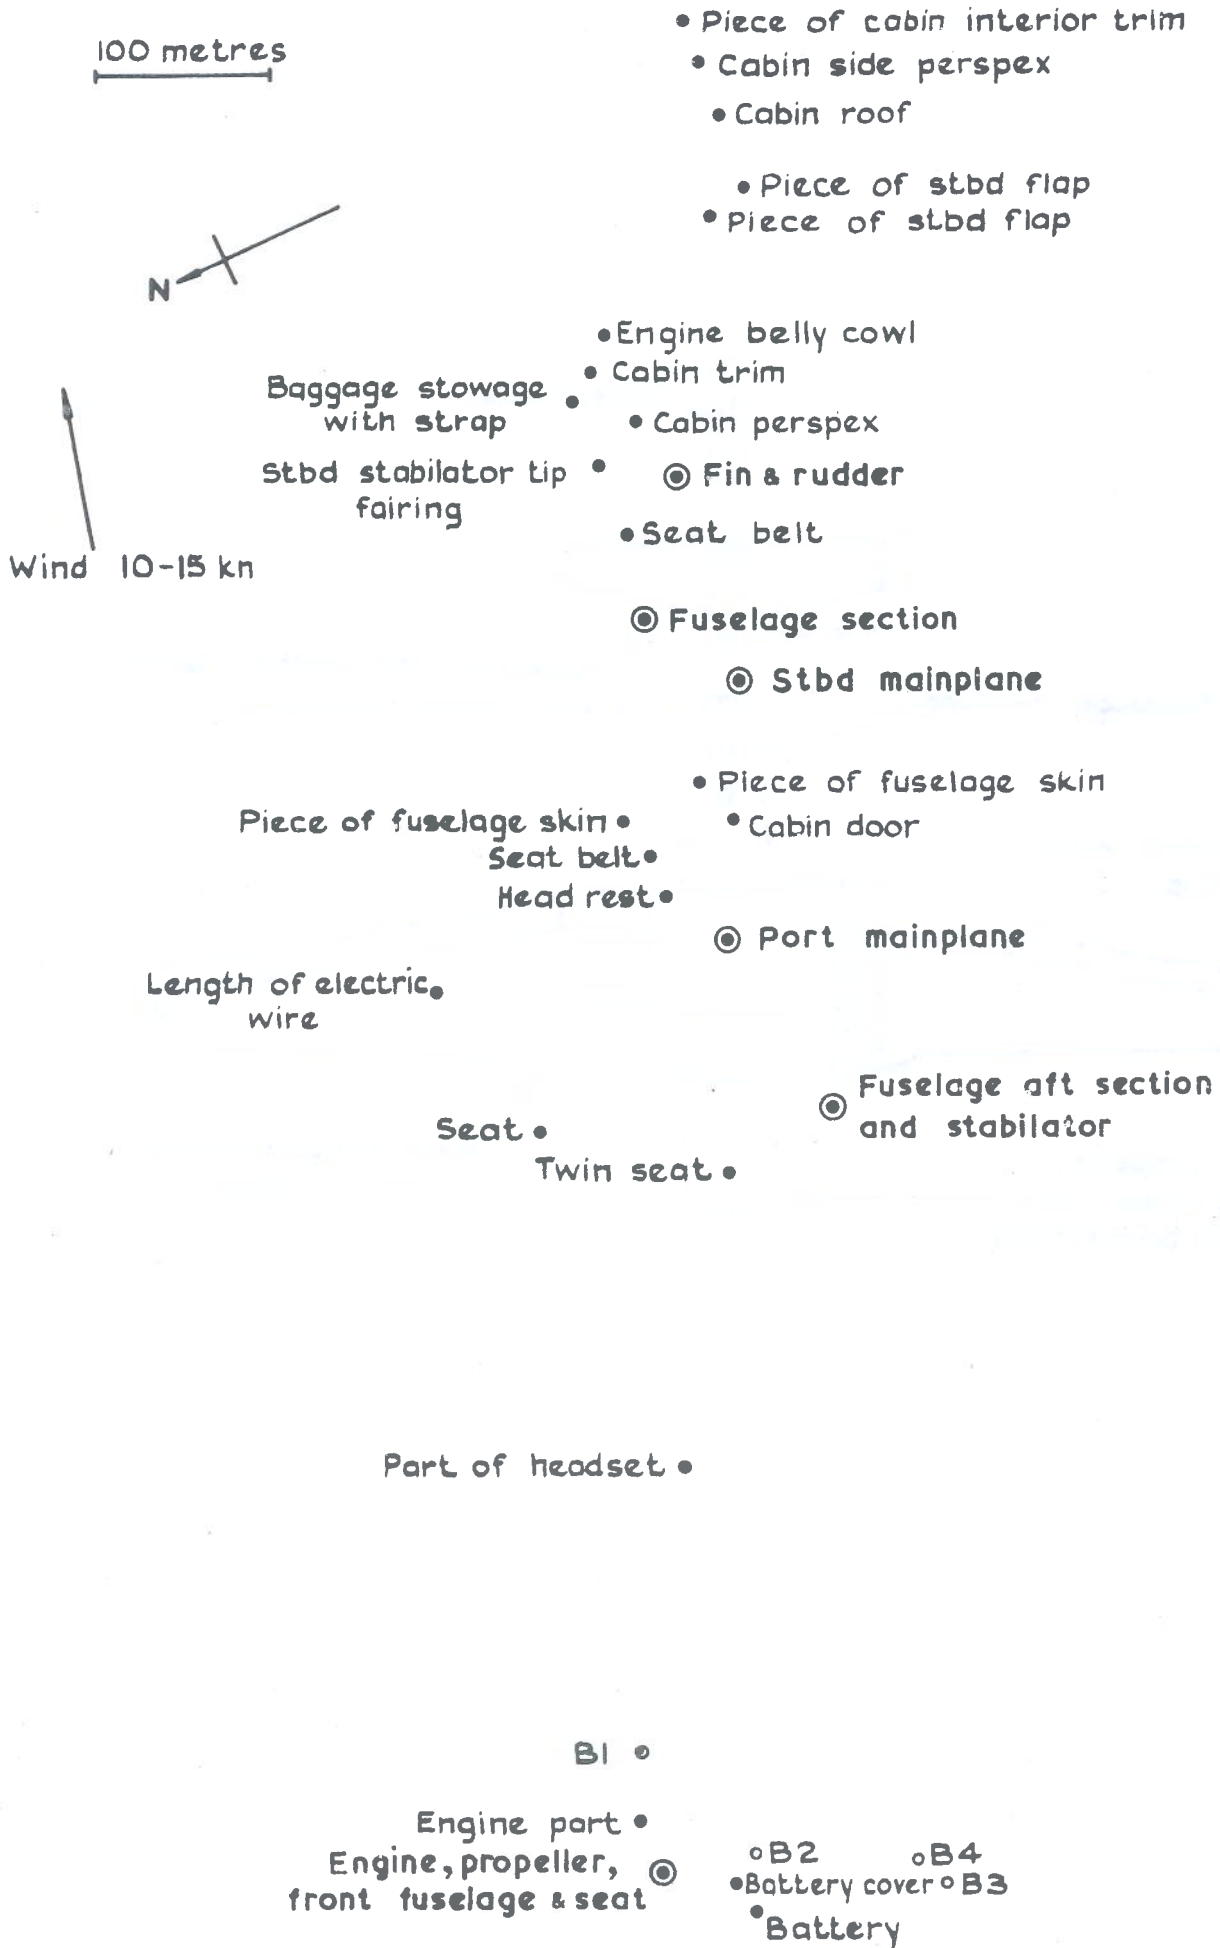
Fig.1 Wreckage trail

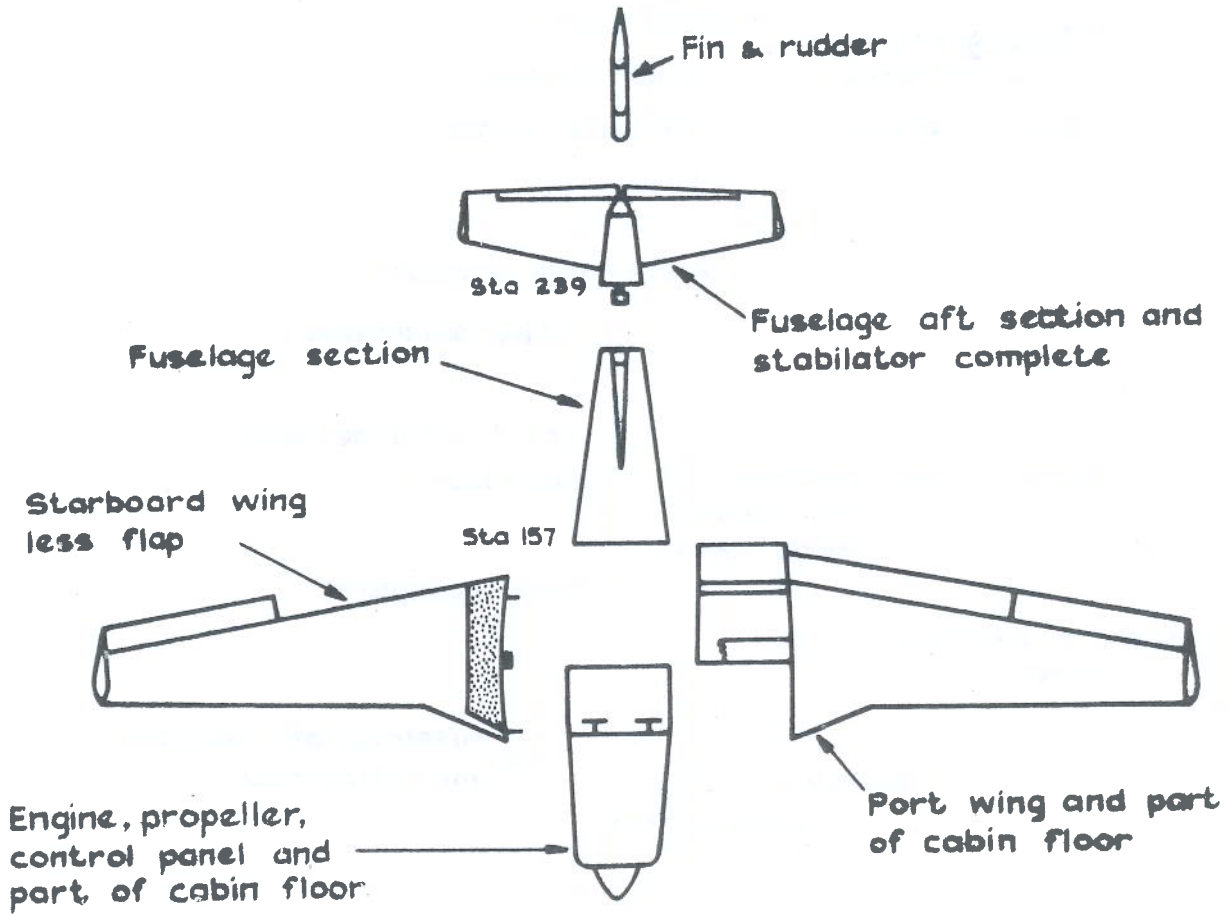
Fig.2 Major portions of wreckage

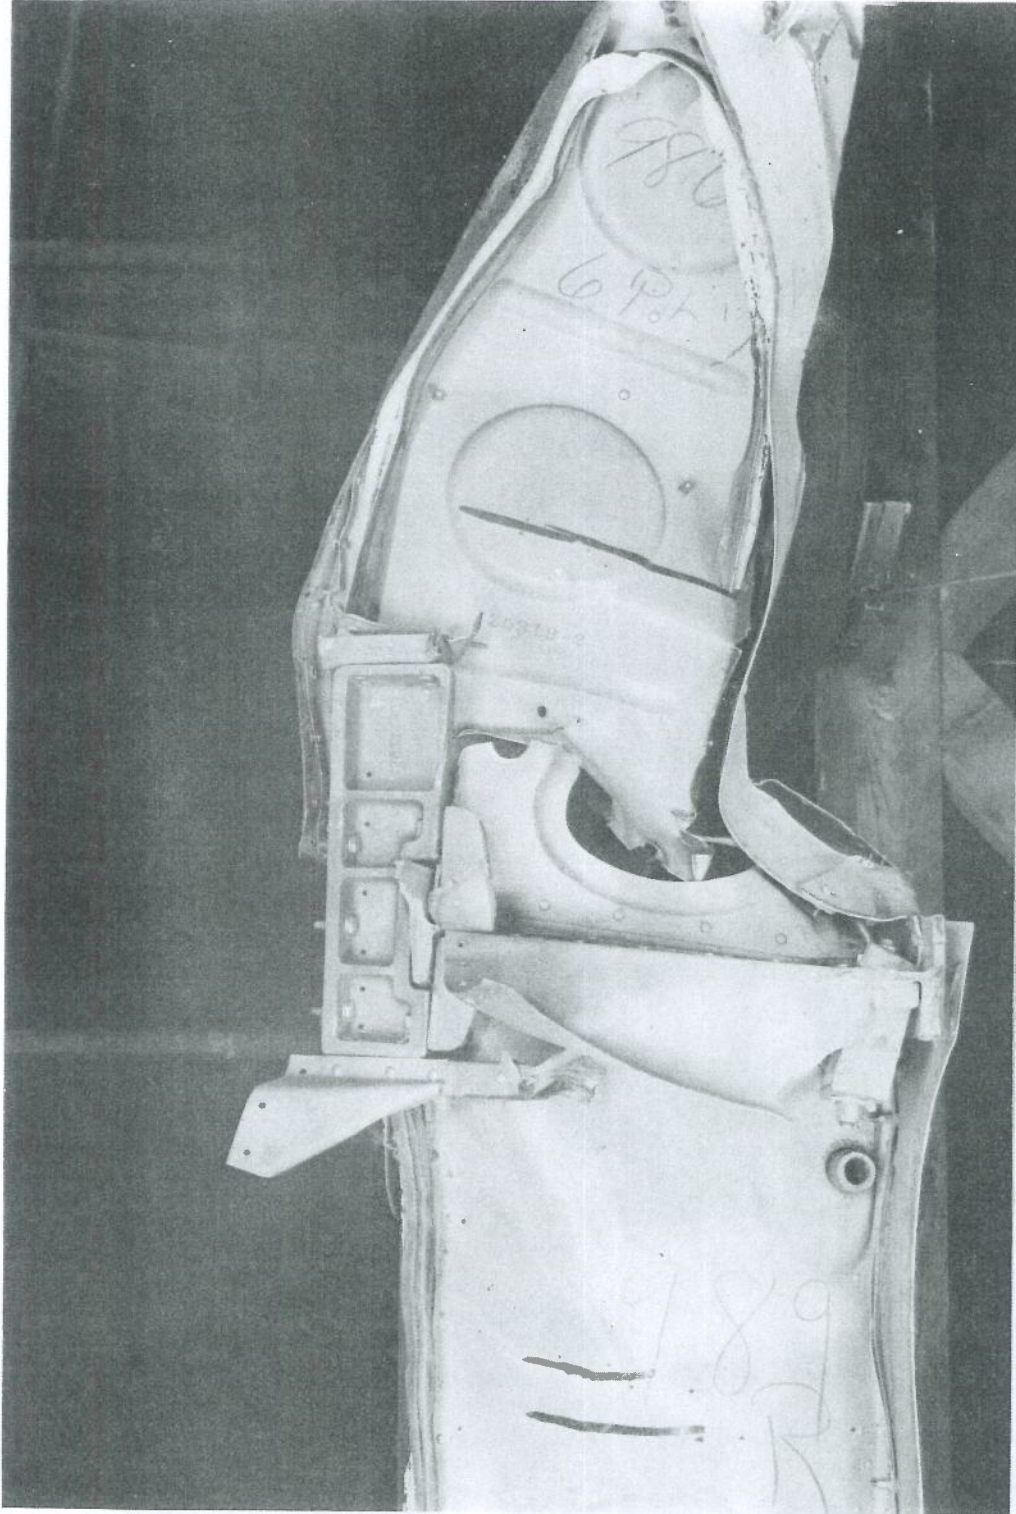
Fig.3 Starboard mainplane root end spar failures

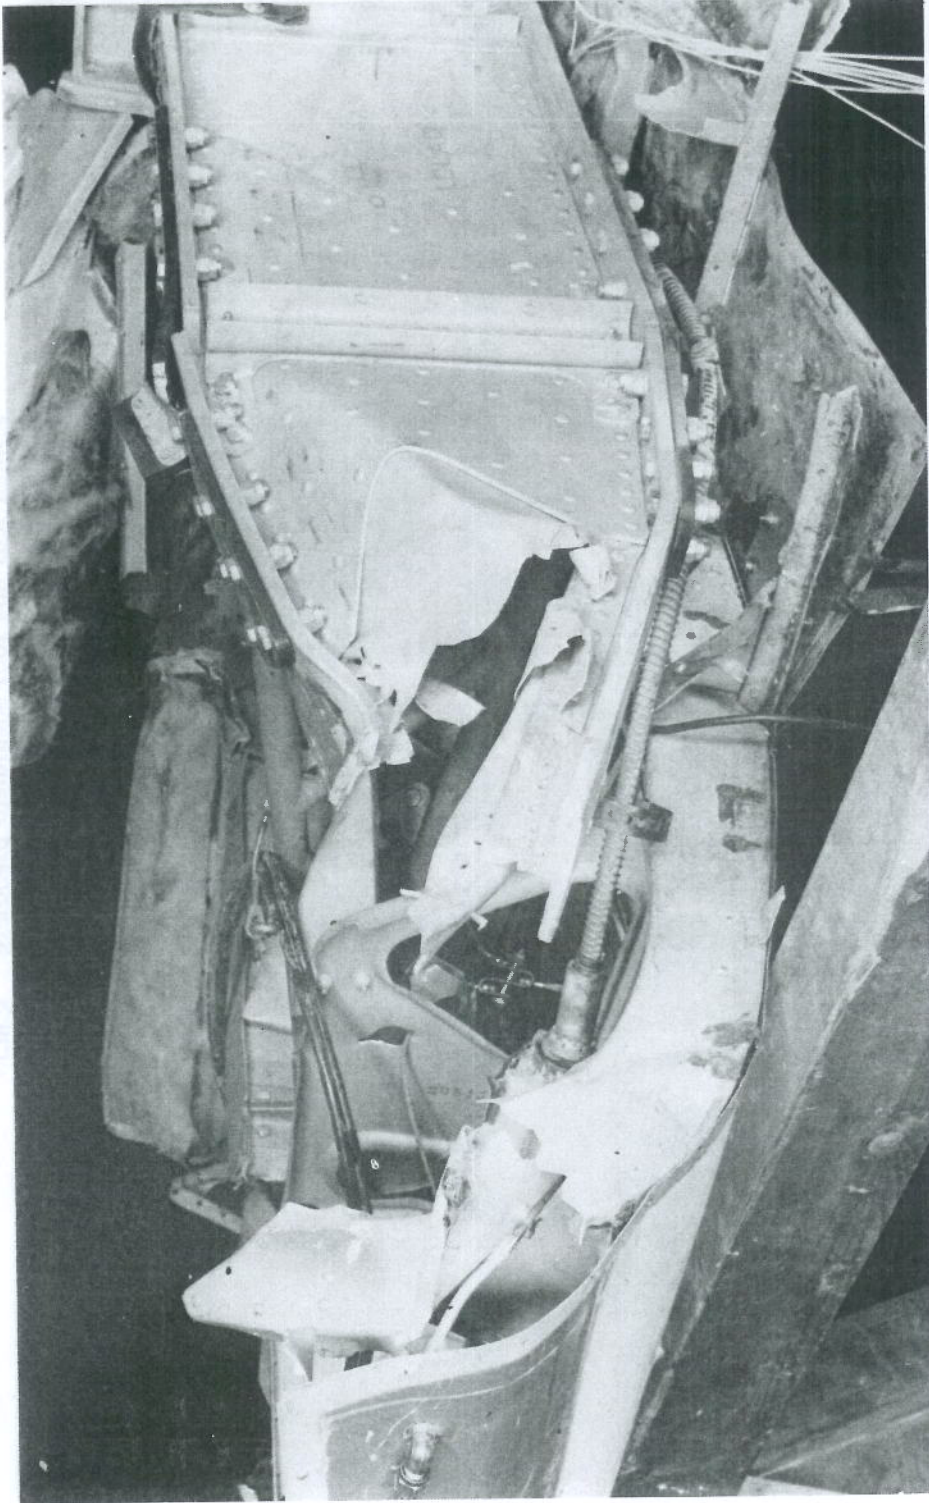
Fig.4 Mainspar centre joint viewed from front

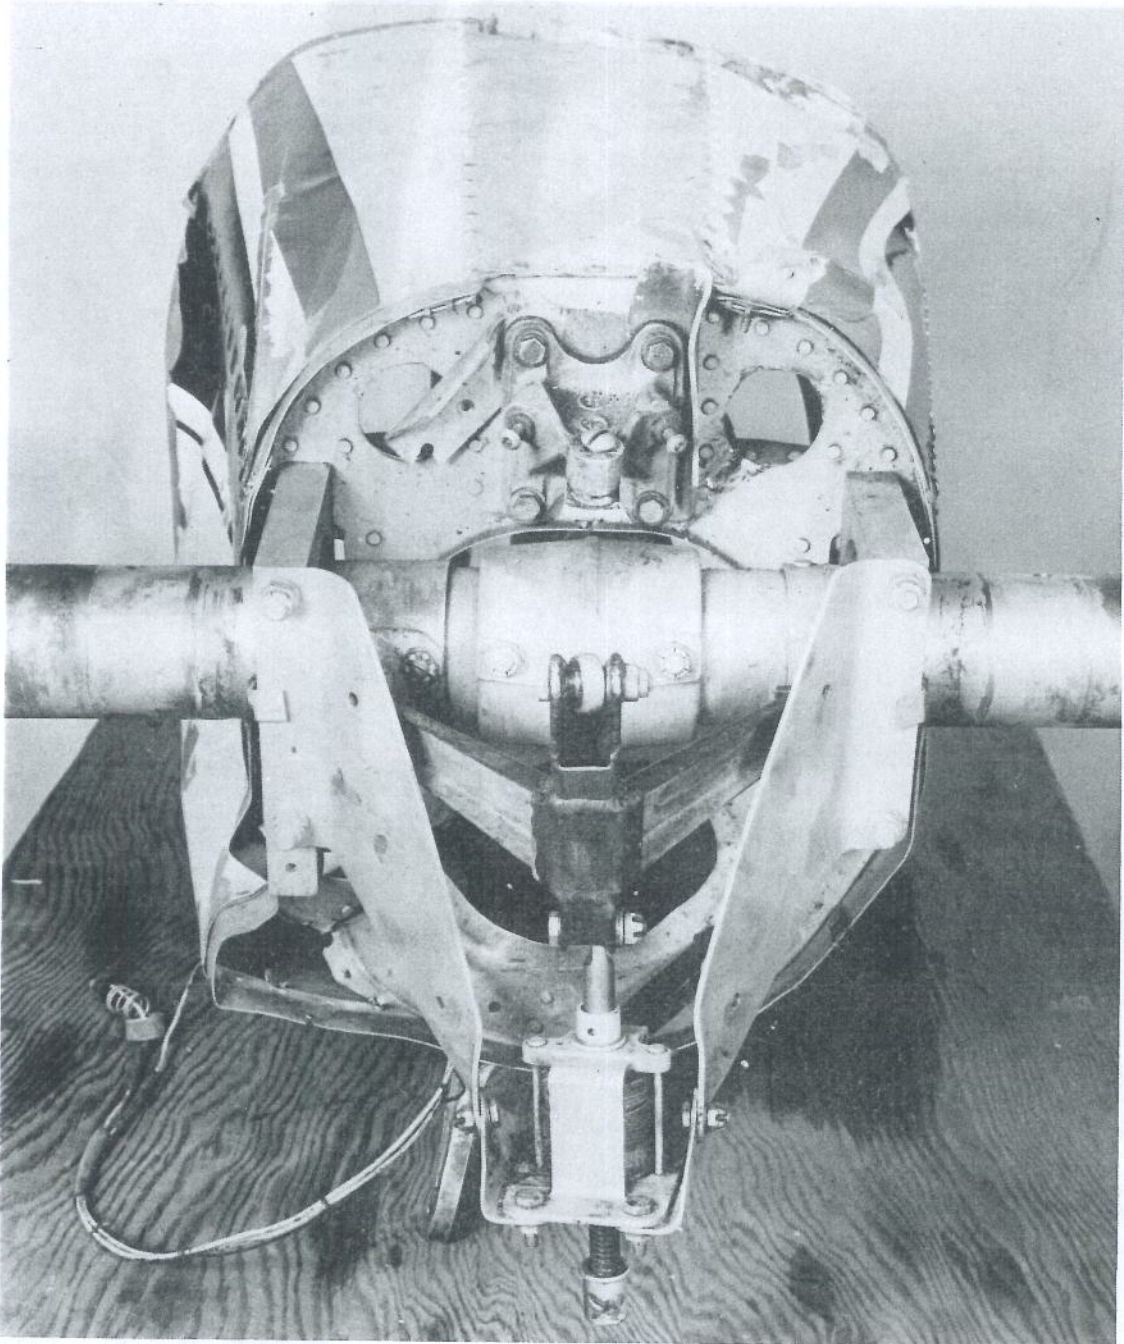
Fig.5 Fuselage aft section after removal of stabilator and fairings

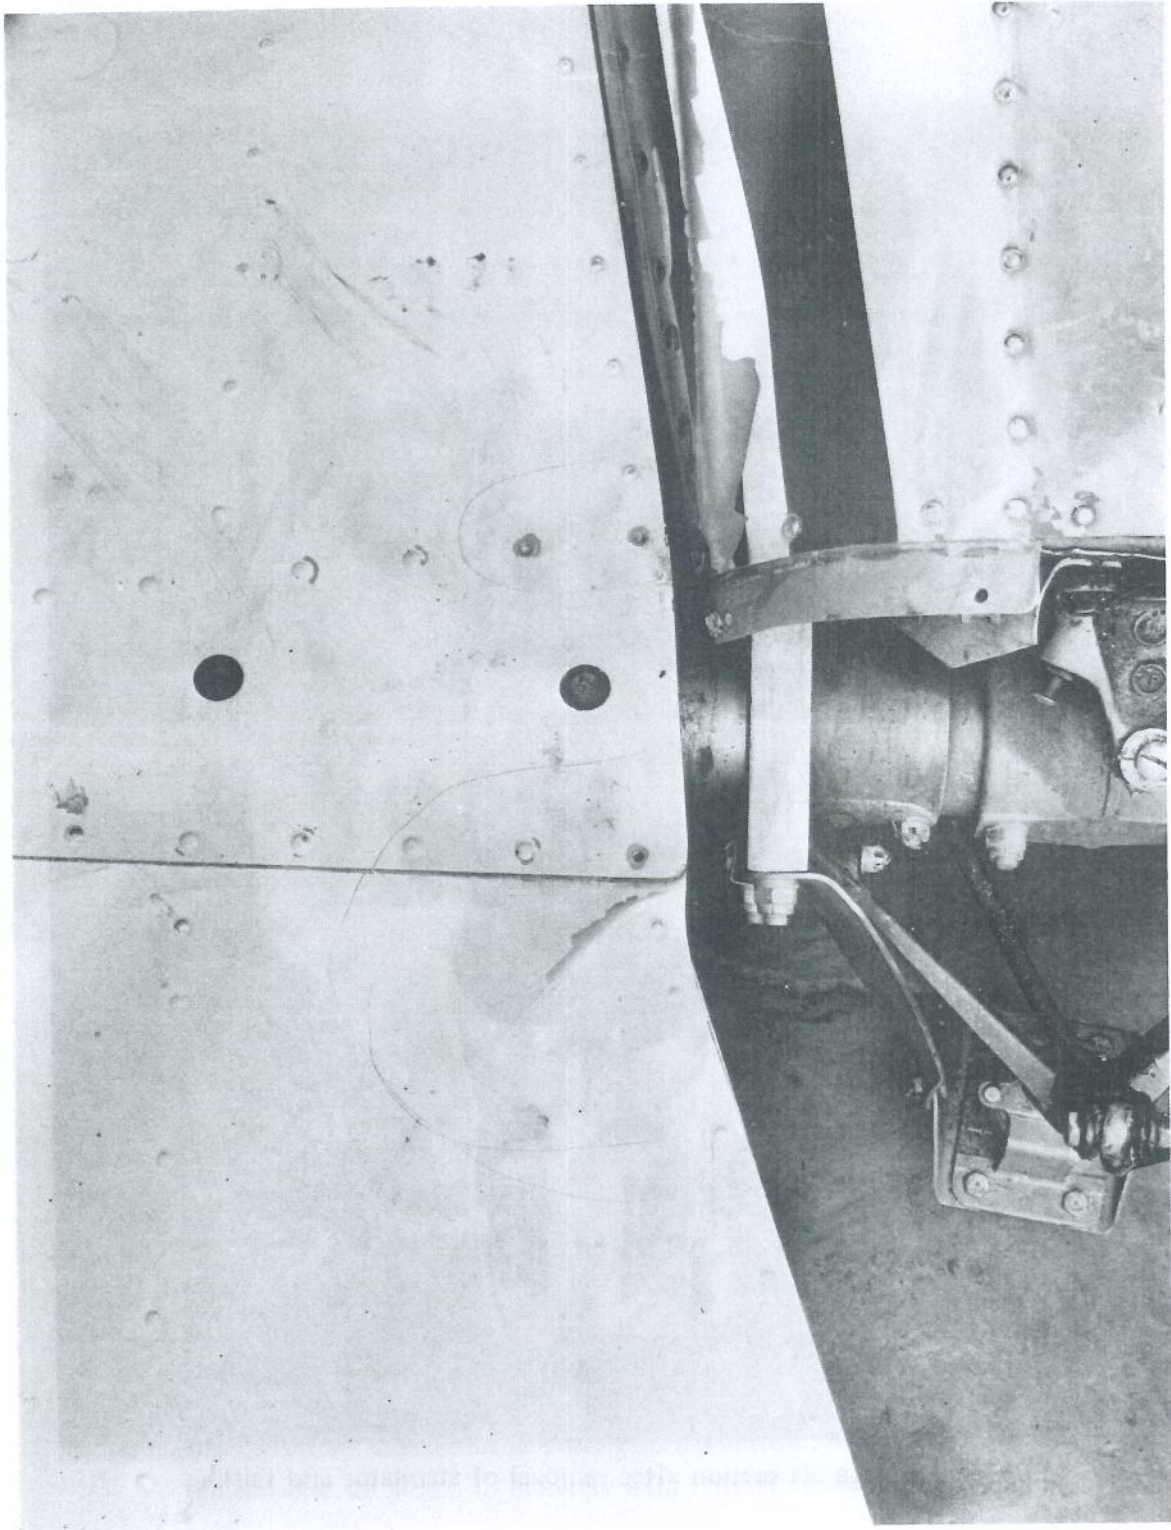
Fig.6 Stabilator port half attachment

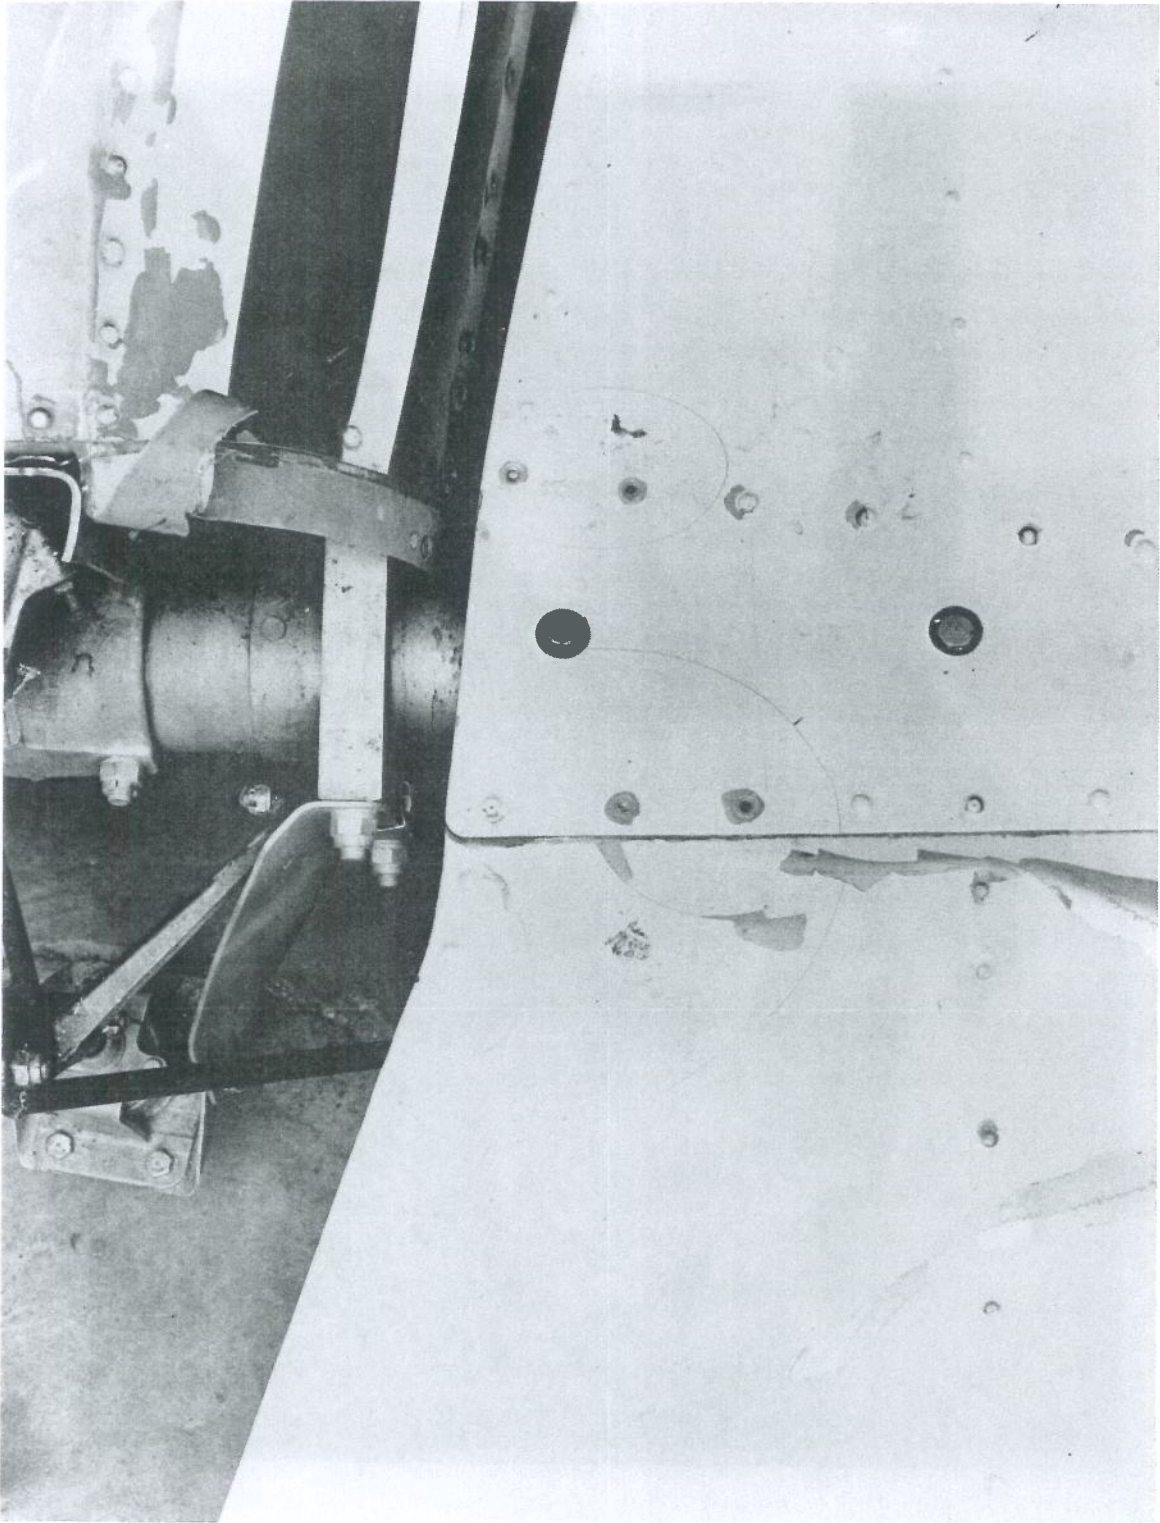
Fig.7 Stabilator starboard half attachment

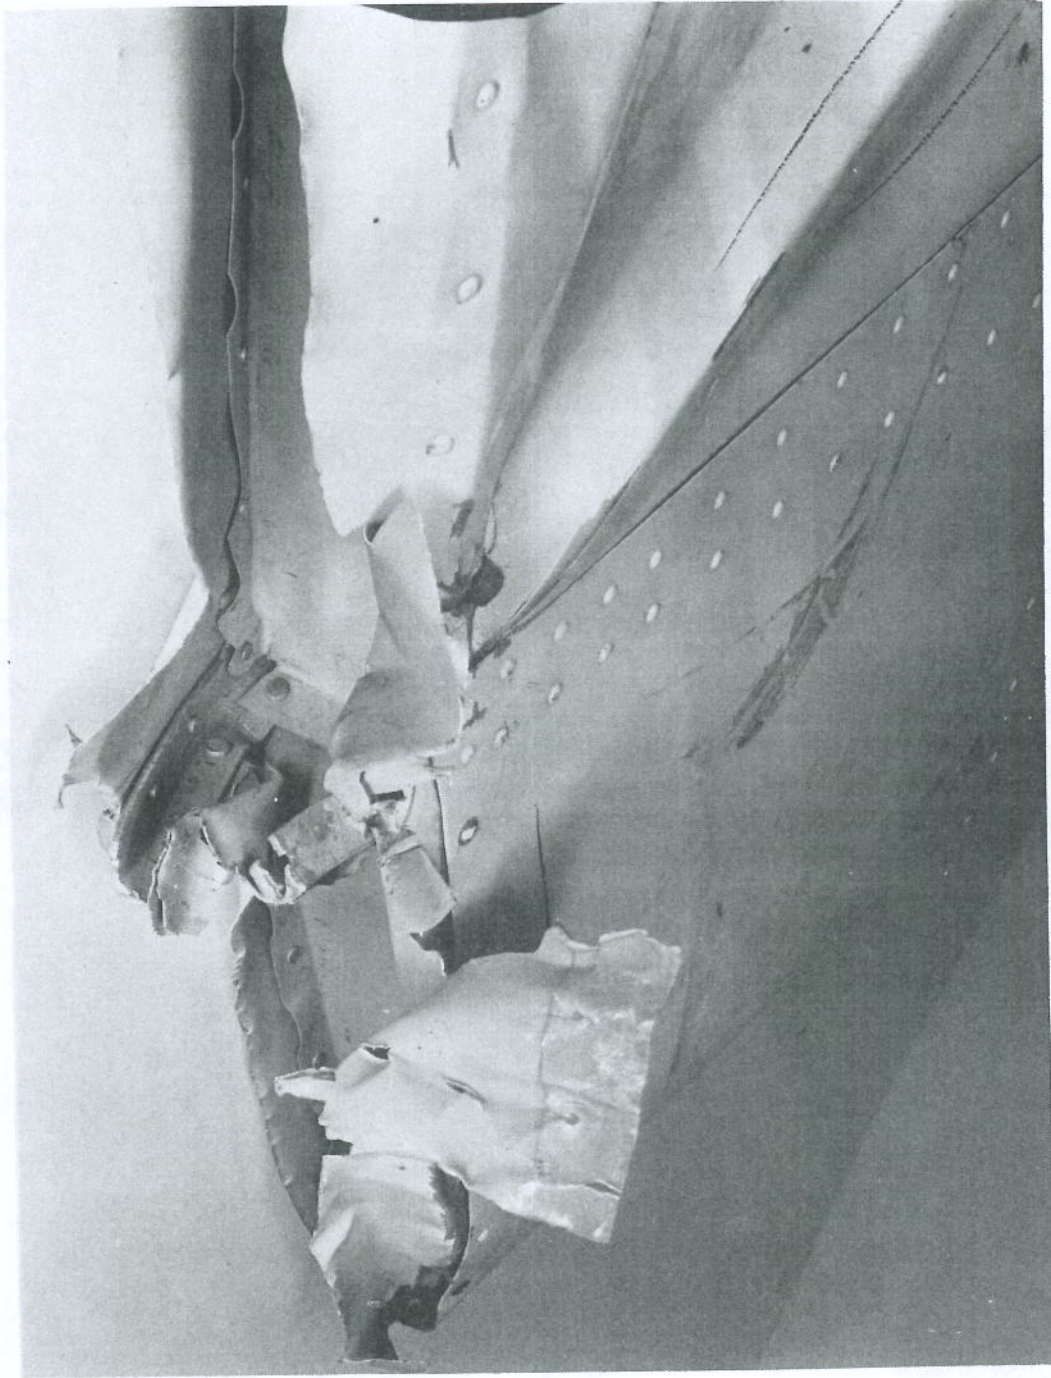
Fig.8 Stabilator port half spar failure — inboard

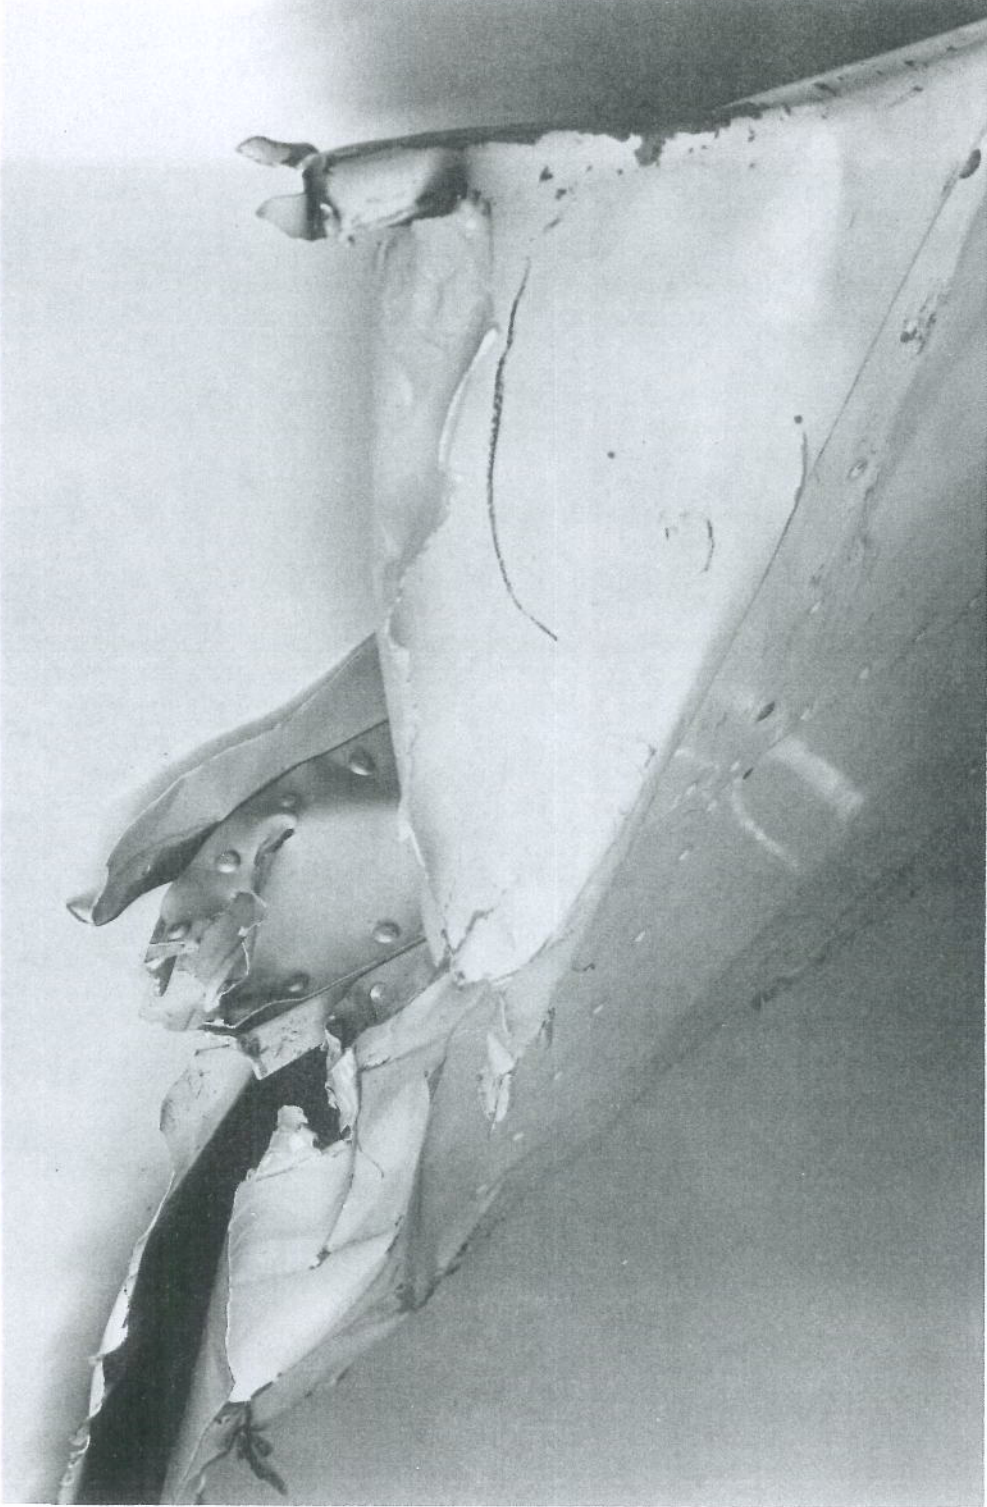
Fig.9 Stabilator port half spar failure — outboard

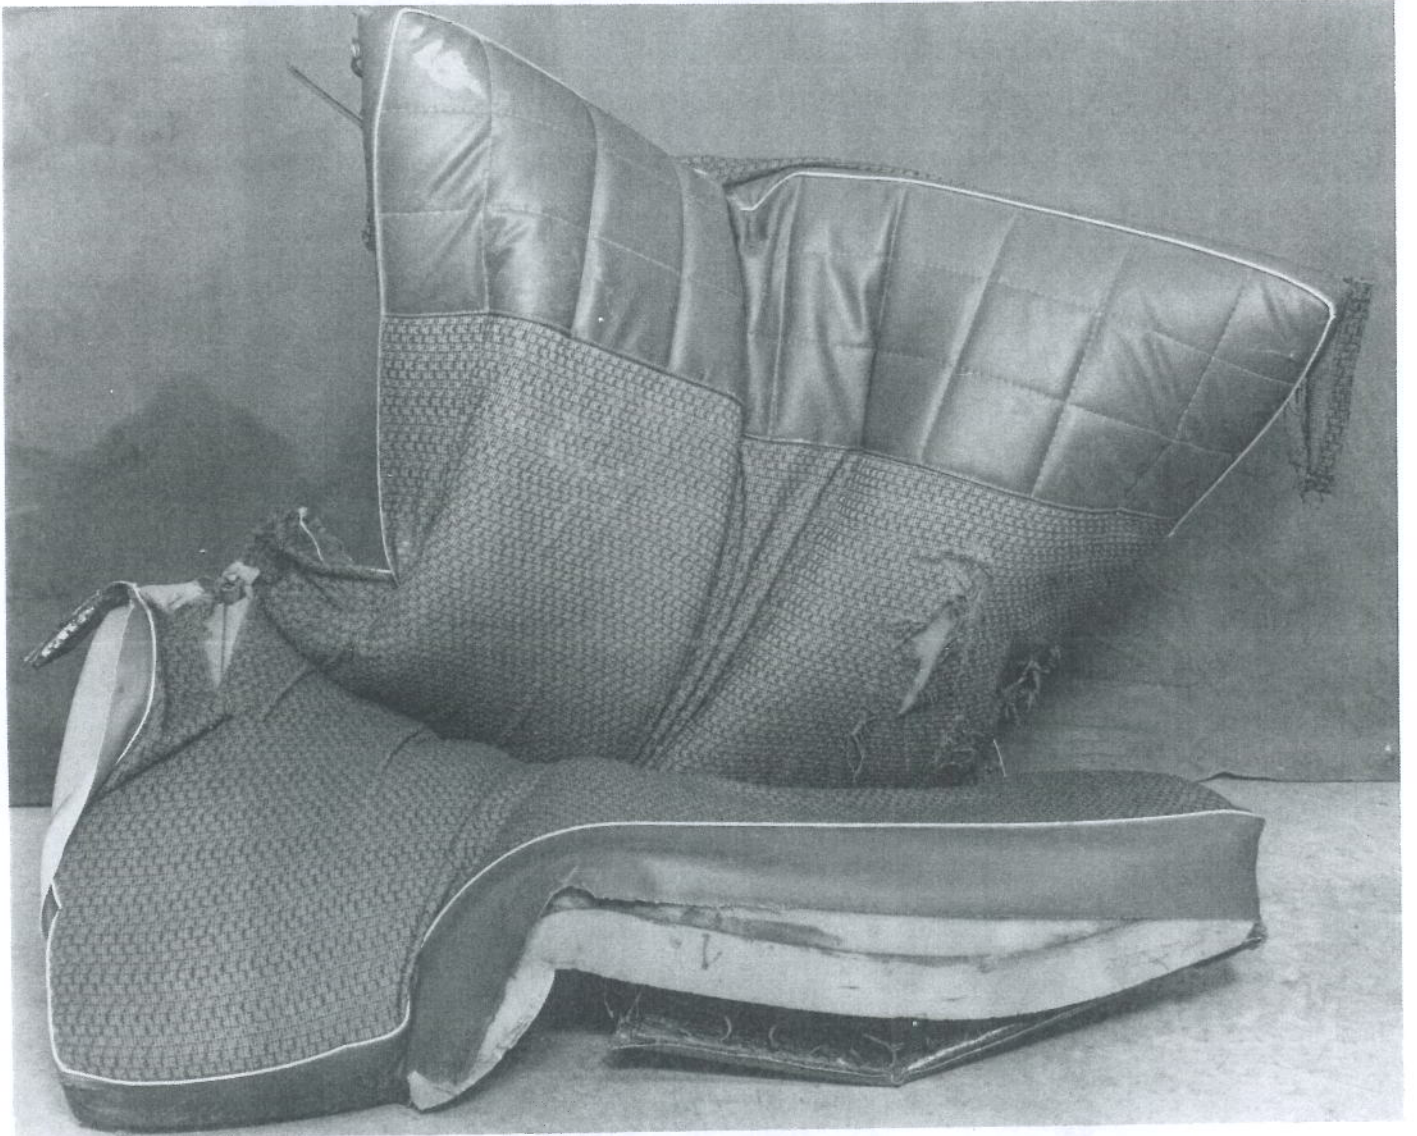
Fig.10 Twin rear seat

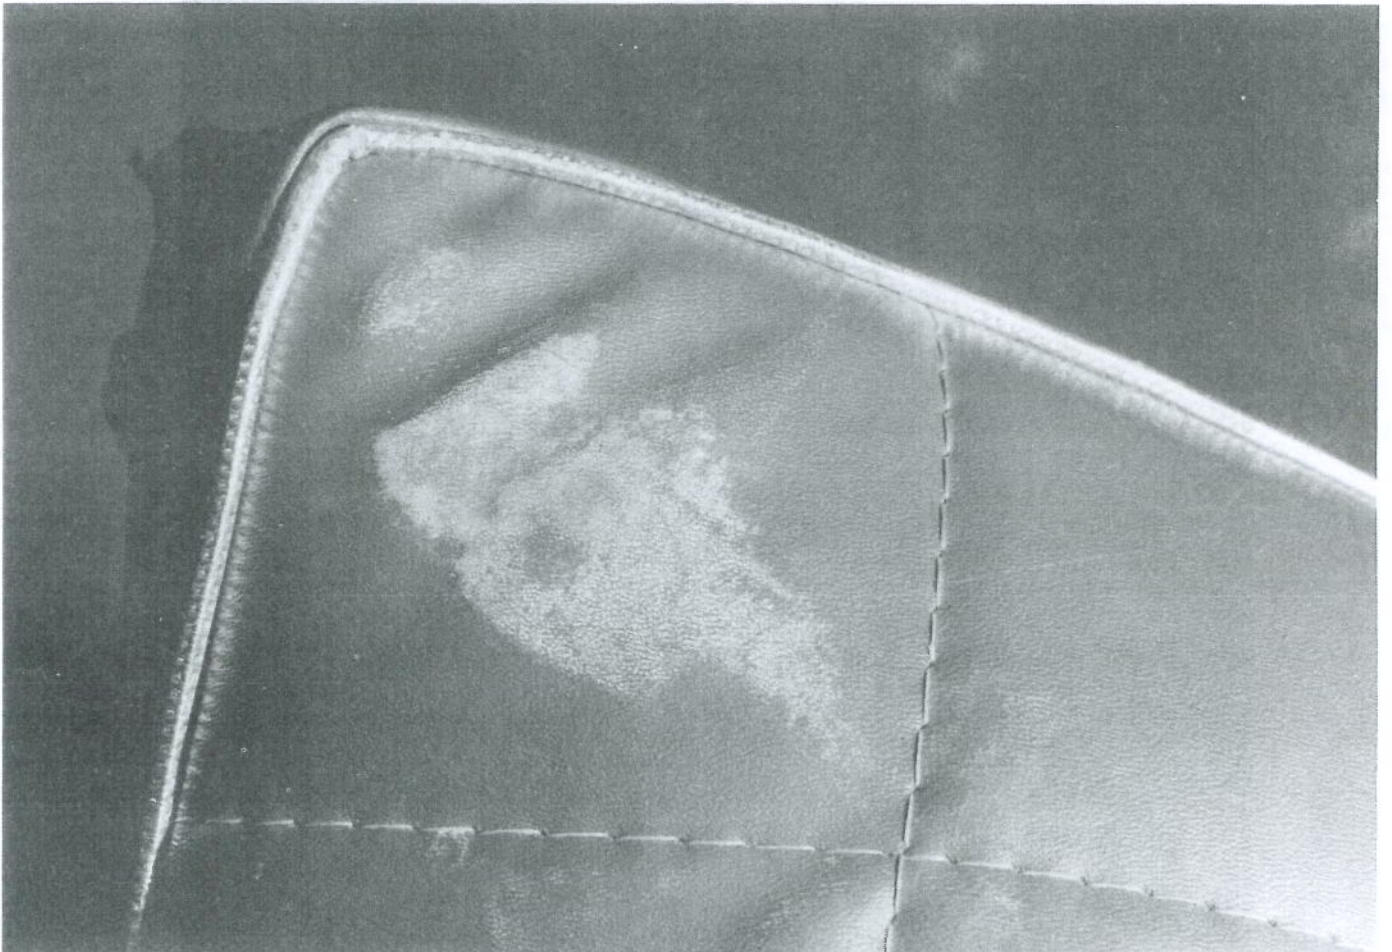
Fig.11 Paint mark on twin seat

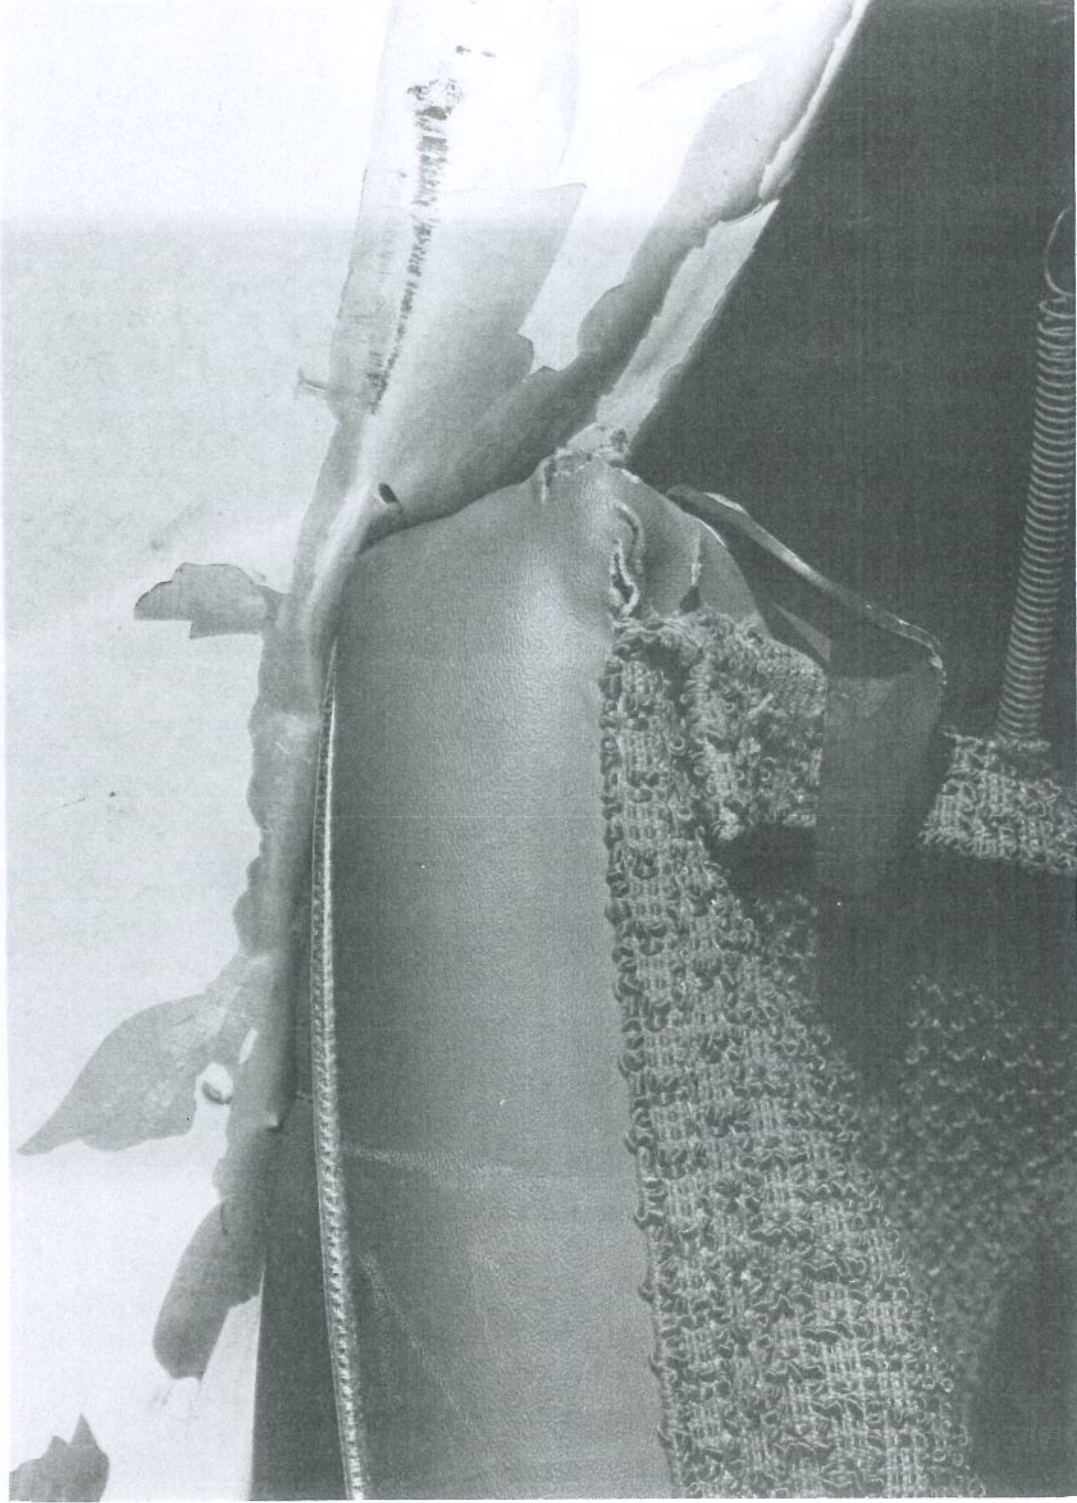
Fig.12 Seat corner fitting stabilator leading edge damage

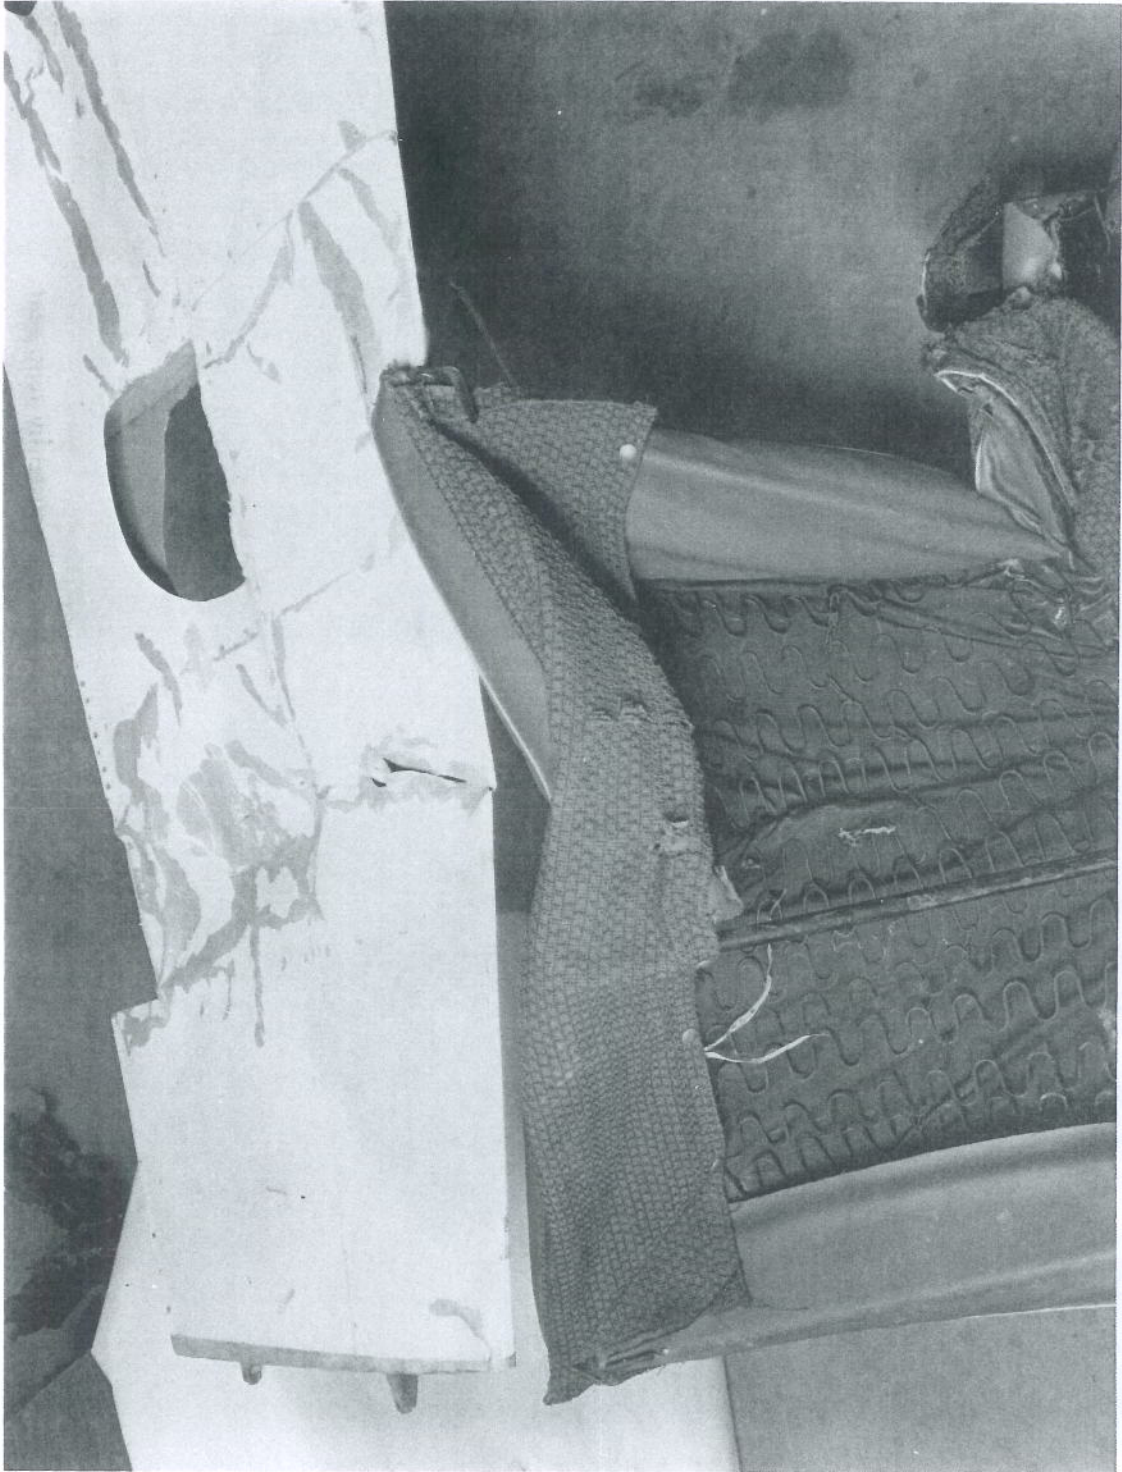
Fig.13 Resulting seat position

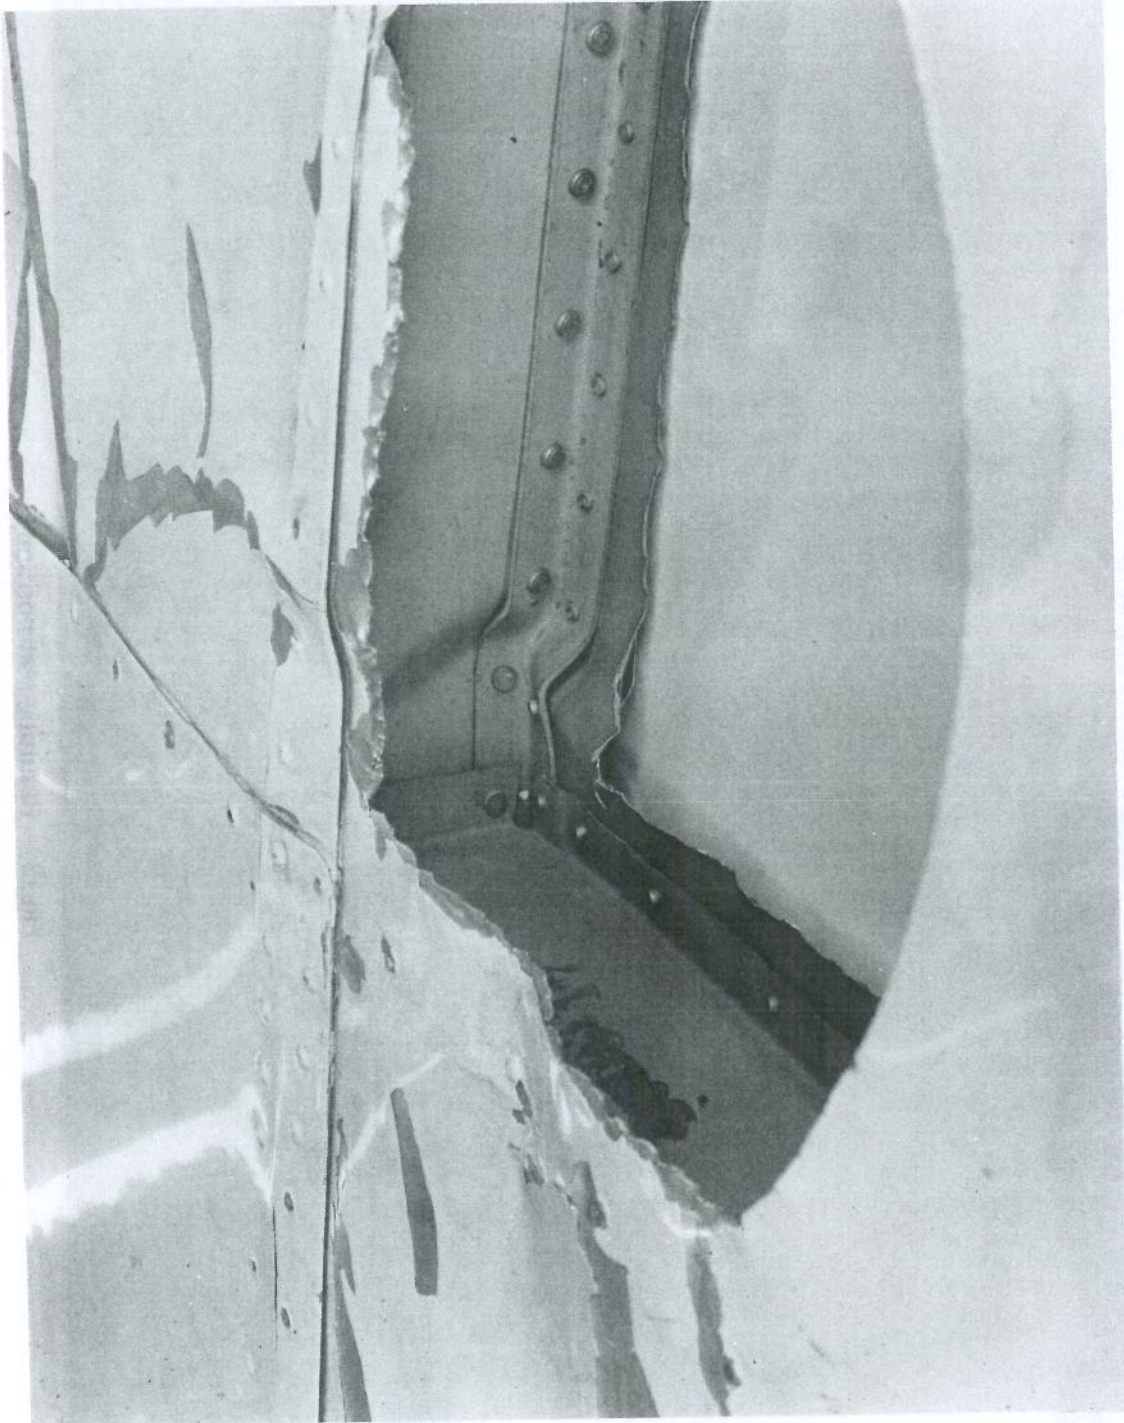
Fig.14 Stabilator starboard half spar damage caused by twin seat
