PIPER PA24-250 AND 260 SERIES AIRCRAFT ONLY  
RECOMMENDED SPEED LIMITATION

PIPER  
Airworthiness Directive  
Volume I

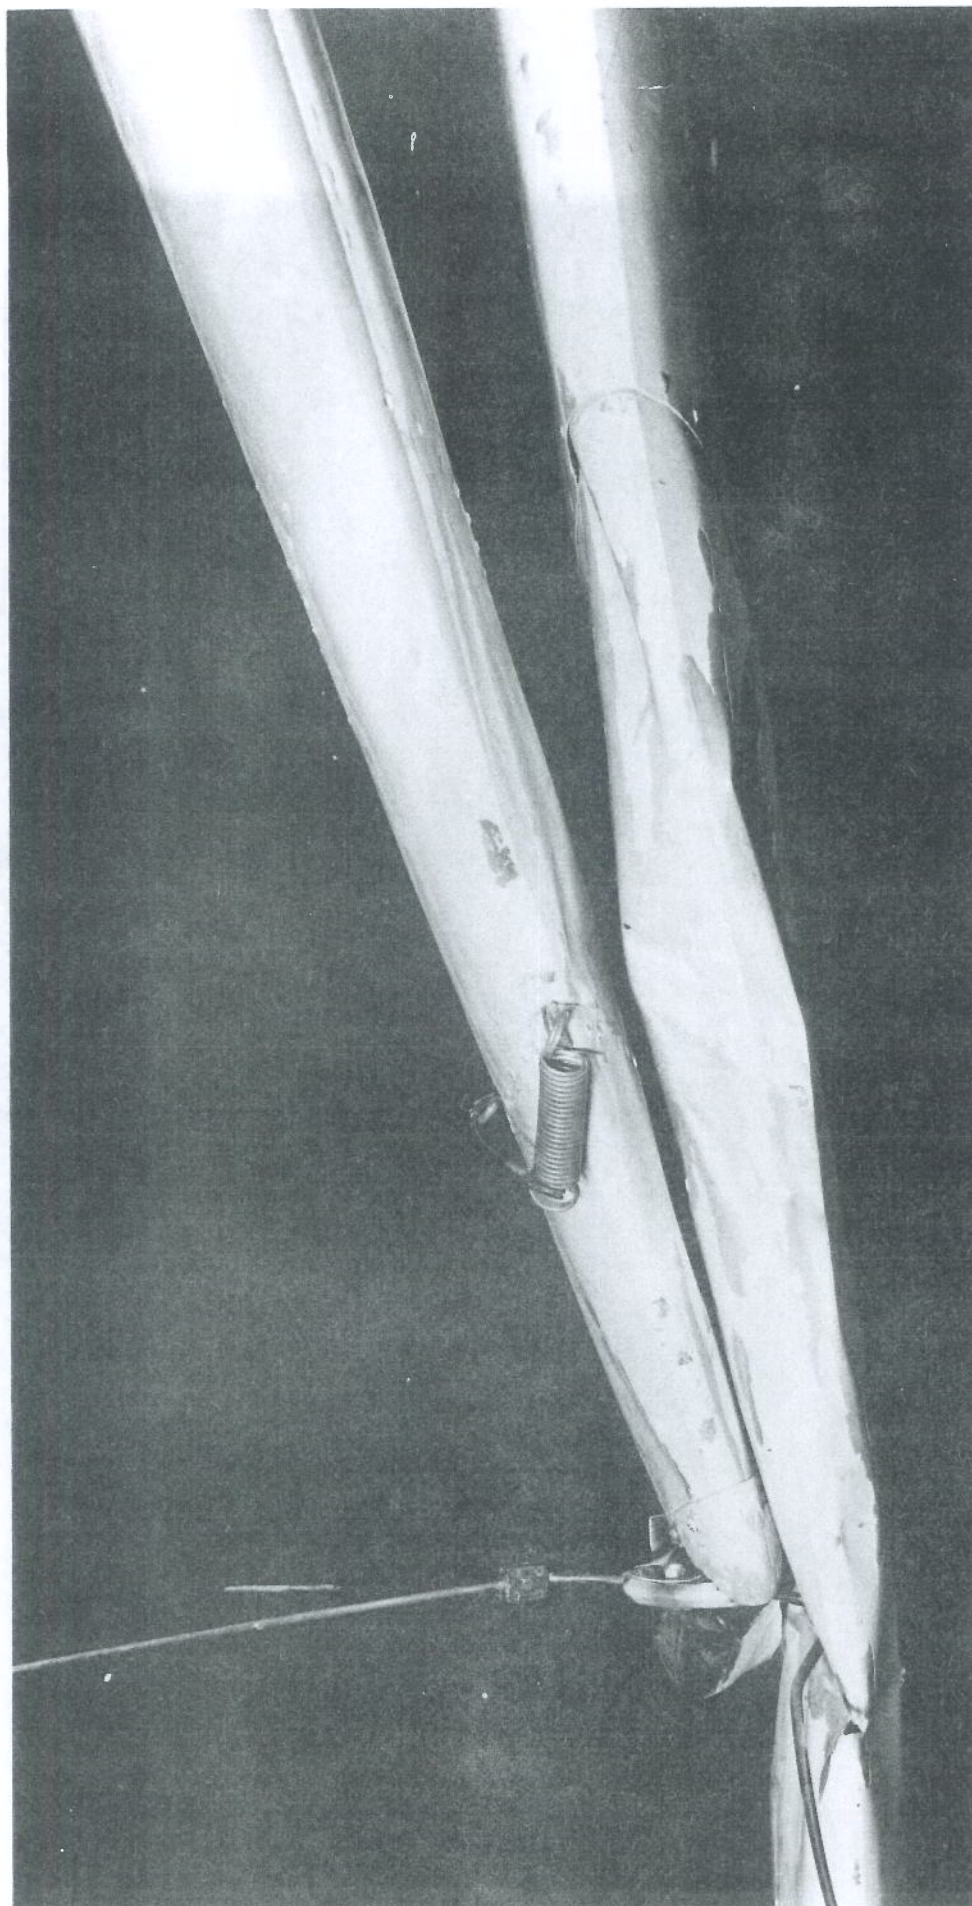
Fig.15 Fin and position on striking stabilator starboard half

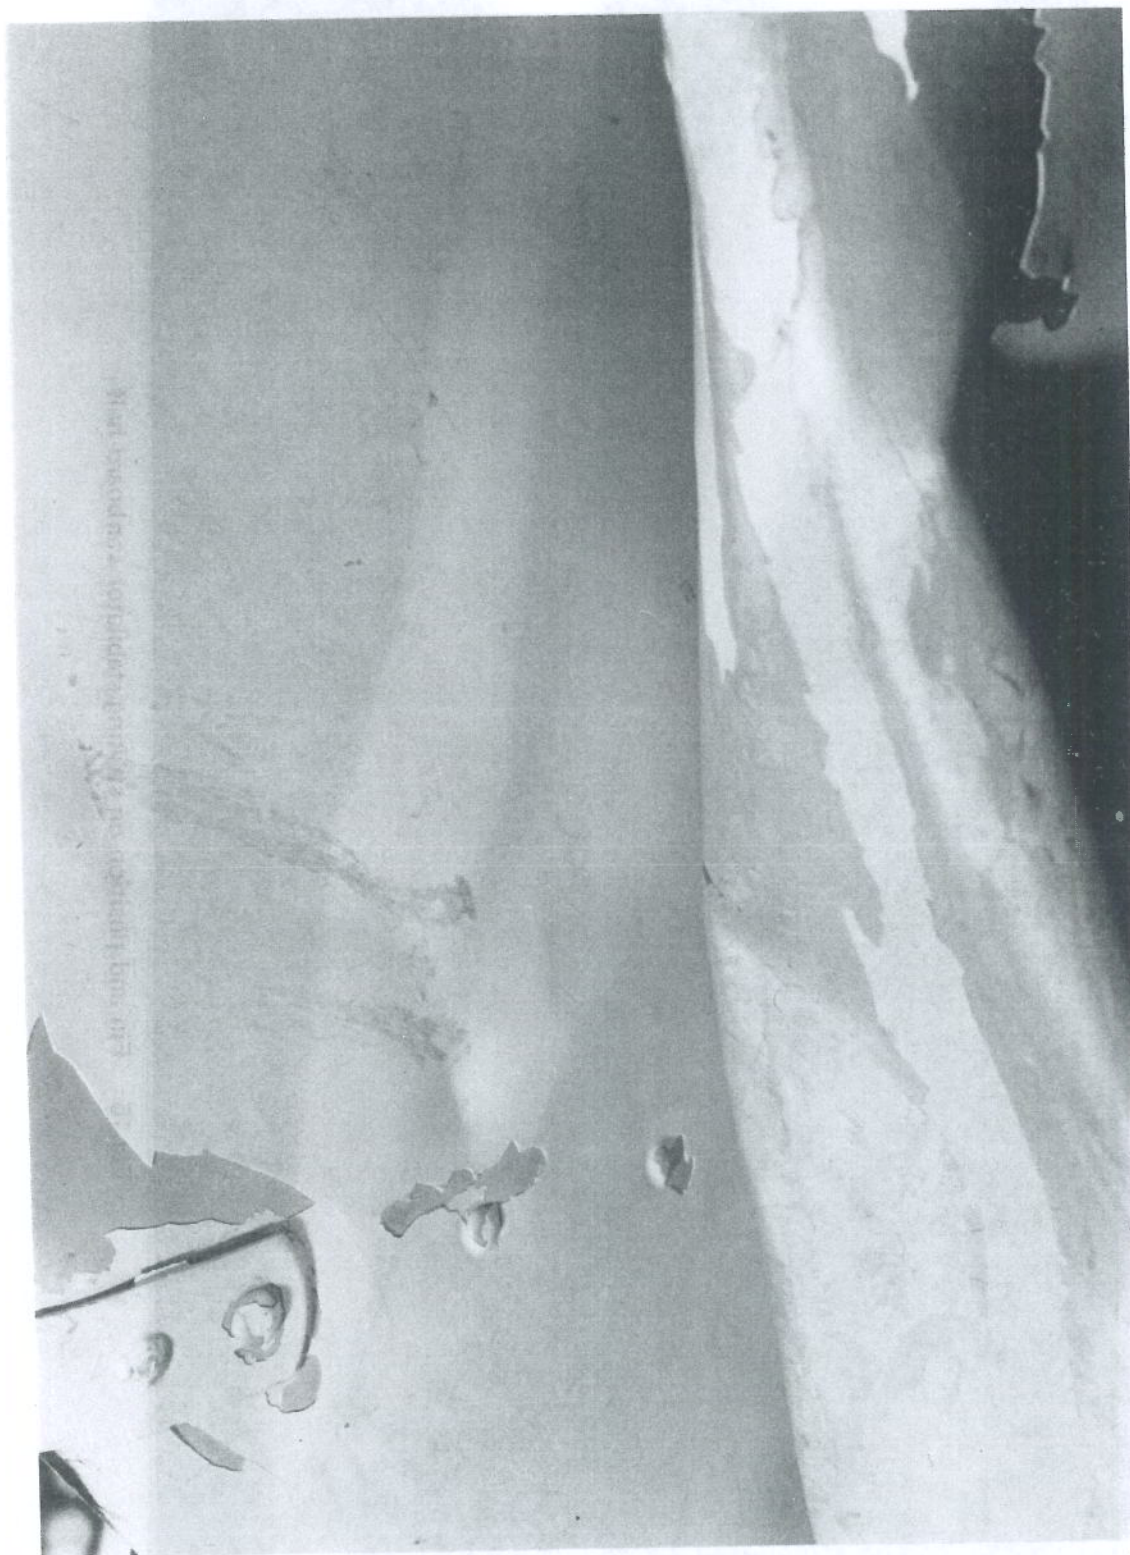
Fig.16 Smear on fin from stabilator leading edge damage

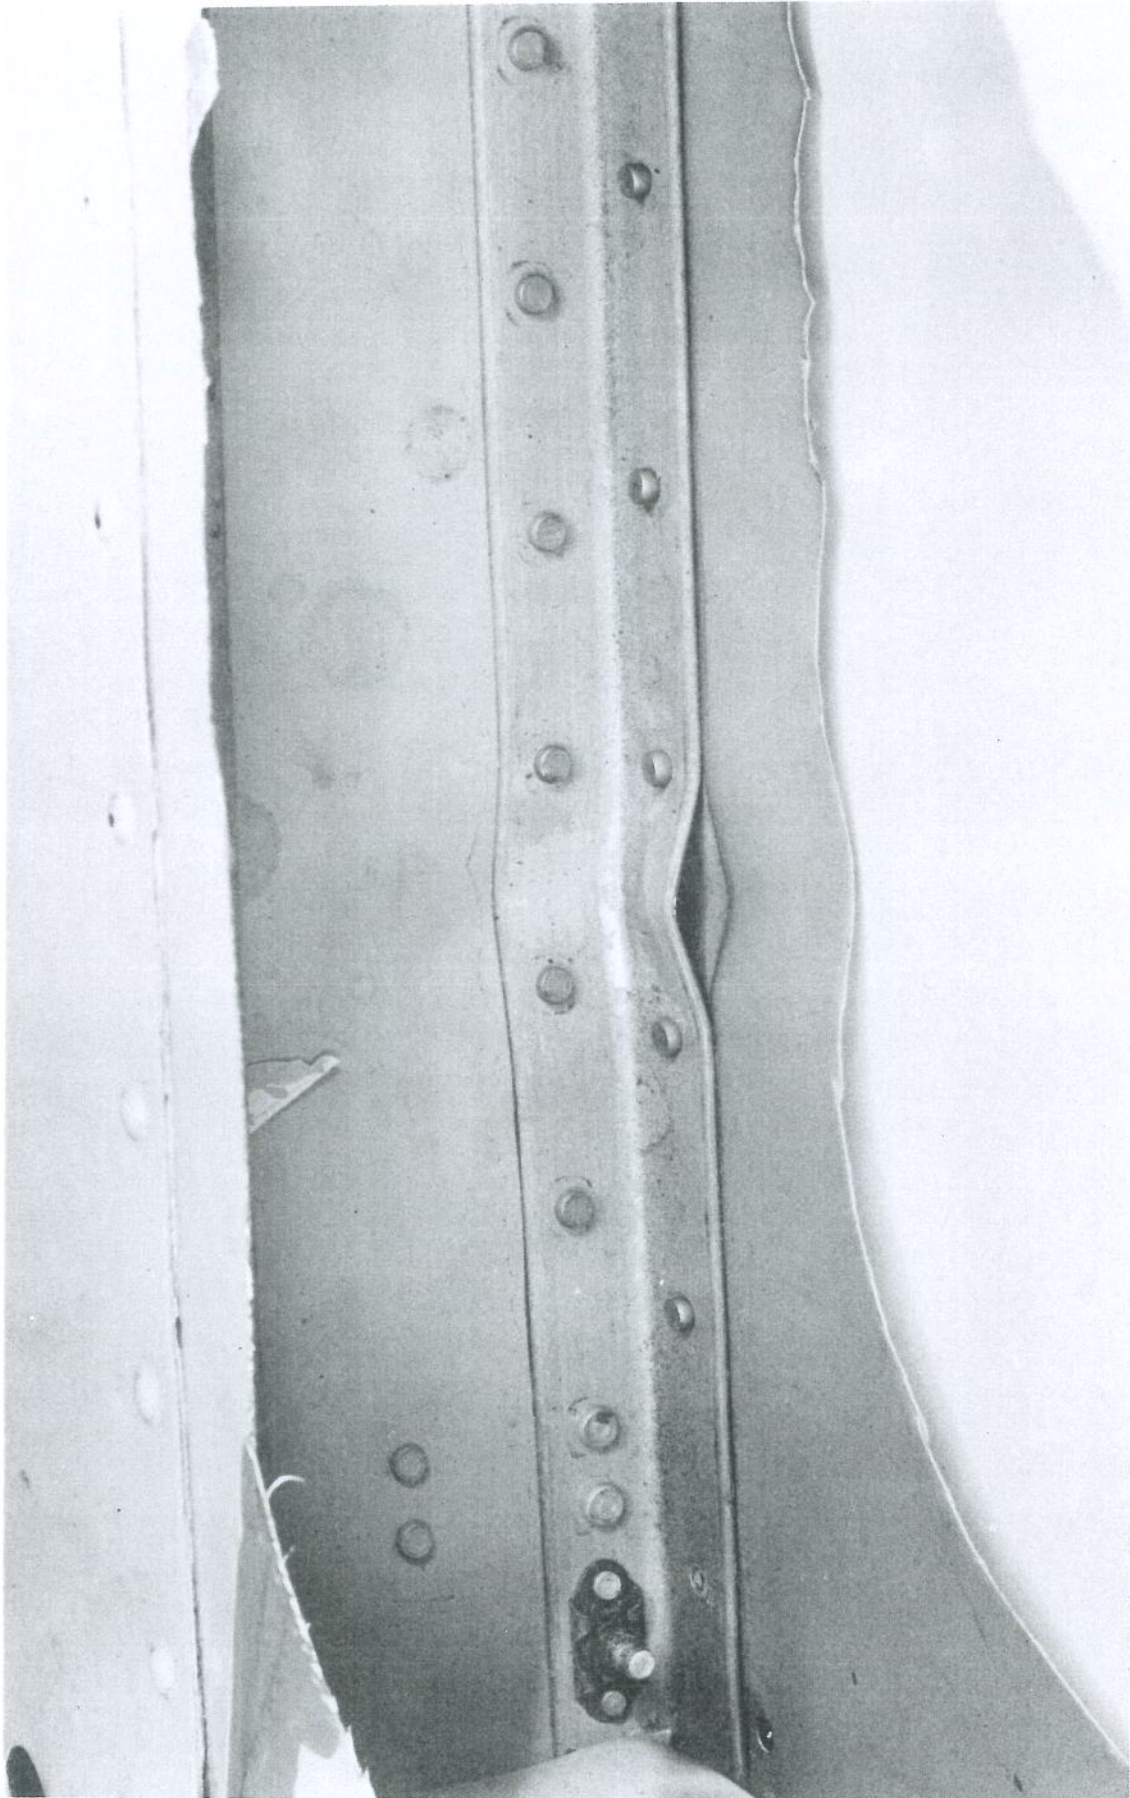
Fig.17 Stabilator starboard half lower spar boom damage
