**Air Accidents Investigation Branch**

**Report on the accident to  
Fokker F27-600 Friendship, G-CHNL  
Near Guernsey Airport, Channel Islands  
on 12 January 1999**

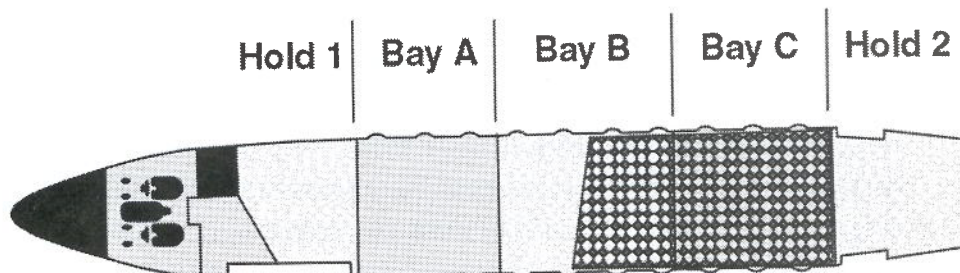
The distribution of the load as shown on the loadsheet completed by the pilots at Luton bore little resemblance to the actual loading. Detailed reconstruction of the loading, based on a combination of physical and witness evidence, revealed that all the cargo had been placed in Bays B and C as shown below:

Calculations indicated that the loaded aircraft centre of gravity was significantly aft of the aft limit of 38%. The positions of the centre of gravity during flight are illustrated on the graph below.

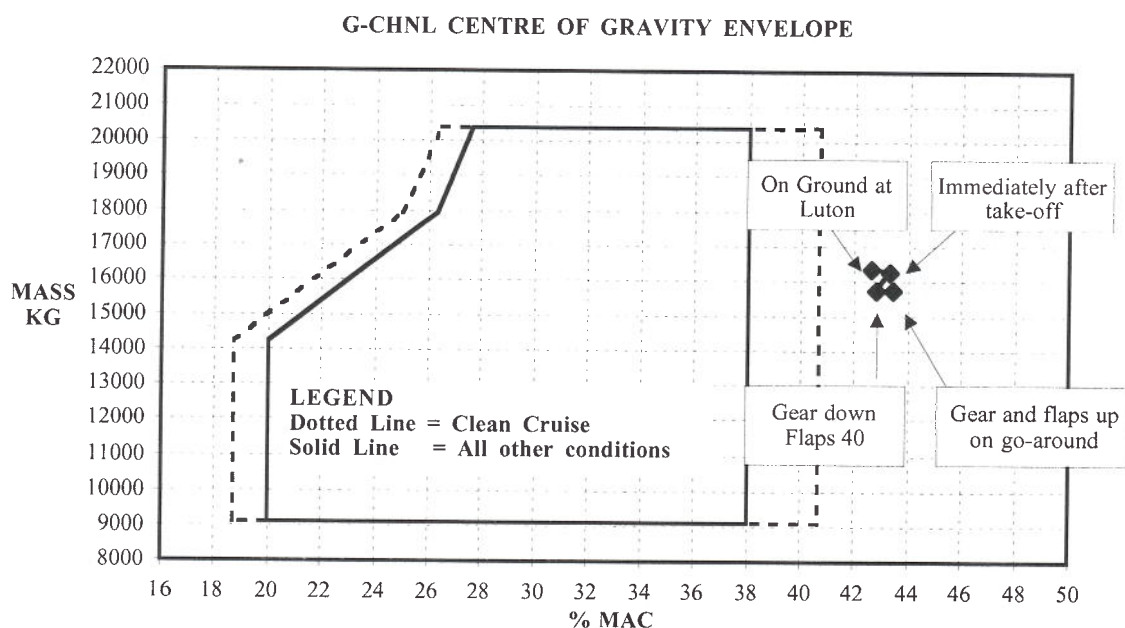
In flight there is a small movement of the centre of gravity arising from fuel consumption but the main changes occur when the gear is raised and lowered.

The graph assumes that cargo migration did not start until after control was lost and the aircraft pitched-up to a near-vertical attitude. However, migration could have occurred earlier. The rear face of the stack of newspaper bundles was essentially vertical but their rearward motion was restrained solely by tension in the net from one side of the cabin floor to the other. If, whilst the aircraft taxied or flew, vibration dislodged one or more bundles, the overall tension across the rear of the net would have been reduced enabling more bundles to slip out. If migration in this manner took place before control was lost, the change in centre of gravity during flight would have produced a more extreme aft centre of gravity position.
