AIRCRAFT ACCIDENT REPORT 2/2014

Report on the accidents to Eurocopter EC225 LP Super Puma

G-REDW
34 nm east of Aberdeen, Scotland
on 10 May 2012

G-CHCN
32 nm southwest of Sumburgh, Shetland Islands
on 22 October 2012

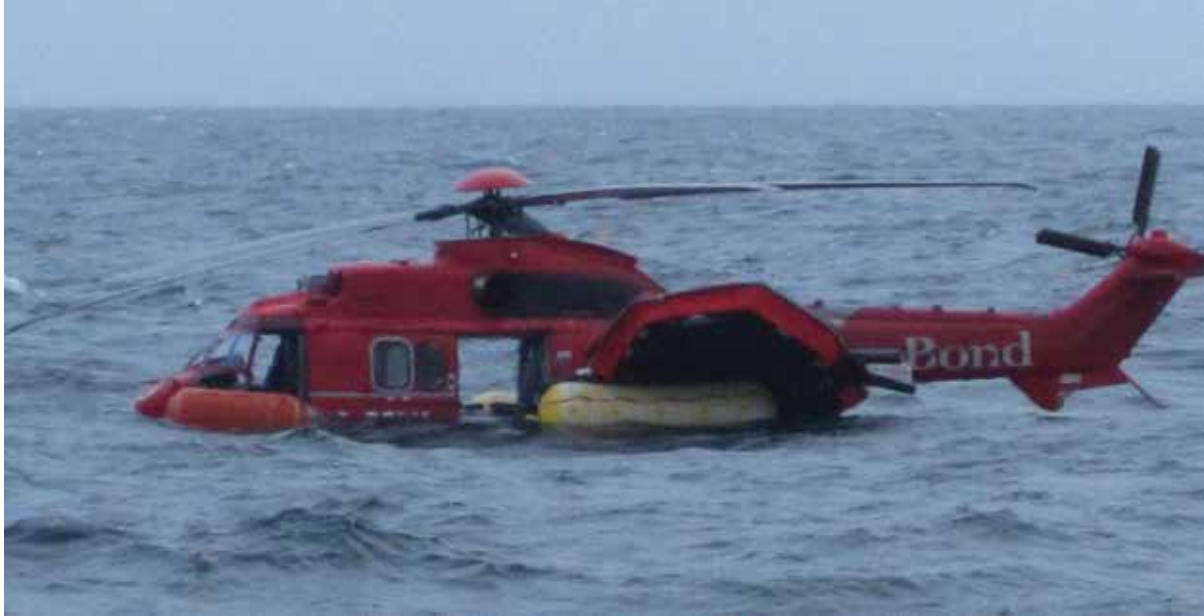
Figure 1

G-REDW afloat, approximately 8 hours after ditching

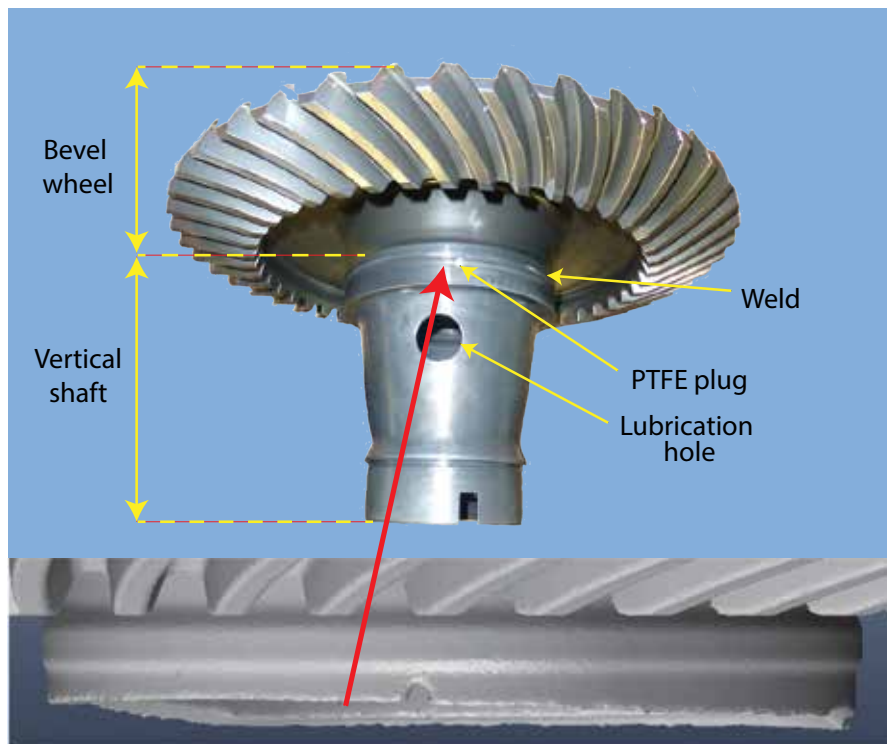
Figure 24

The bevel gear vertical shaft on G-REDW failed as a result of a 360° circumferential crack that initiated at the inner countersink of the 4.2 mm hole in the weld. A representation of the location of the crack is at Figure 24.

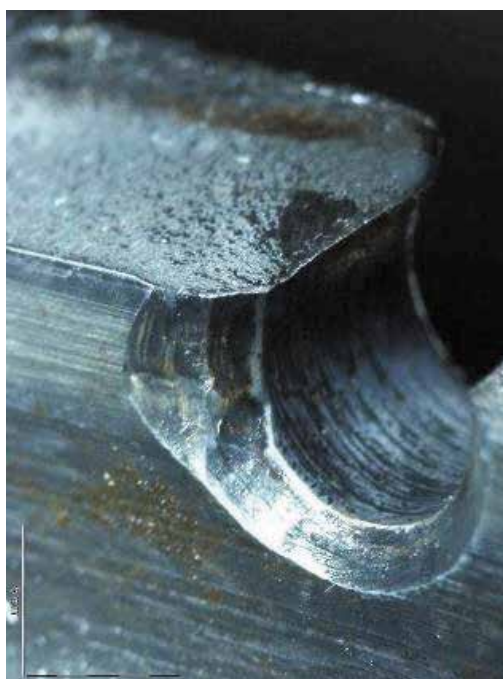
Figure 25

From an examination of the weld using a Scanning Electron Microscope (SEM), a review of the x-rays and results of the inspections performed during manufacturing, it was established that the weld had been correctly formed. The weld was within the design tolerances. While the 4.2 mm hole was of the correct size, and correctly aligned in the weld, there was evidence of tooling marks and a spiral scratch that ran along the length of the bore. The geometry of the countersinks was found to be outside the design specifications; there were also a number of 'scoops' in the inner countersink (Figure 25).

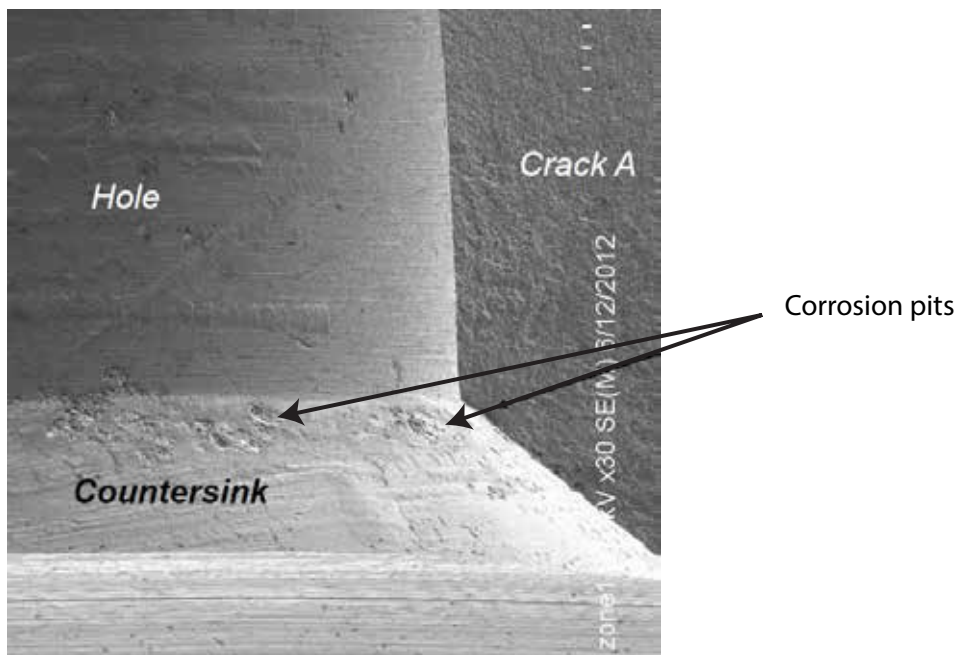
Figure 26

There were patches of very small corrosion pits in the walls of the hole and around the inner countersink, in the area where there is a gap (crevice) between the PTFE plug and the countersink. These corrosion pits were only initially detected using a SEM (Figure 26).

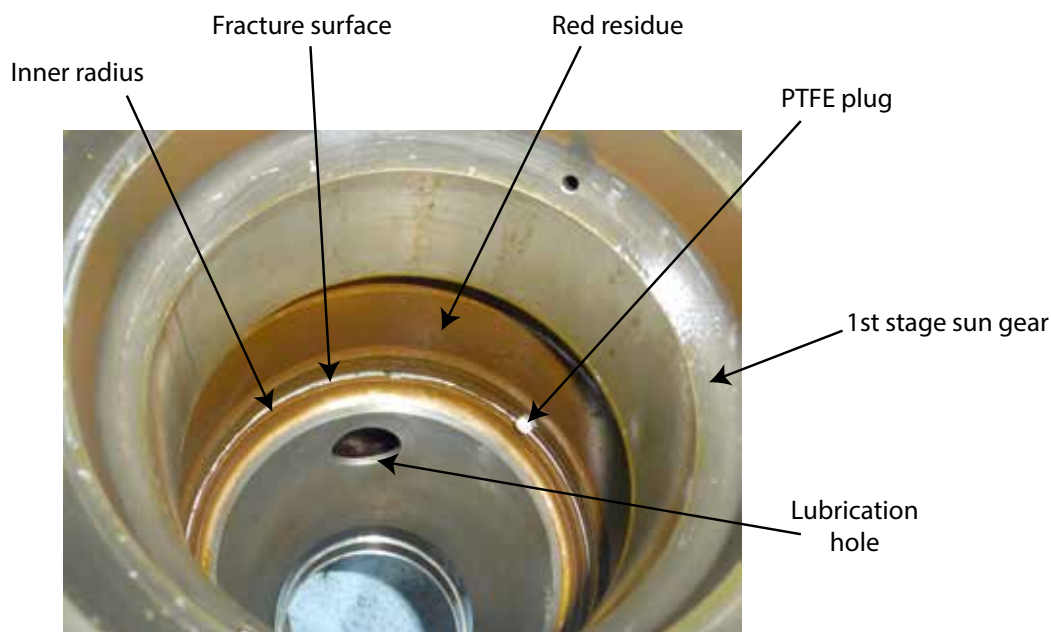
Figure 27

A red deposit was present on the inside of the bevel gear²⁸ part of the shaft which appeared to be slightly more concentrated on the inner radius and above and below the splines (Figure 27). Apart from on the inside of the first stage sun gear and in the fluid found in the gearbox sump, this deposit was not seen on any other part of the bevel gear vertical shaft or in the MGB. The deposit was found to contain iron oxide that had most probably been generated as a result of wear debris from the splines that drive the first stage sun gear.

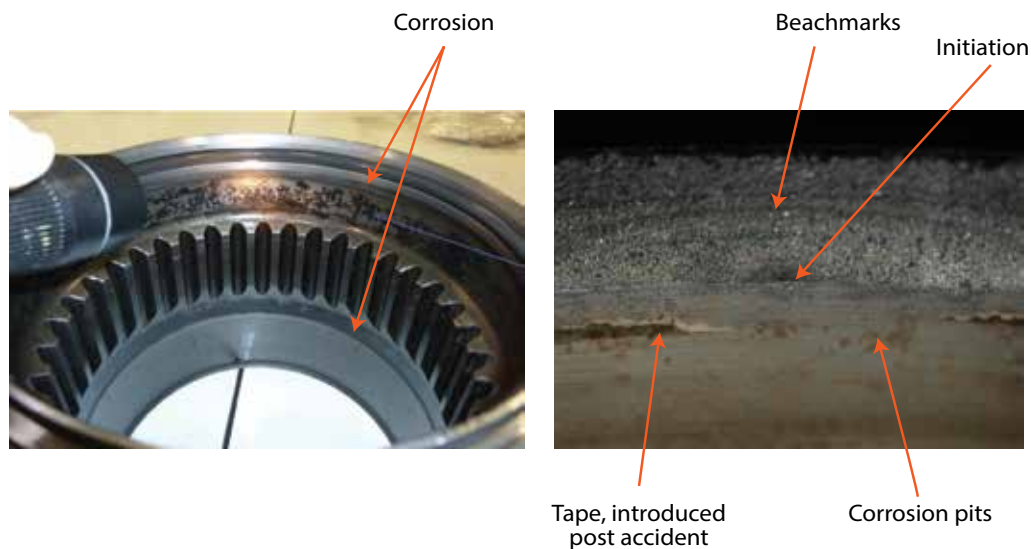
Figure 28
Evidence of corrosion pits on G-CHCN

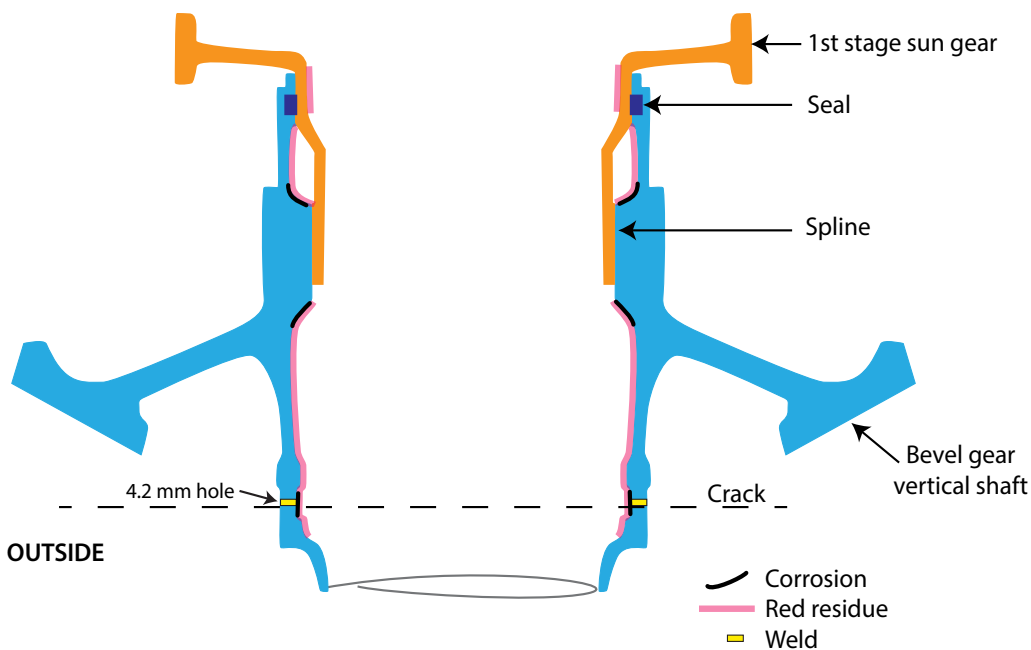
Figure 29
Location of corrosion on bevel gear vertical shaft G-CHCN

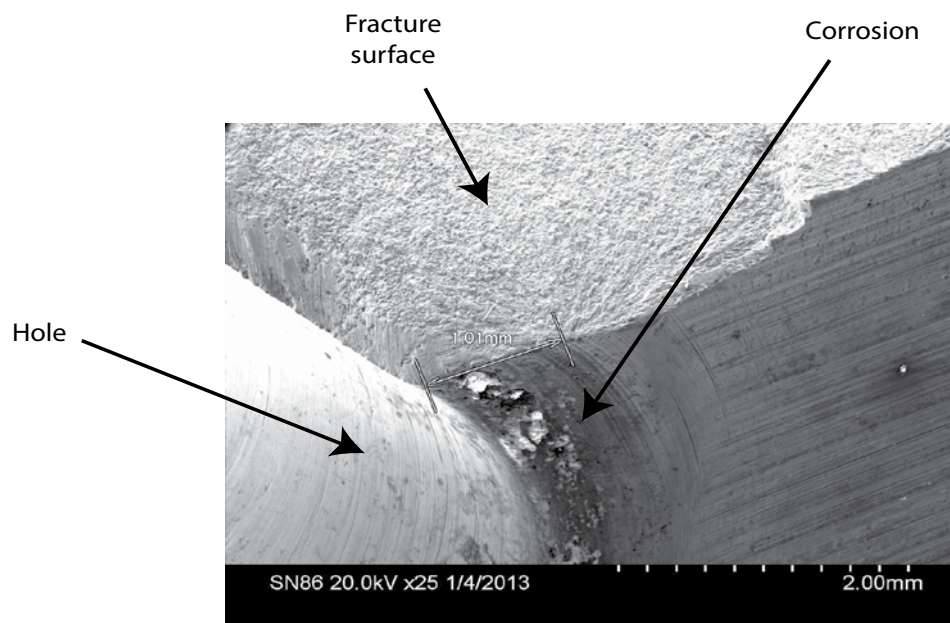
Figure 30

Corrosion similar to that seen on G-REDW was also found on the inner countersink of the 4.2 mm hole in the weld (Figure 30). There was no evidence of corrosion elsewhere on the shaft.

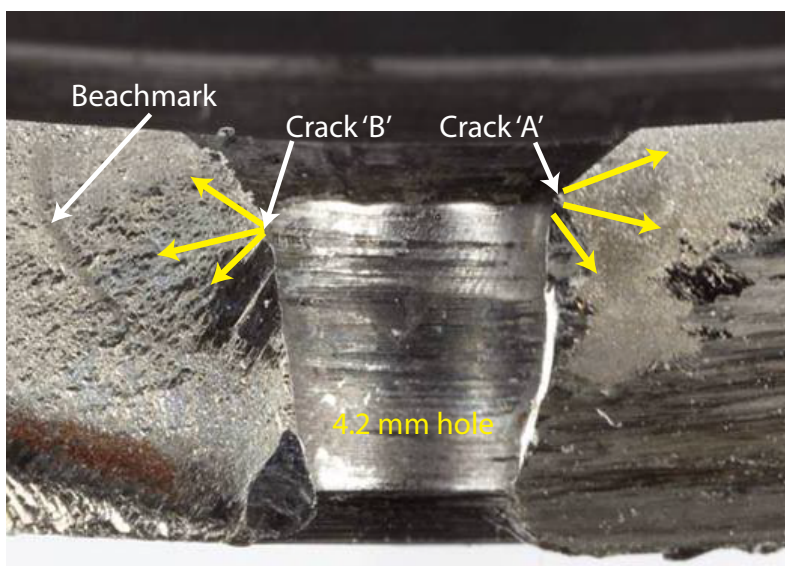
Figure 31

to the fusion line, on the inside of the shaft, up to a minimum of 61 mm and was observed to be in the parent material at a distance of 135 mm from the point of initiation. A second crack, Crack 'B', then initiated at a small defect in the internal surface of the hole. The propagation of Crack 'A' may have caused the initiation of Crack 'B' and the deviation of Crack 'A' into the HAZ may have been as a result of the propagation of Crack 'B'. Crack 'B' ran into a third crack identified as Crack 'C' (Figures 31 and 32).

Location of cracks 'A' and 'B' on G-REDW

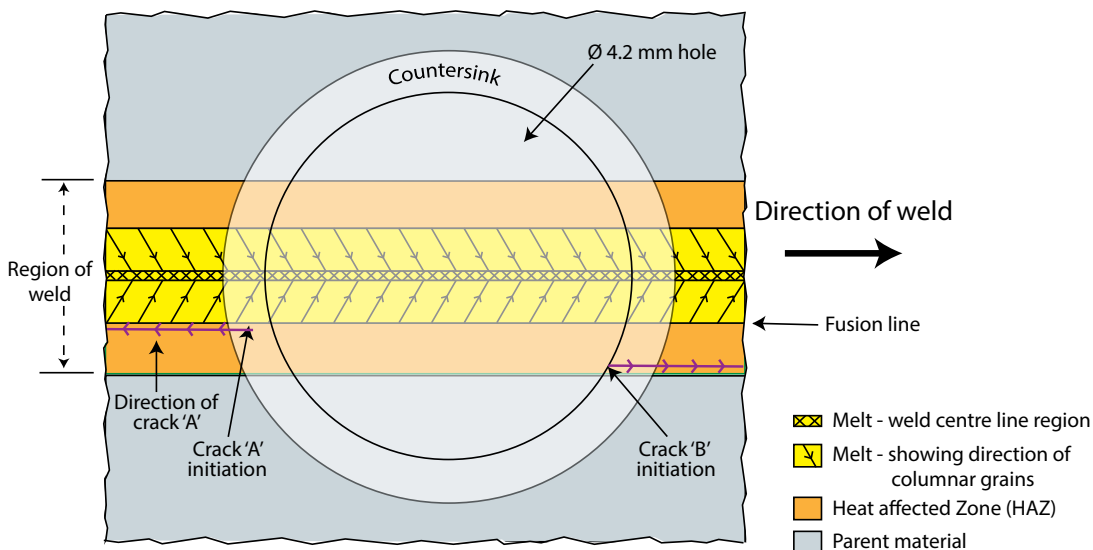
Crack A initially propagates close to the fusion line in the HAZ.

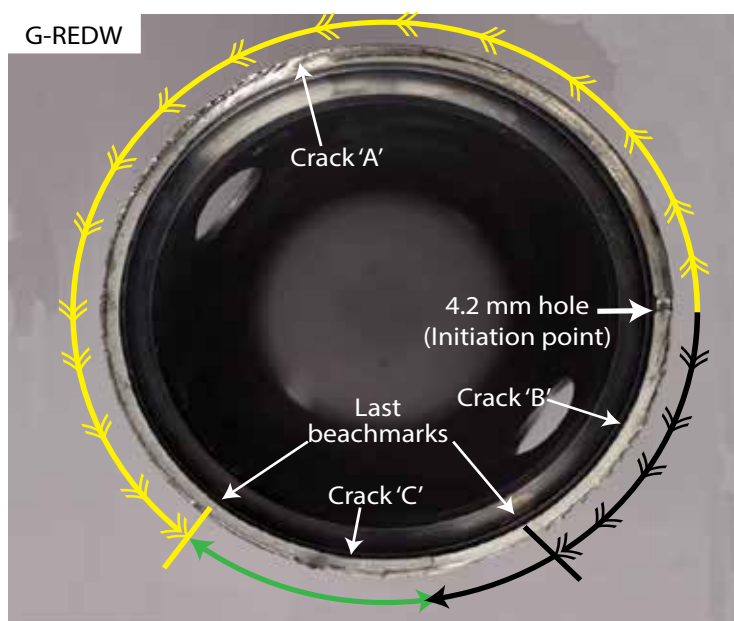
Figure 33

Crack 'A' extended around the circumference for approximately 250°, Crack 'B' extended in the opposite direction to crack 'A' along an arc of approximately 80° (Figure 33). Crack 'C', which showed no evidence of beachmarks, ran between Crack 'A' and 'B' along an arc of approximately 30°. The inner part of the fracture surface was flat and perpendicular to the axis and what appeared to be a 45° shear lip ran around the outer edge. Striations²⁹ were also detected, by the use of a SEM, on the fracture surfaces of Crack 'A' and 'B'.

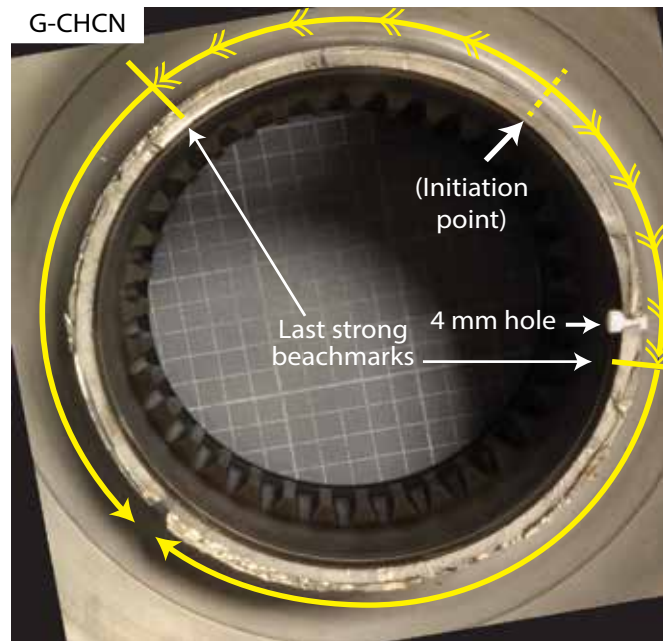
Figure 34

G-CHCN fracture surface

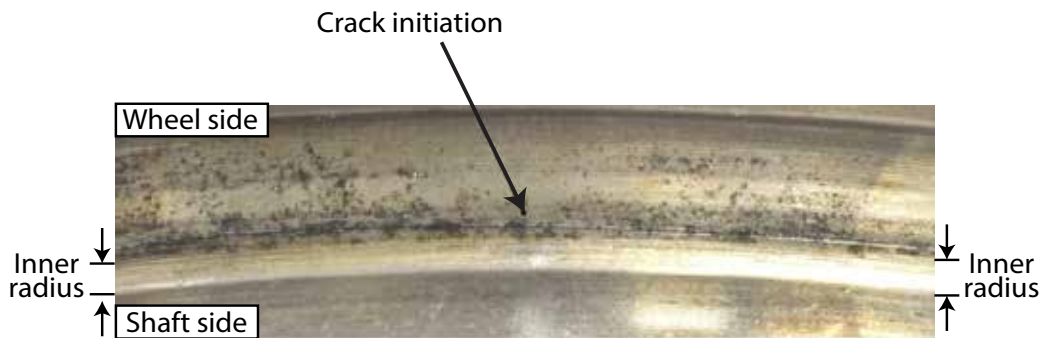
Figure 36

The machining marks on the inner flange of the shaft, in the area of the weld, appeared to be more pronounced than the marks left on other parts of the shaft. Additionally, there were numerous small tears in the surface consistent with a machine tool vibrating as it cut the metal during the manufacturing of the shaft. Localised pits of corrosion were also present in this area, particularly in the inner radius, and appeared to have developed in the crevices of the machining marks in this location (Figure 36).

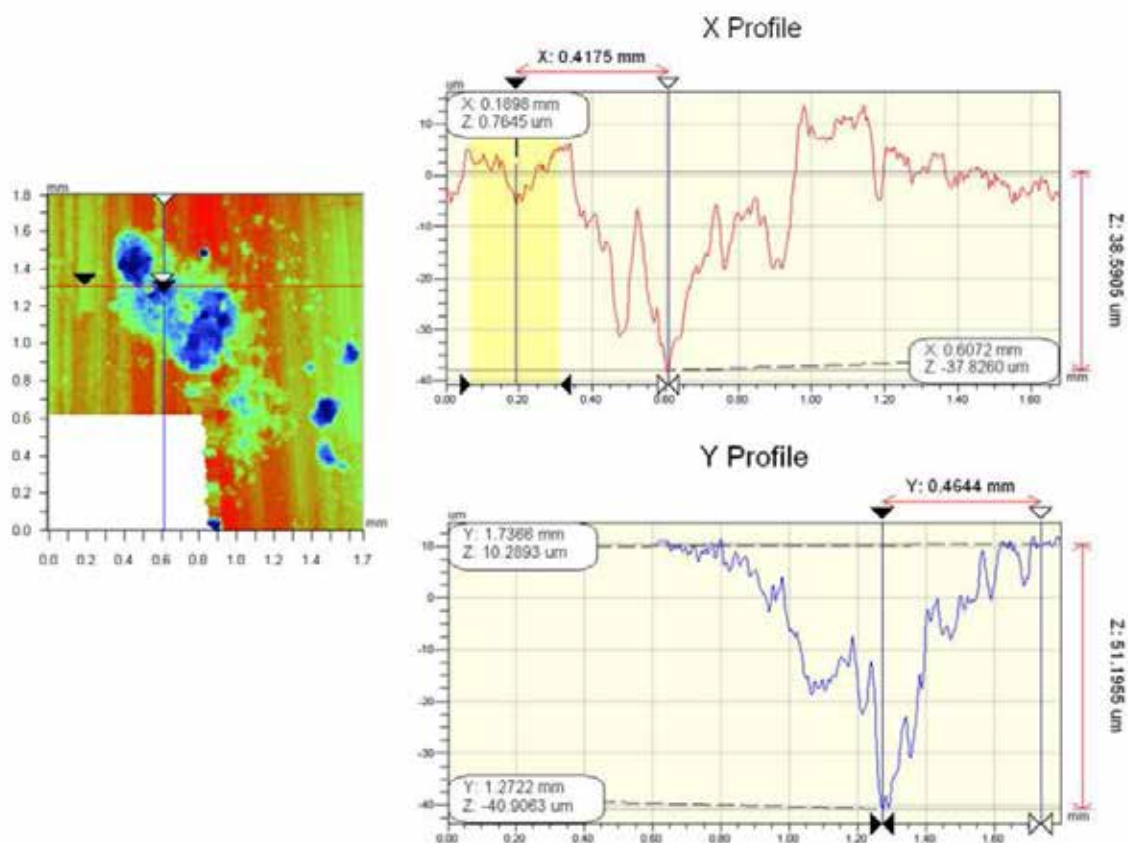
Figure 38 (a)

Profile of a corrosion pit on the shaft fitted to G-CHCN
 (Note the scale of the horizontal and vertical axis is different)
