# Accident to British Airtours Boeing 707 GAPFK at Prestwick Scotland on 17th March 1977

**BOEING 707 G-APFK, PRESTWICK 17 MARCH 1977**

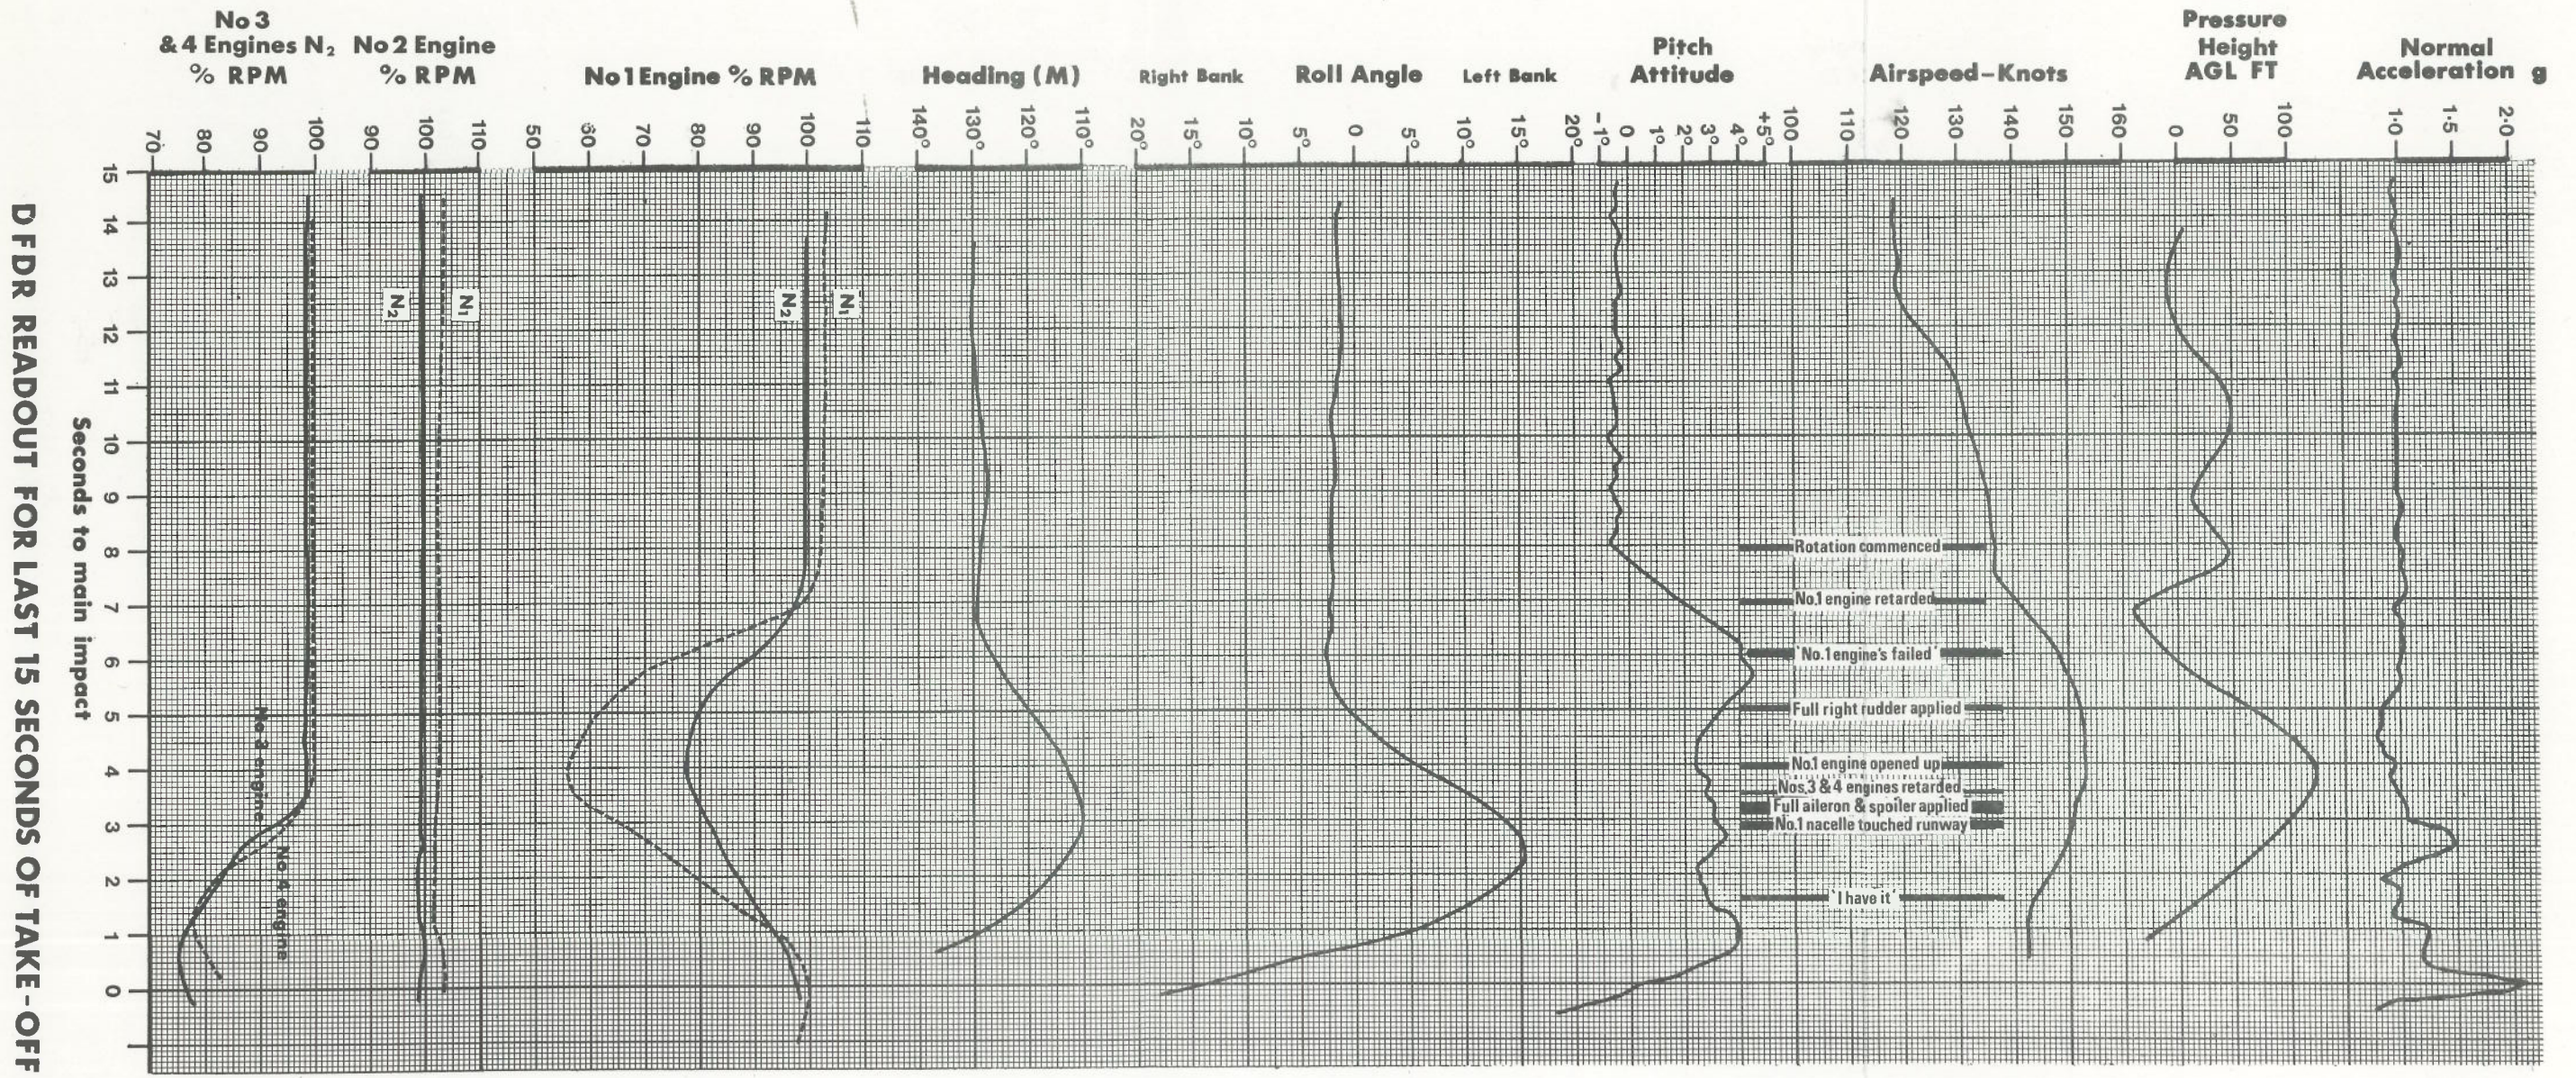
- (i) The take-off ground roll proceeded normally; at – 8 seconds (ie 8 seconds before the main impact) and at a recorded airspeed of 137 knots ( $V_R$  135 knots), rotation commenced, and continued through the following 2.3 seconds, with the pitch attitude changing from – 0.6° (nose-down) to 4.6° nose-up.

- (ii) At – 7 seconds (1 second after commencement of rotation) No. 1 engine rpm started to reduce and continued to do so over a period of approximately 3 seconds. The roll attitude, which had been at 2° right bank for several seconds prior to rotation, increased to 2½° right bank with the airspeed increasing through 149 knots. Almost coincidentally with the commencement of the engine run-down, the aircraft started to yaw quickly to the left. This was followed one second later by a rapid left roll, reaching 15.4° left bank at – 2½ seconds.

- (iii) During this left roll the airspeed increased to a peak of about 153 knots and then commenced to decrease. The aircraft, which had been heading 129° prior to rotation, yawed slightly to the right and then rapidly to the left to 110° by – 3 seconds.

- (iv) An impact ‘g’ spike of 1.44g coincided with the maximum left bank angle; this was caused by the No. 1 engine nacelle striking the ground.
- (v) Immediately following the strike a rapid yaw and roll to the right started, the aircraft passing through the wings level position just after – 1 second and reaching 17.6° right bank coincident with a second ‘g’ spike of 2.15g. The last recorded value of heading was 137° and of airspeed about 142 knots.

The DFDR was powered by the No. 3 engine bus bar. Therefore the second ‘g’ spike was probably caused by impact of the No. 4 engine, and this was followed immediately by the impact of No. 3 engine and its separation from the aircraft, causing the termination of the record.

- (vi) During the roll manoeuvres the pitch attitude fluctuated between 4.6° nose-up at the end of rotation and between 2.5° and 4° nose-up just prior to the main impact. It then started decreasing rapidly, reaching a minimum value of 2.8° nose-down.

- (vii) No. 1 engine rpm started to increase from a minimum  $N_1$  of 57%,  $N_2$  of 77.5% at – 4 seconds, (1½ seconds after the commencement of the left roll), to reach 100%  $N_1$ , 98%  $N_2$  by the time of the main impact. Nos 3 and 4 engines  $N_2$  rpm decreased from their original settings of 99% and 100% respectively at – 3½ seconds, to 76% and 78% at – 1 second. One second later data points were recorded of 76% and 83% respectively. However, as these coincided with the time of the main impact, their validity is questionable. The No. 2 engine  $N_1$  and  $N_2$  rpm remained at their original settings of 103% and 100% throughout the recording apart from a slight decrease at – 2 seconds which was probably caused by disturbance of the intake airflow due to the rapid yaw to the right. The examination of previous flight recordings showed no anomaly in the operation of the No. 3 engine, and during the taxi out to the runway at the start of the accident flight the readout showed that the engine was responding normally to thrust lever movements.

Note: The fluctuations in the height trace are considered to be mainly due to variations in the position error of the static vents due to the yaw which developed; at the point around - 3 seconds, when the No. 1 engine nacelle first touched the runway, the true height can have been only about 10 feet. The recorded airspeed will also have been effected by this static error variation.
