CONTENTS

SPECIAL BULLETINS

COMMERCIAL AIR TRANSPORT

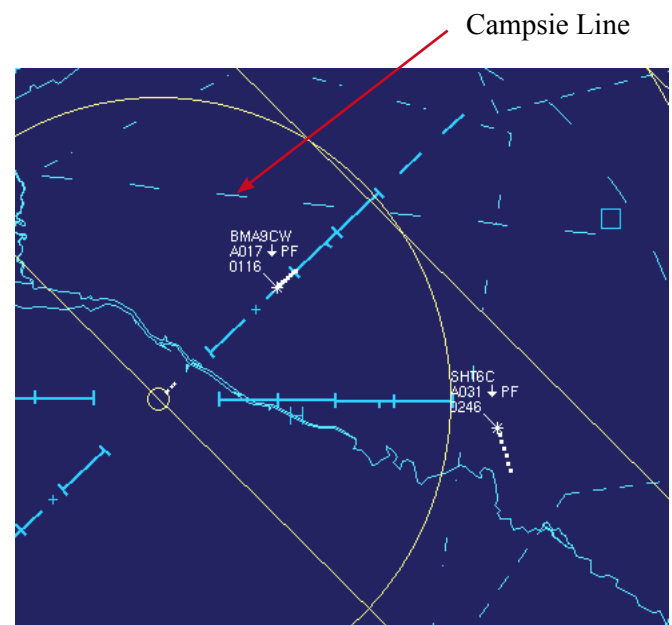
Figure 1

Radar 'screen grab' - Campsie Line & G-EUUR (SHT6C)

The ATCO had available two sources of terrain information however the radar overlays of certain features, including the Campsie Line (Figure 1), were his primary source of information. A laminated colour copy of the Glasgow Terrain Chart (Figure 3) was also available at his station. This chart is also contained in Glasgow's MATS Part 2 document. The track overlay in Figures 2 to 5 was generated using data overlays not available to the controller. Figure 5 is a summary, in side view, of data in Figures 2 to 4 (all in plan view).

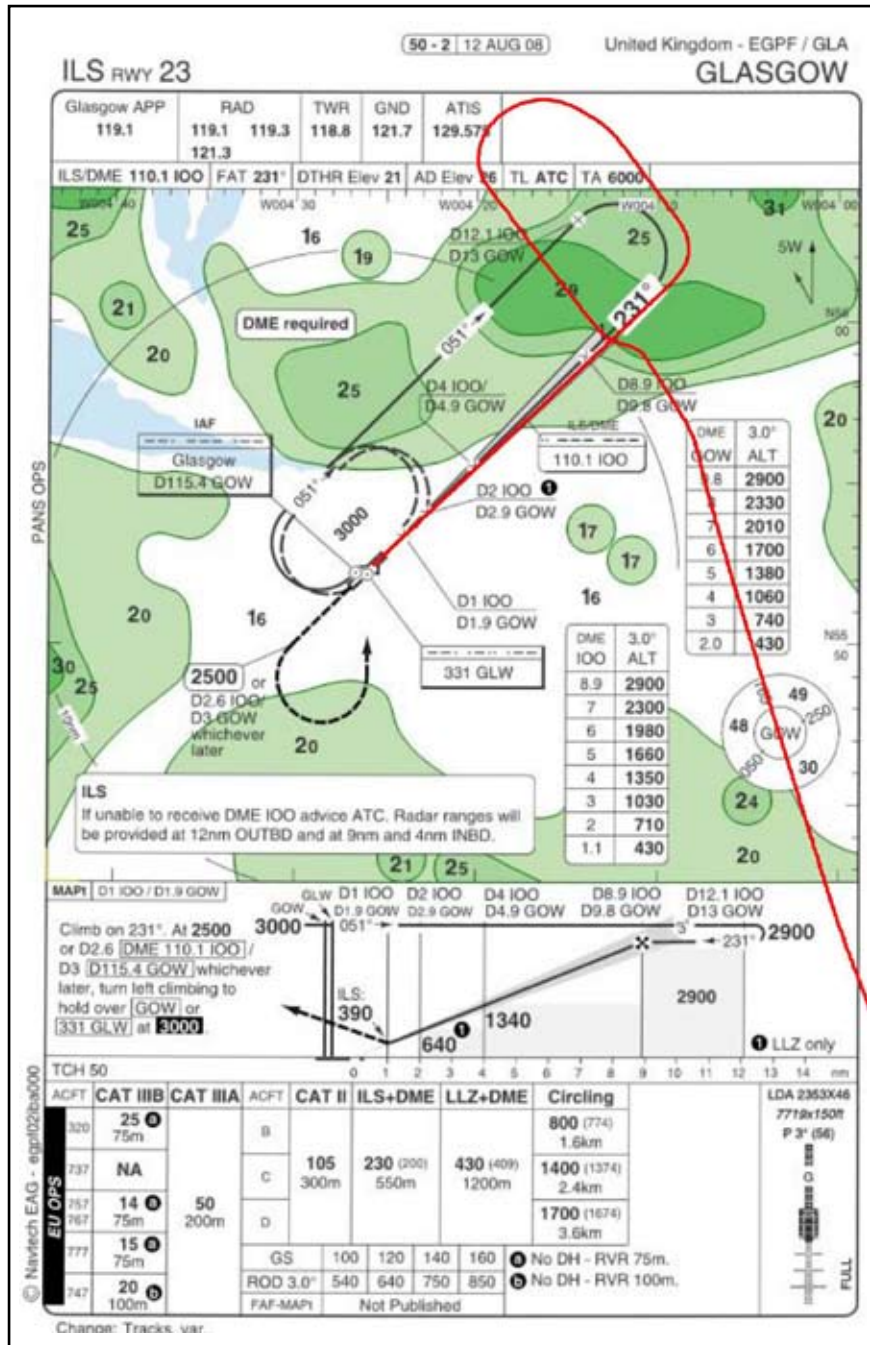
Figure 2

On receiving the GPWS warning the PF had climbed the aircraft to 5,000 ft, which was above the Minimum Safe Altitude (MSA) on the approach chart (Figure 2) of 4,900 ft. The crew levelled at 5,000 ft before being vectored for a second approach.

Approach chart - ILS RWY 23

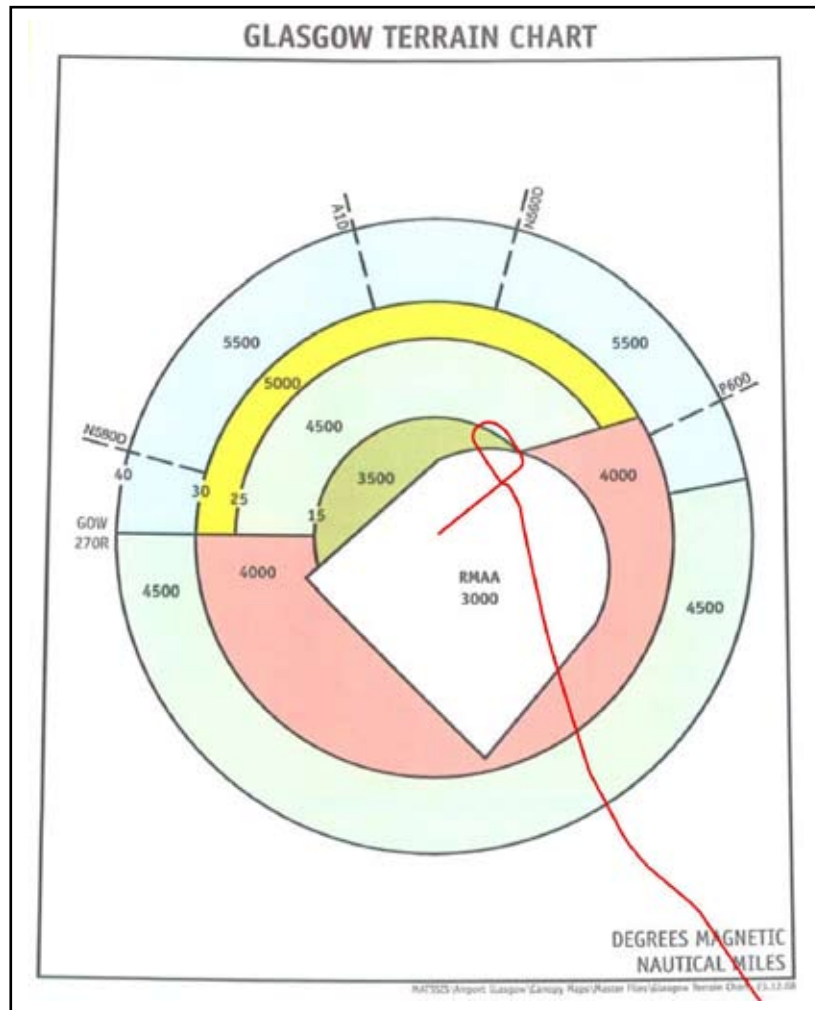
Figure 3

Glasgow Terrain chart

During the investigation an attempt was made, by a CAA Air Traffic Services Investigator (ATSI), the AAIB Inspector and a NATS ATC Manager, to locate accurately the incident aircraft on the ATC Glasgow terrain chart, using an 'as live' radar replay. The team found this chart difficult to use and were unable to perform the task satisfactorily.

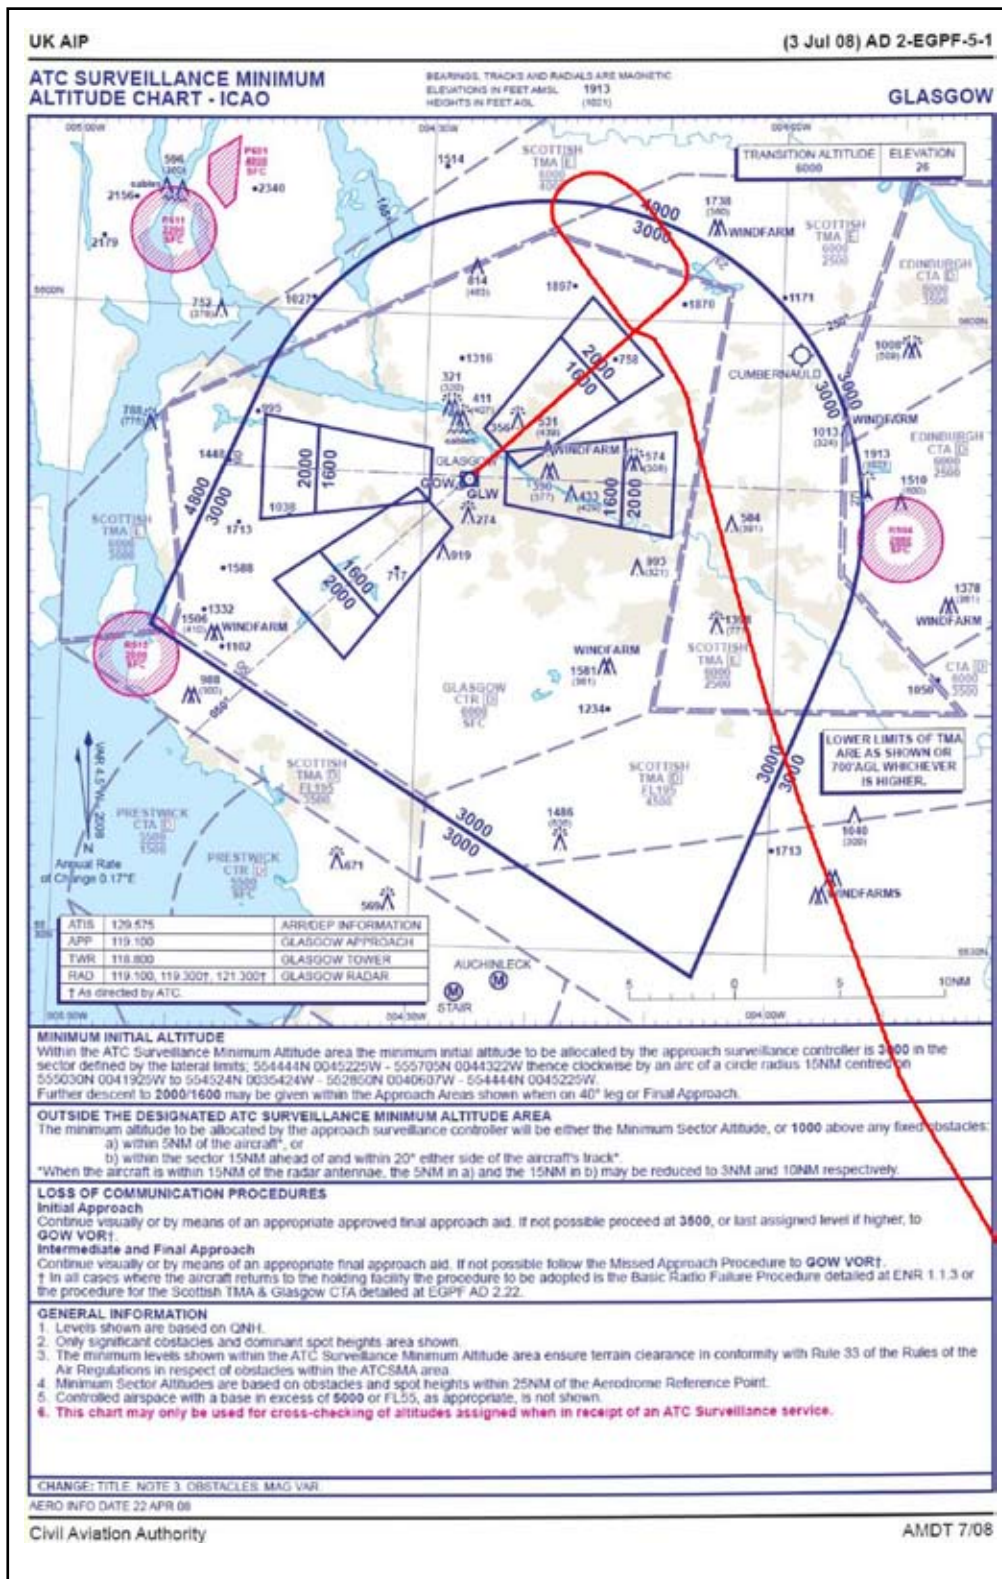
Figure 4
Minimum Altitude chart

the company approach plate booklets, The aircraft's ground track has been overlaid on these figures. The radar minimum altitude chart provides an area overview and minimum vectoring heights for flight crew to use.

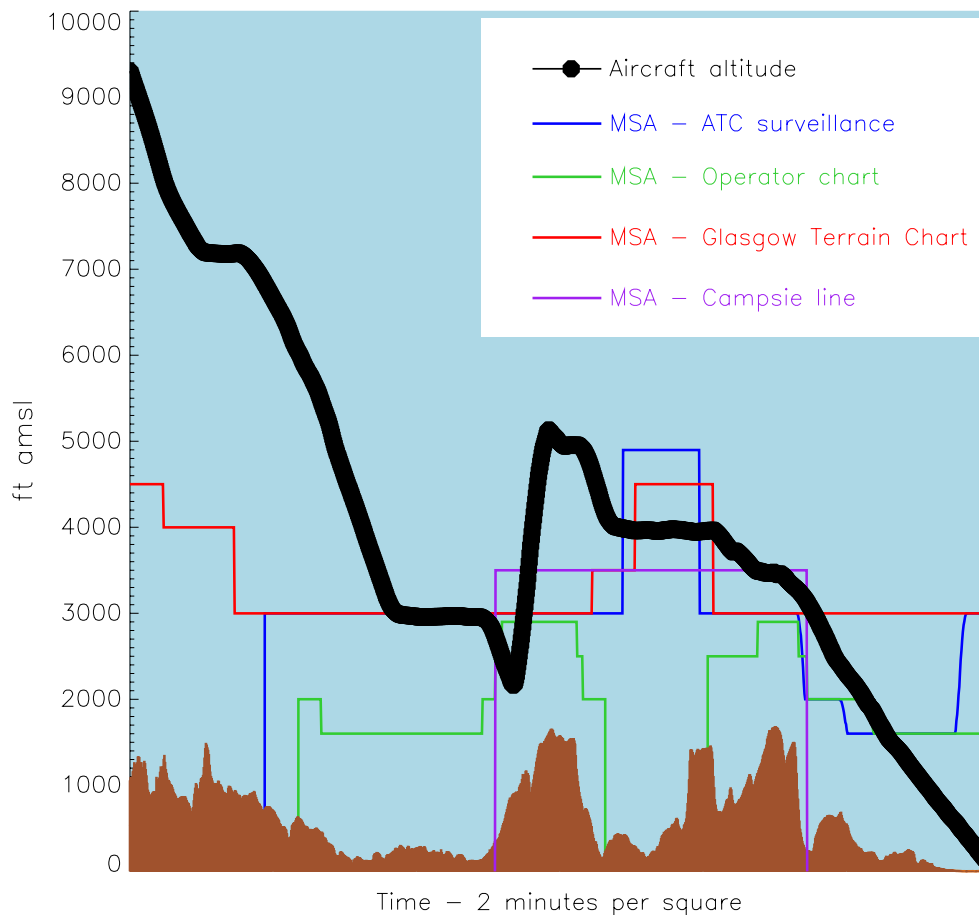
Fig 5

Summary of altitude data - G-EUUR

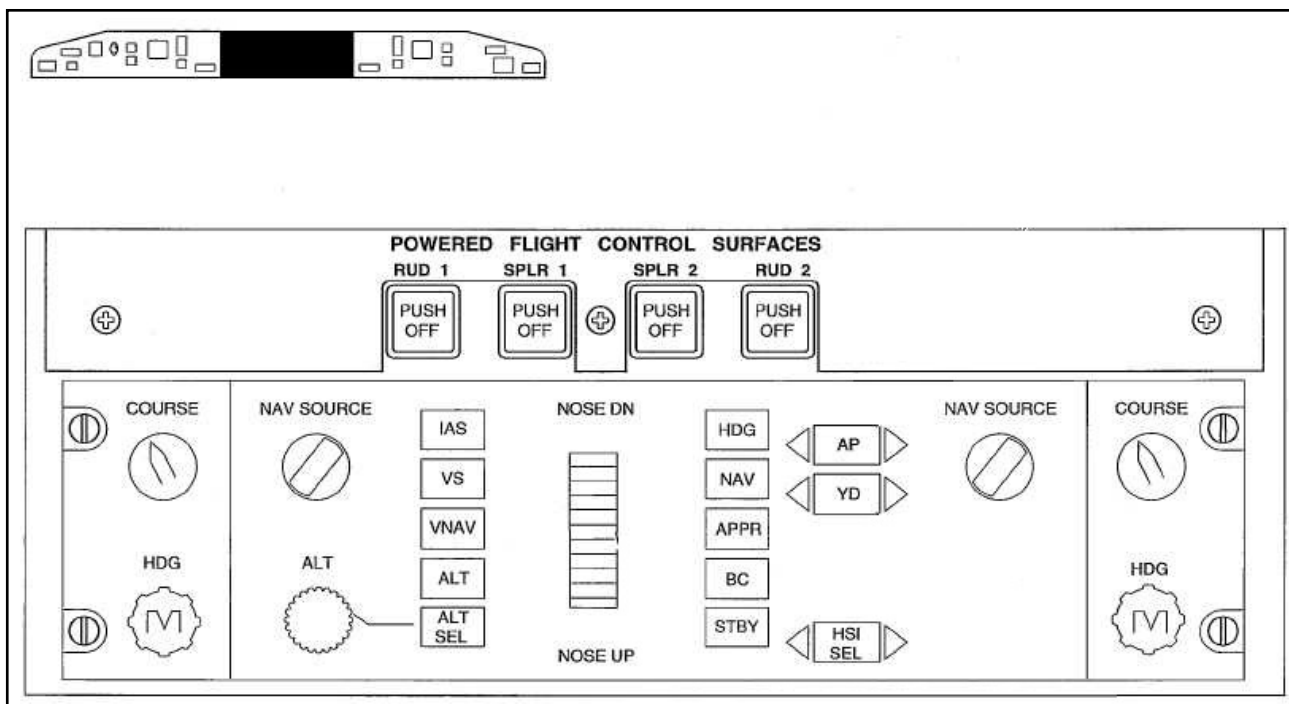
Figure 1

Flight guidance and control panel, location and functions

Both incidents appear to have been initiated by FGCP selections which resulted in FD modes other than those intended by the pilots. In the case of G-JECI, recorded data indicates that the ALTITUDE SELECT mode was not armed after selection of a lower altitude. This problem would be alleviated if the ALTITUDE SELECT mode was automatic upon selection of a new altitude and vertical mode, as is the case on several other aircraft types and as envisaged by the aircraft manufacturer in its discussions with operators. Therefore, the following Safety Recommendation is made:

It is recommended that Bombardier Aerospace enable automatic arming of the altitude select mode of the flight director fitted to Dash-8-400 series aircraft upon selection of a new altitude and vertical mode.

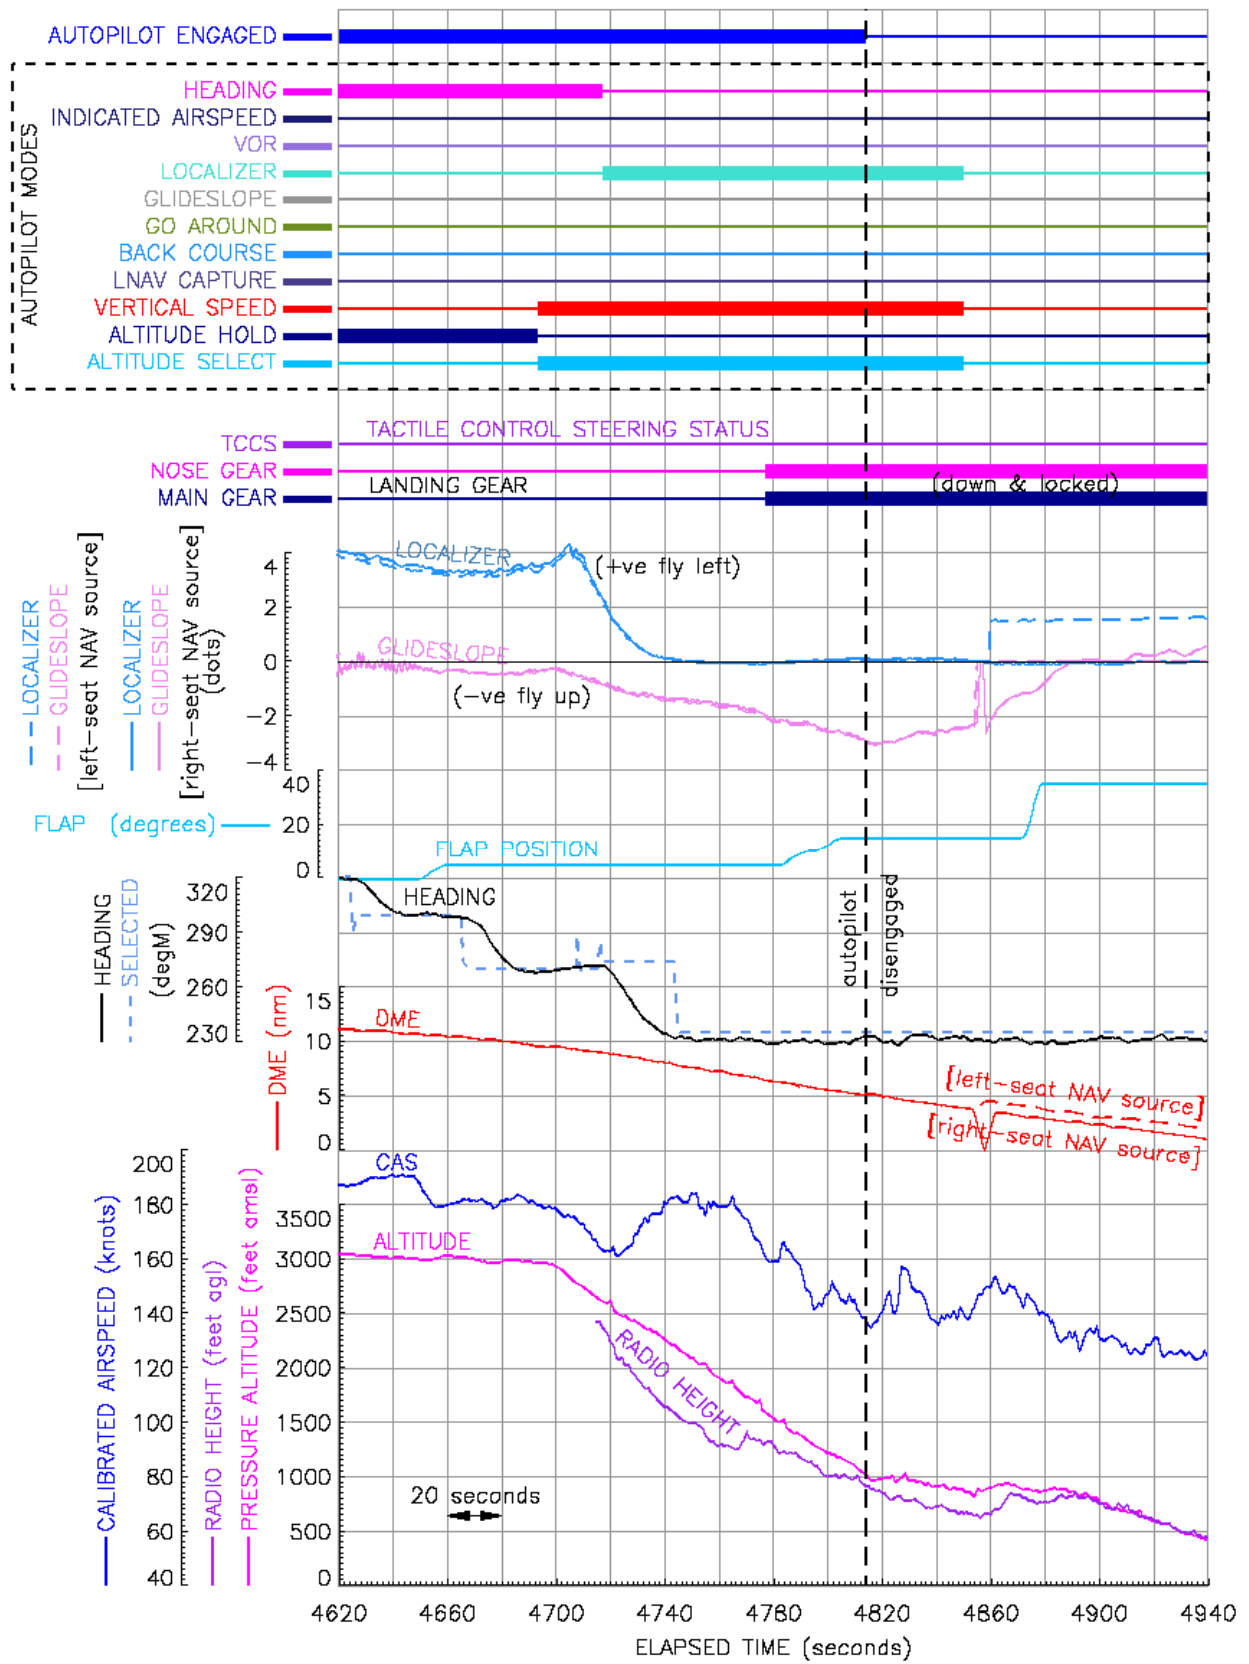
Figure 3

Salient FDR Parameters, G-JECK

- The pilots set the go-around altitude before the flight director entered a capture mode (GS* or ALT*), causing the aircraft to continue to descend at the selected vertical speed.
- The pilots did not monitor aircraft behaviour adequately during the approach and aircraft profile.
- Knowing that a previous crew had reported a problem with the aircraft ILS system the pilots may have suspected failure, rather than mis-selection, of the associated FD modes.
- Weather avoidance may have been a distraction.
- The commander followed FD guidance with little or no reference to other available data.

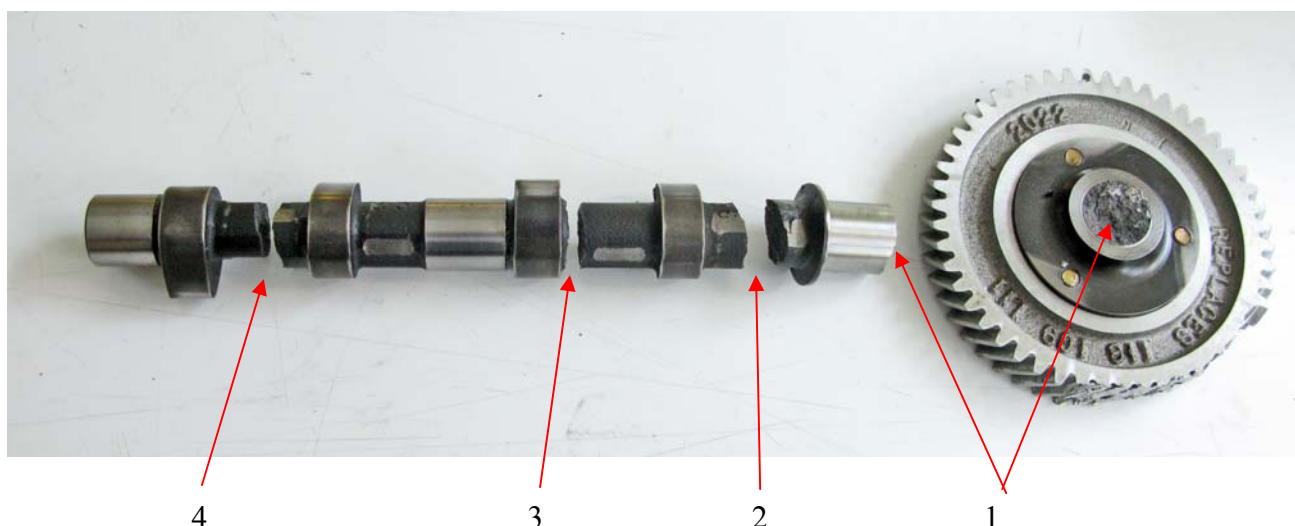
Preliminary examination of the engine by Rotorway's UK agent, established that it would not turn freely and that, within the little movement of the crankshaft available, no corresponding movement of the valve gear could be detected. Subsequently, a bulk disassembly of the engine under the AAIB supervision established that the aluminium camshaft drive gear teeth were stripped over a segment comprising almost a quarter of its circumference. The camshaft had fractured at three separate locations along its length internal to the crankcase, and also at a fourth location, externally, in the accessory case, immediately behind the drive gear attachment flange. Figure 1 shows the fractured camshaft and partially stripped gear, with the camshaft fractures identified and numbered one to four for reference.

Camshaft fractures and gear failure

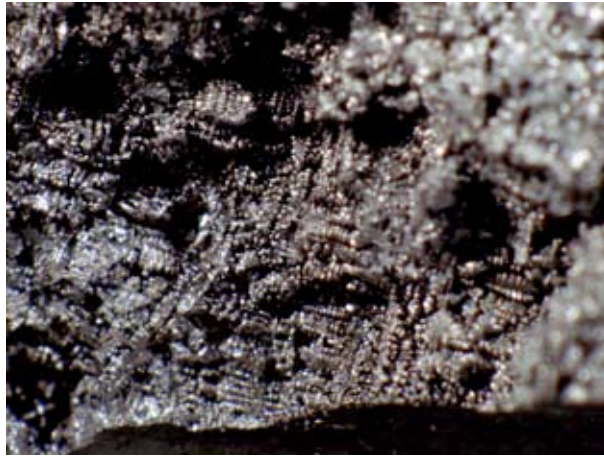
Figure 2

Tooth fracture face, displaying extensive voiding (evidenced as bead-like features) where metal has solidified upon encountering a void

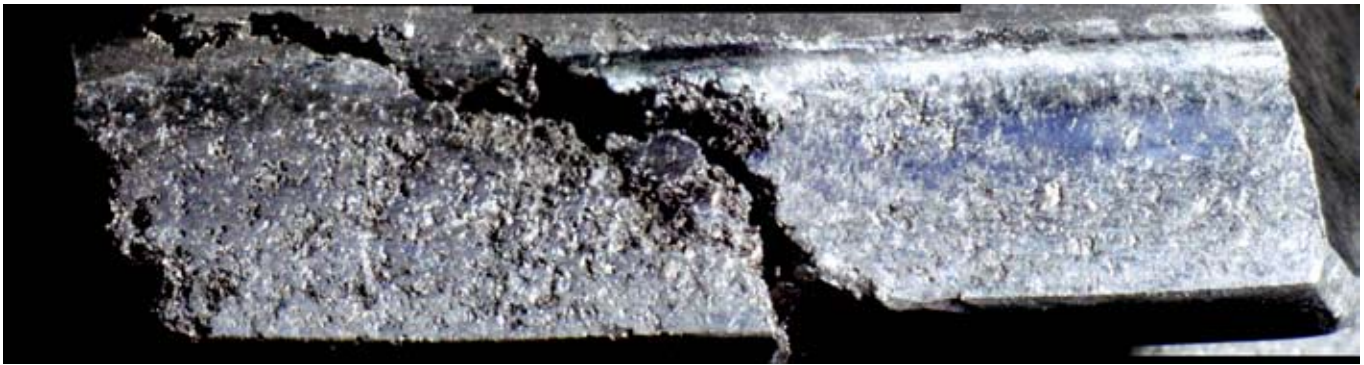
Figure 3

Flank of fractured tooth (separated piece re-positioned, showing porosity at the surface)

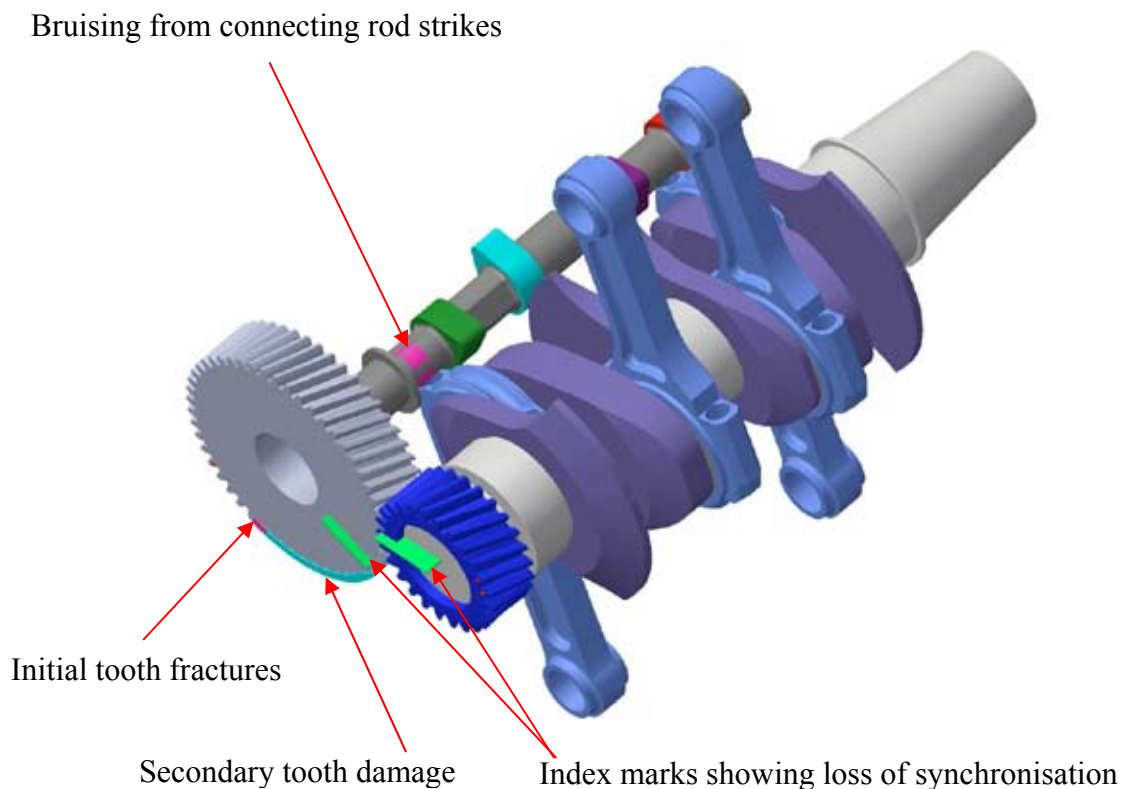
Figure 4

Analysis of the various connecting rod strikes on and around fracture No 2 showed that several strikes at this location, including strikes on opposing sides of the camshaft, corresponded with positions of the gear where teeth were intact, ie, at positions where the gears

Typical example of connecting rod strike on the camshaft and associated loss of synchronisation

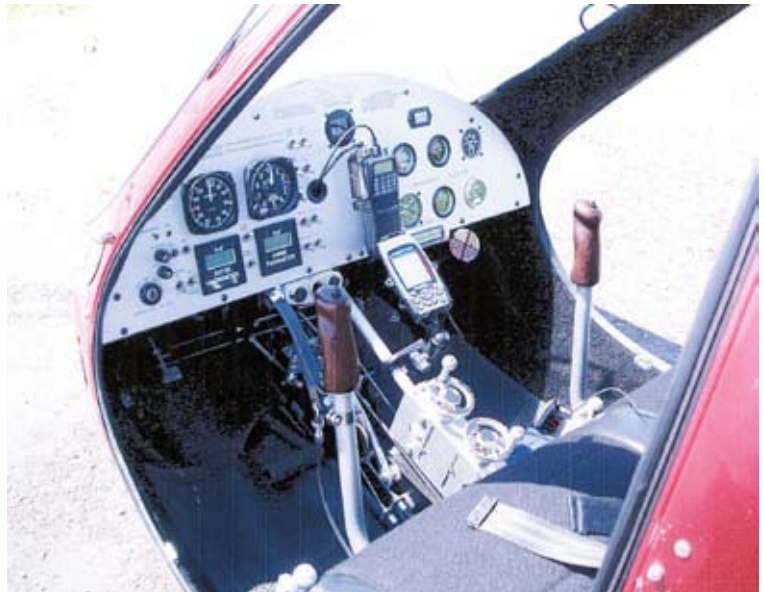
Figure 1

The RAF 2000 type is not approved for night flying and G-CBCJ had neither cockpit lighting nor illuminated flight instruments. See Figure 1.

G-CBCJ cockpit

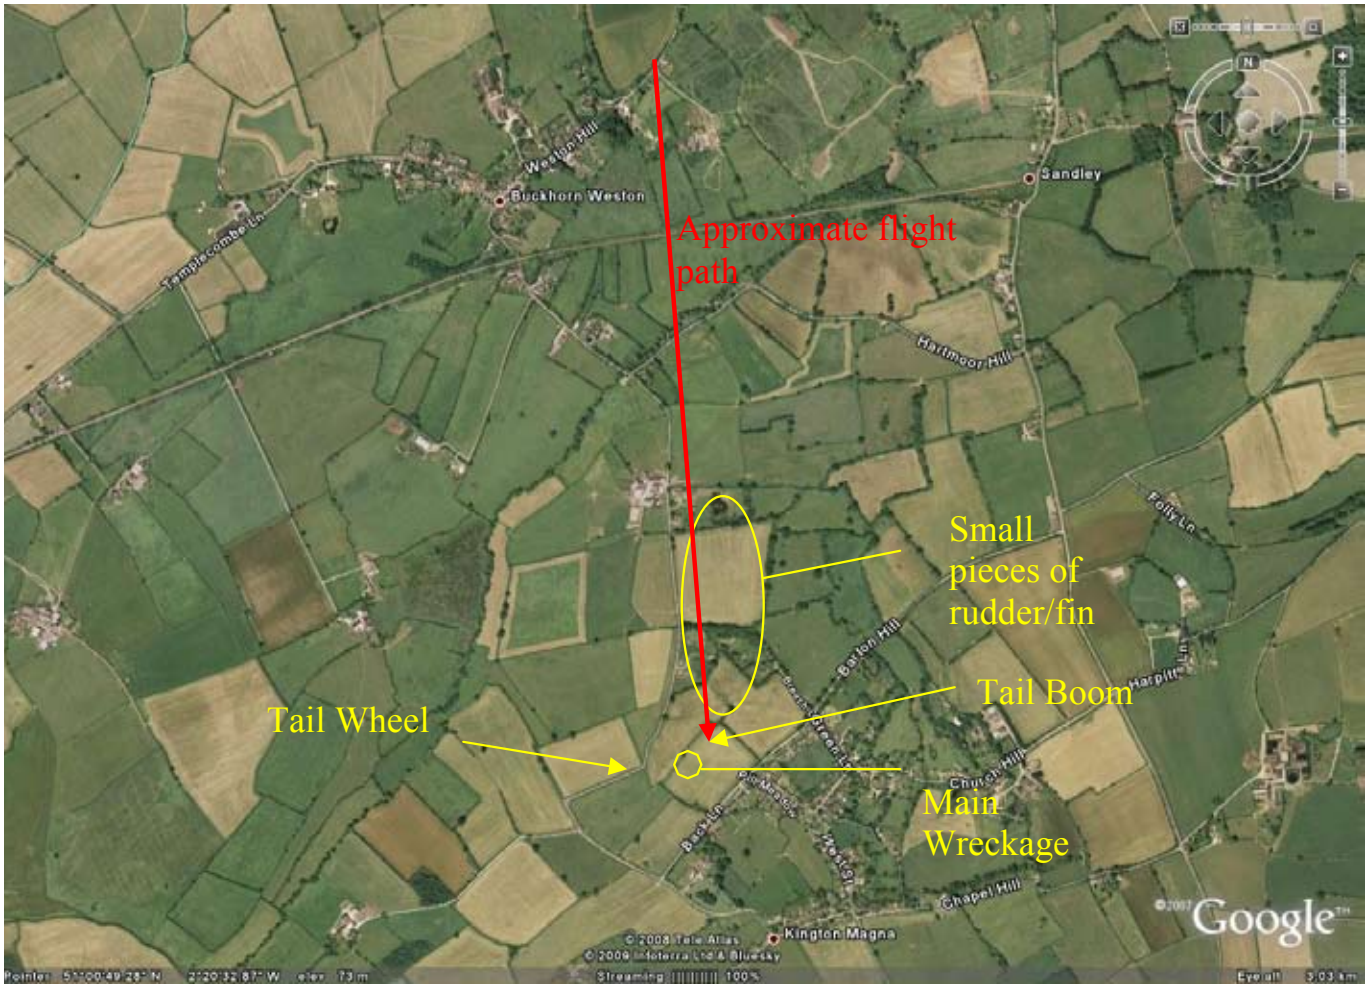
soft ground. The tail boom and a portion of the fibreglass fin were found in the same field, approximately 50 m to the north. Further pieces of wreckage, comprising the remainder of the fin and the rudder, were spread along a trail, in a northerly direction from the main wreckage site, up to a distance of 600 m. The tail wheel was found approximately 100 m to the west of the main wreckage. Figure 2 shows the wreckage distribution.

Wreckage distribution

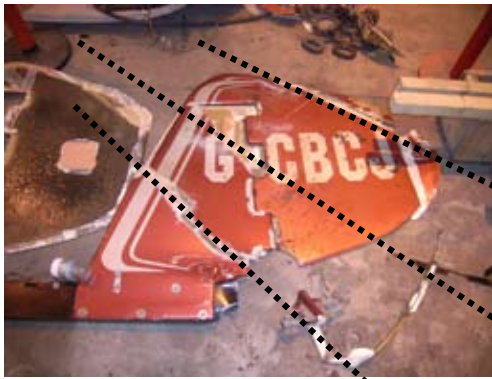
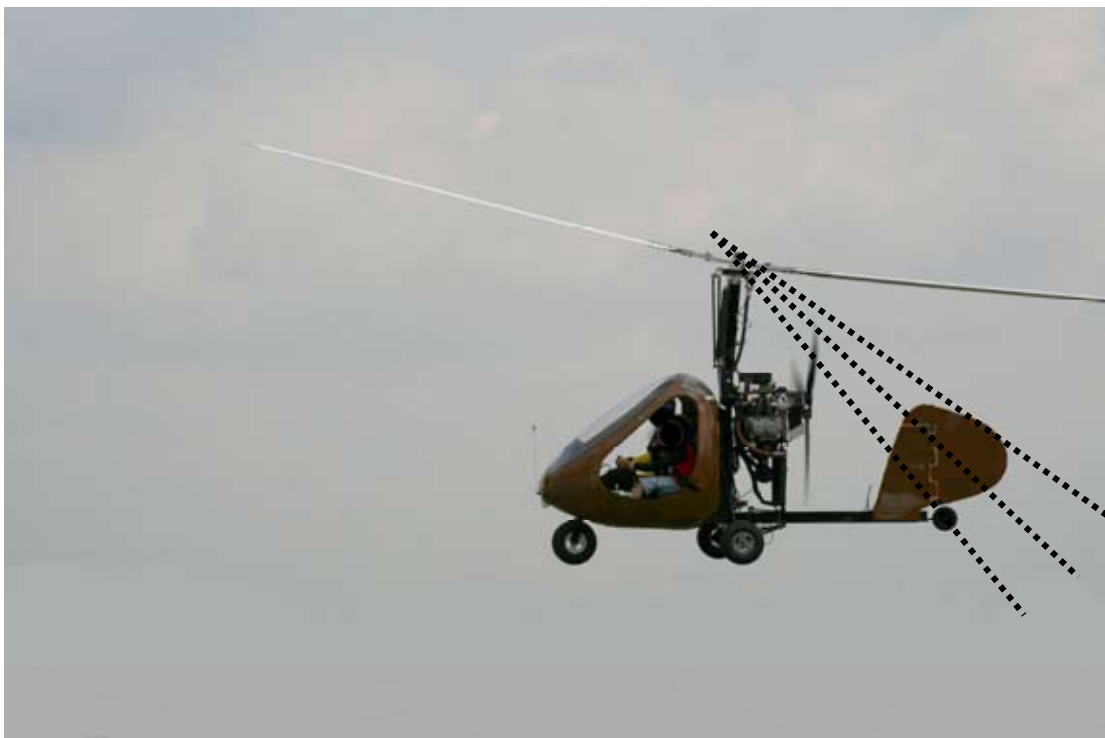
Figure 3

Evidence from ground marks indicated that the rotor blades had not been rotating at impact. However, there was evidence along the length of the blades of multiple impacts with the propeller blades, together with paint transfer arising from impact with the fin and rudder. Reconstruction of the fin and rudder pieces recovered from the wreckage trail indicated that there had been three strikes from the main rotor blade. The first strike had been at the top of the fin/rudder, the second mid-way down, and the third at the base of the rudder, resulting in the detachment of the tailwheel and most of the keel beam. See Figure 3.

Illustration of the three strikes on the fin and rudder by the main rotor
