ACCIDENT

Aircraft Type and Registration:	AS355F1, G-XCEL
No & Type of Engines:	2 Rolls-Royce (Allison) 250-C20F turboshaft engines
Year of Manufacture:	1985
Date & Time (UTC):	2 December 2003 at 1438 hrs
Location:	Hurstbourne Tarrant, near Andover, Hampshire
Type of Flight:	Private
Persons on Board:	Crew - 1 Passengers - 2
Injuries:	Crew - 1 (Fatal) Passengers - 2 (Fatal)
Nature of Damage:	Helicopter destroyed
Commander's Licence:	Airline Transport Pilot's Licence
Commander's Age:	51 years
Commander's Flying Experience:	7,800 hours (of which 1,322 were on type) Last 90 days - 81 hours Last 28 days - 18 hours
Information Source:	AAIB Field Investigation

Synopsis

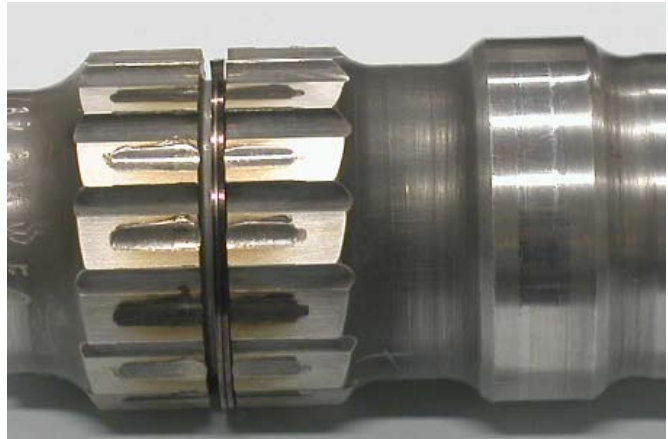
Figure 4

gearbox. After the casing was split, it could be seen that it was in good condition internally. However, when the two freewheels were extracted, it was obvious that the ramps associated with the left unit were in a highly distressed state, consistent with slippage under load (see Figure 4). There was evidence of wear, overheating and material build-up on the ramps. The rollers too, whilst not showing significant wear, were discoloured due to overheating. The outer race, under moderate magnification, appeared to be normal. The right freewheel bore none of these signs and was, at first, thought to be completely normal. Subsequent comparison with in-service units however, later suggested that the slight polished band on the ramps was not normal for an almost new assembly and that this had probably also slipped, but not to the same extent as the left freewheel. Subsequent strip examination of the MRGB revealed no anomalies with the rest of the transmission.

Left input shaft showing wear and overheating damage to ramps of the freewheel

40-50 microns. Although an attempt was made, it was not possible to determine categorically the severity of any re-engagement by examination of the indentations. However, the remains of the 'Thomas coupling' bolts, which were still retained in the combining gearbox input flange, bore signs of deformation suggesting that at least a 250% over-torque had occurred on both sides. This figure was arrived at through tests and calculations carried out by Eurocopter, early in the helicopter's service life, and is normally used for assessing damage caused by events such as main or tail rotor strikes.

Further consideration of the marks on the right freewheel also concluded that this had slipped, but to a much lesser degree than the left.
