INCIDENT

Aircraft Type and Registration:	ATR 42-300, G-TAWE	
No & Type of Engines:	2 Pratt & Whitney Canada PW120 turboprop engines	
Year of Manufacture:	1994	
Date & Time (UTC):	20 January 2006 at 2107 hrs	
Location:	Runway 31 at Glasgow Prestwick Airport	
Type of Flight:	Public Transport (Passenger)	
Persons on Board:	Crew - 3	Passengers - 34
Injuries:	Crew - None	Passengers - None
Nature of Damage:	Nose gear uplock bent and five runway edge lights damaged	
Commander's Licence:	Airline Transport Pilot's Licence	
Commander's Age:	57 years	
Commander's Flying Experience:	13,233 hours (of which about 5,000 were on type) Last 90 days - 123 hours Last 28 days - 38 hours	
Information Source:	Aircraft Accident Report Form submitted by the pilot and report by Glasgow Prestwick Airport

Synopsis

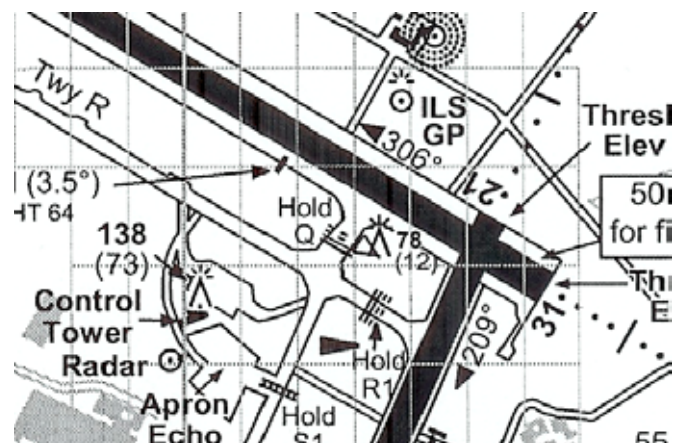
**Figure 1**

While taxiing for a departure from Runway 31, the commander was given clearance to enter the runway by either 'R1' or 'Q'. The disposition of these holding points is as shown in Figure 1. He elected to enter by 'Q' and lined up the aircraft in a position he thought was just to the left of the runway centreline. The first officer then commented that he did not think that the 'perspective' looked quite right and the commander taxied G-TAWE to the left until it was lined up exactly over lights.

Disposition of the holds for Runway 31

All taxiways have green centreline lights except for the entry to Runway 31 by holding point ‘Q’. There are blue edge lights on all taxiways. The lights were on at the time of the incident.

The UK AIP contains a warning about the possibility of mistaking the runway edge lights for the centreline lights. In the incident involving G-TAWE, the use of ‘Q’, which has no centreline lights as a lead-in to the runway was a contributing factor. Since the incident, ATC no longer allow aircraft to use ‘Q’ when entering the runway at night or in poor visibility.
