Sikorsky S76 Main Rotor Blade Failure

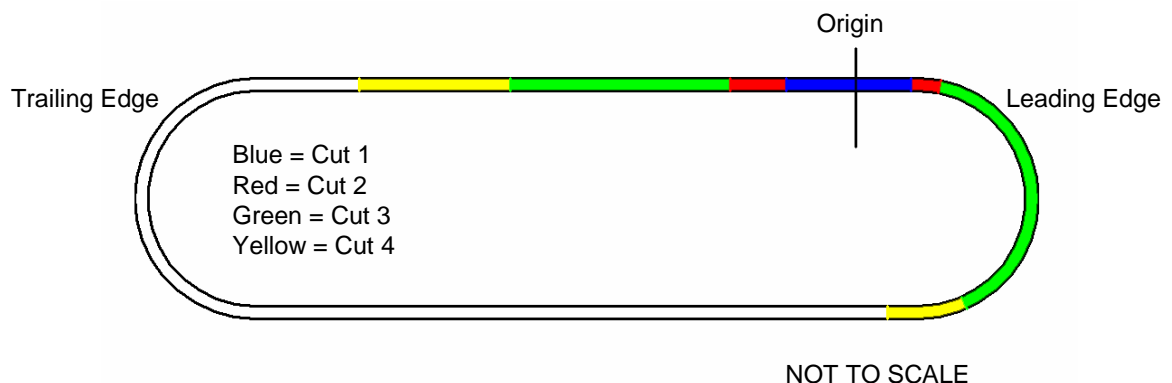
Figure 1. Cross section through spar showing crack positions.

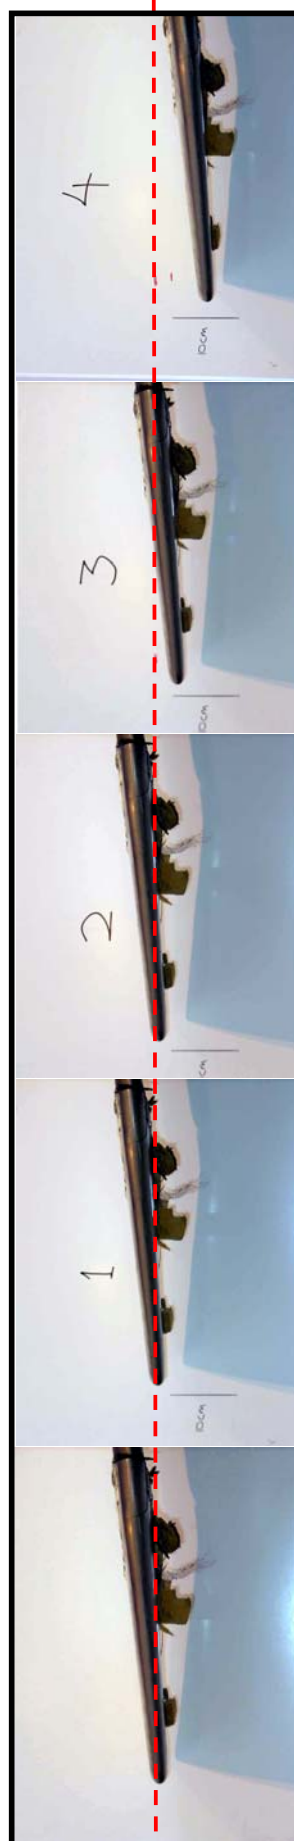
Figure 2. Blade droop at various crack lengths

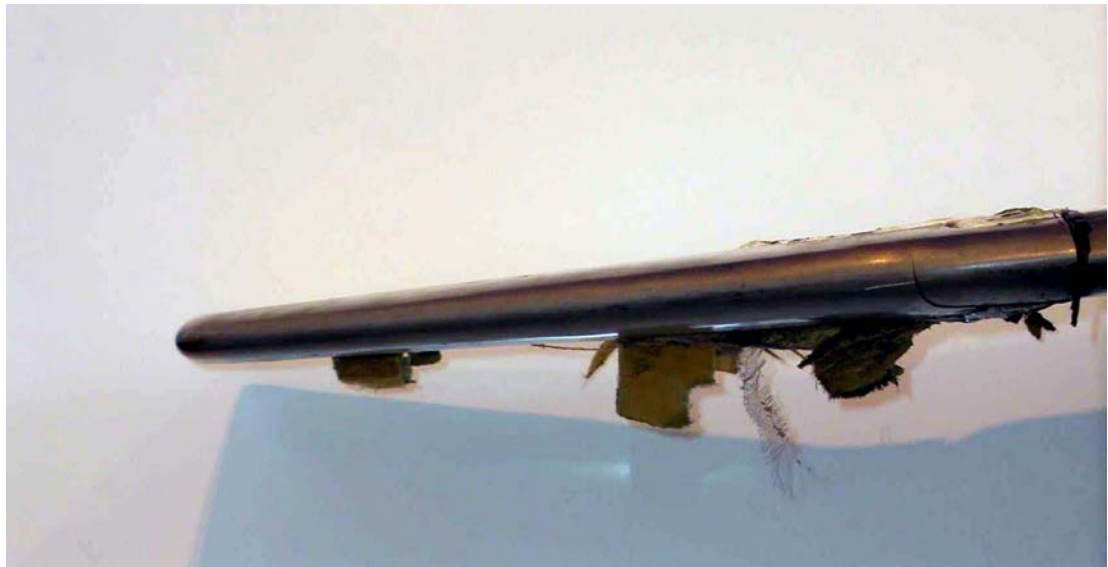
Figure 2. a) blade droop, b) change in droop at different crack lengths.

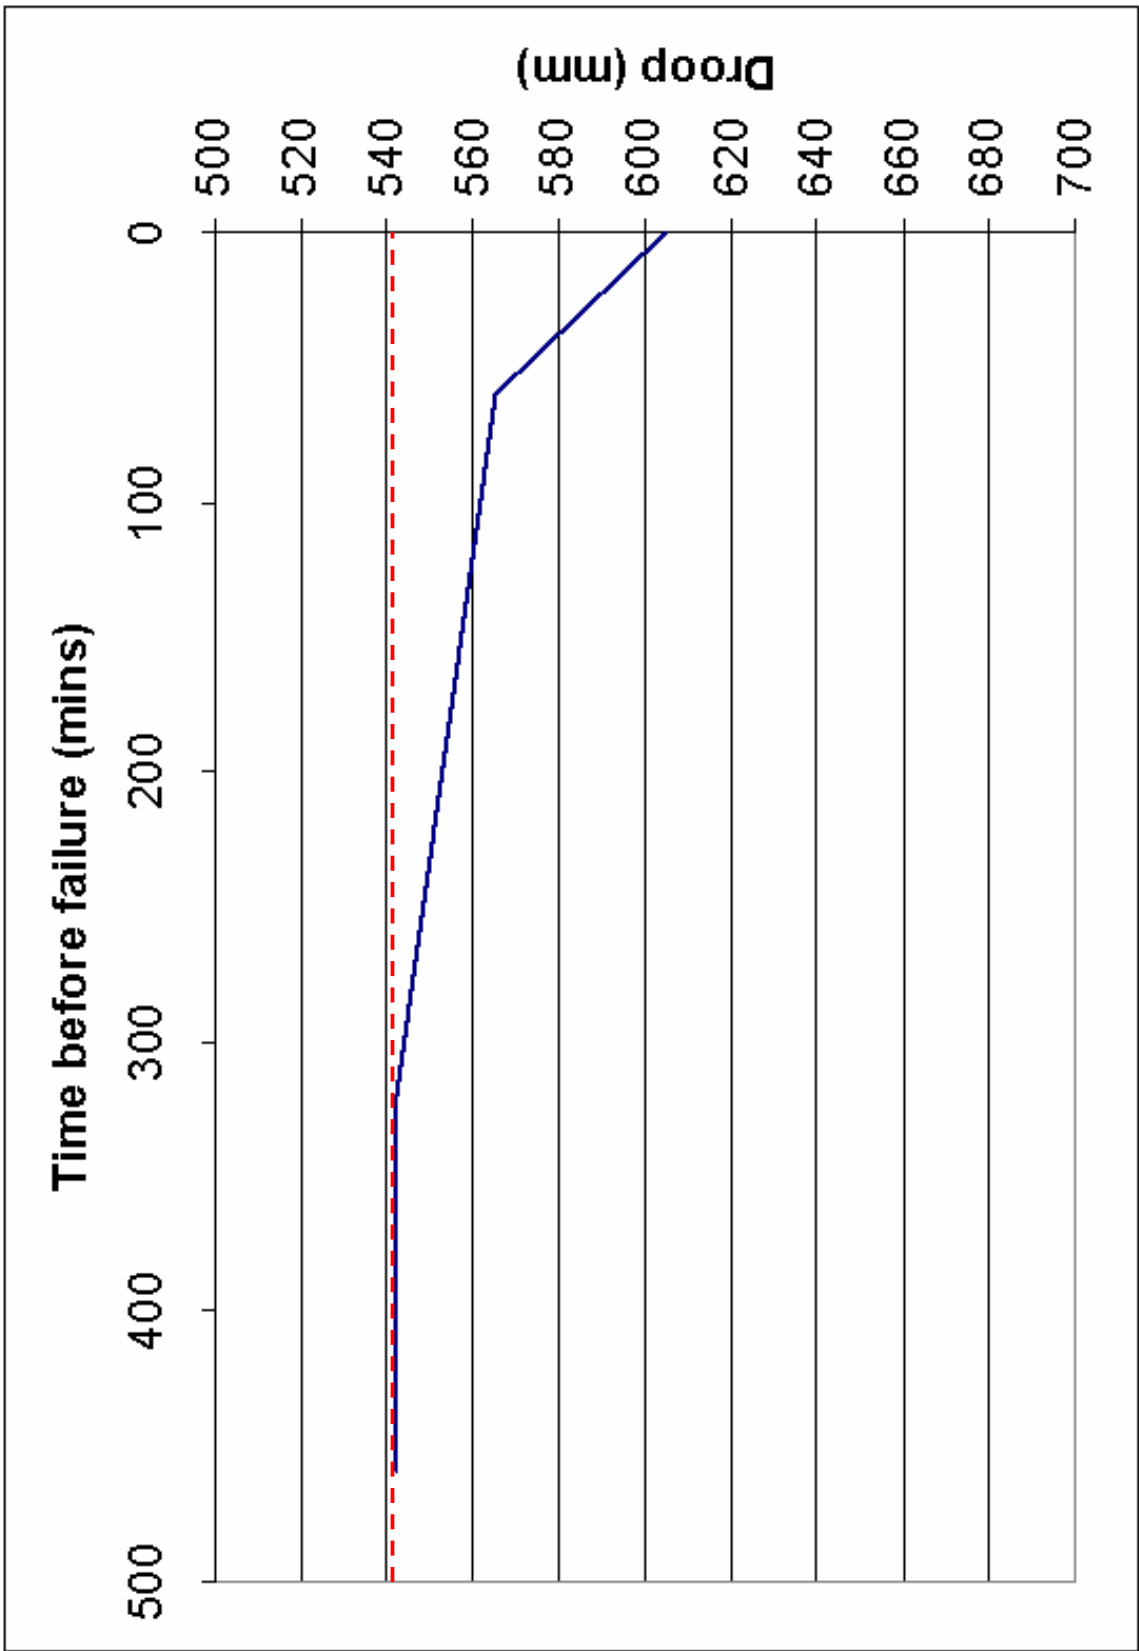
From the experiment, it was found that at a crack length of 19mm in the leading edge direction and 22mm in the trailing edge direction (cut 2), there was no increase in the blade droop. Fatigue striation measurements carried out in QINETIQ/FST/SMC/LR024608 and reported in QINETIQ/FST/SMC/LR026770 indicated that an approximate time before failure at the crack length of cut 2 was 5hrs 20mins which corresponds to the evening before the day of the accident when a visual inspection of the aircraft was carried out. Approximately one hour before failure, a pre-flight inspection was also carried out. The corresponding crack length at this time (cut 3) produced an increase in blade droop of 23mm over the blade length of approximately 6m.

Figure 3. Graph of blade droop results.
