**INCIDENTS**

<b>Aircraft Type and Registration:</b>	Avro 146-RJ100, G-CFAC and others
<b>No &amp; Type of Engines:</b>	4 Lycoming LF507-1F turbofan engines
<b>Year of Manufacture:</b>	Various
<b>Date &amp; Time (UTC):</b>	Various dates and times
<b>Location:</b>	Various
<b>Type of Flight:</b>	Public Transport (Passenger)
<b>Persons on Board:</b>	Crew - Various          Passengers - Various
<b>Injuries:</b>	None
<b>Nature of Damage:</b>	None
<b>Commanders' Licences:</b>	Airline Transport Pilot's Licence
<b>Commanders' Ages:</b>	Various
<b>Commanders' Flying Experiences:</b>	Various
<b>Information Source:</b>	Aircraft Accident Report Forms submitted by pilots and subsequent enquires by the AAIB

**Synopsis**

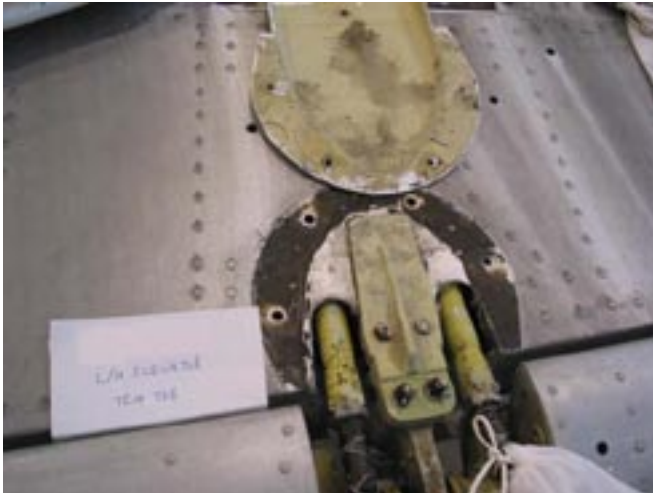
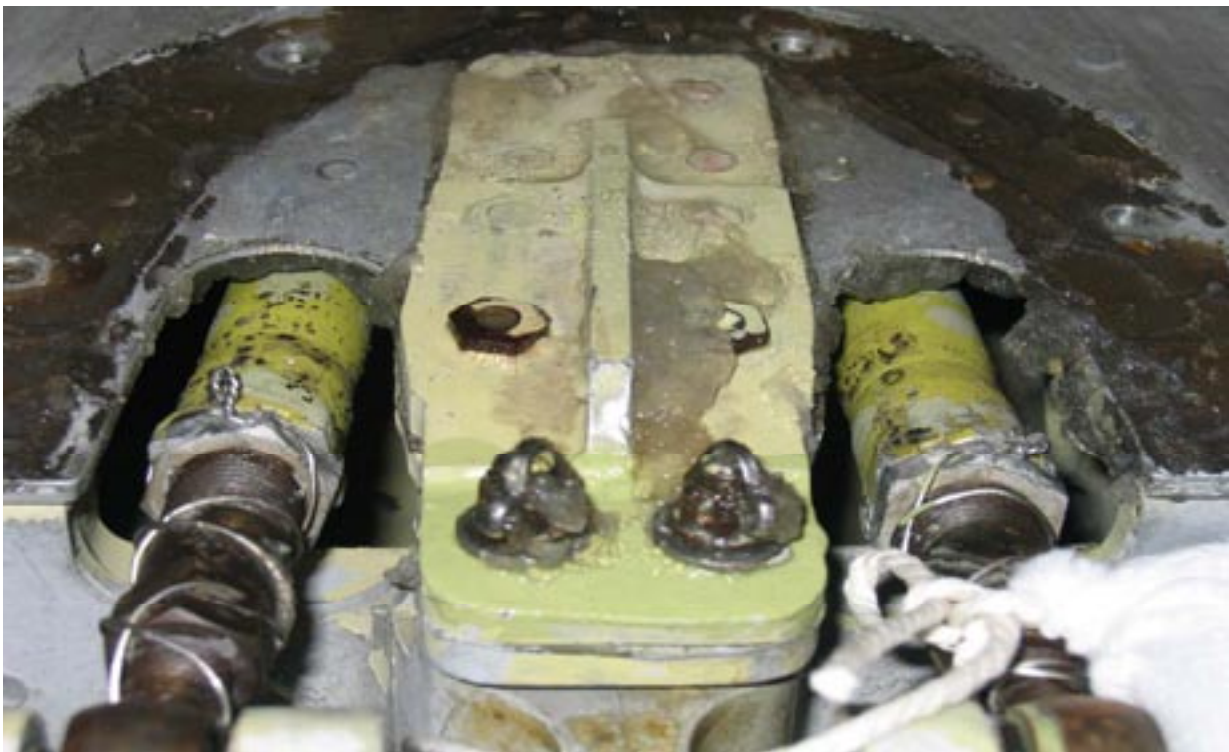
• • • • • **All Operator Message: Ref 06/001V**

During the winter of 2005/2006, one operator reported three incidents of elevator trim circuit restrictions on an Avro RJ aircraft. A significant amount of anti-icing fluid residue was found to have accumulated under fairings on both elevators. These fairings covered the two trim circuit control rods where the trim tab drive passed in to the trim tab itself. As a result of this finding, on 20 January 2006, the manufacturer issued an All Operators Message (AOM), 06/001V, to highlight this finding and recommend rectification action. A copy of this AOM is appended to this report (see page 20).

Operators are advised to remove the fairings when inspecting the aircraft for fluid residue accumulations. If residues are found ensure they are removed before further flight. The fairing is retained by tri-wing screws, part number NAS4403-4 and -5. These fasteners have proved difficult to remove on occasion, particularly when the slots become filled with paint. It is permissible to replace them with NAS7403-4 and -5 screws if required. BAE Systems will supply necessary approvals if required. Operators are recommended to ensure their service providers are following the guidelines of BAe146/AvroRJ De-icing/Anti-icing Application Guide as issued by BAE Systems, in particular with the respect to direction of de-icing.
