INCIDENT

Aircraft Type and Registration:	Avro 146-RJ100, G-JEAV (and others and Embraer 145)	
No & Type of Engines:	4 Lycoming ALF502R-5 turbofan engines	
Year of Manufacture:	1986	
Date & Time (UTC):	17 January 2006 at 1600 hrs	
Location:	Between Southampton and Manchester	
Type of Flight:	Public Transport (Passenger)	
Persons on Board:	Crew - 5	Passengers - 37
Injuries:	None	
Nature of Damage:	None	
Commander's Licence:	Airline Transport Pilot's Licence	
Commander's Age:	N/A	
Commander's Flying Experience:	N/A	
Information Source:	Aircraft Accident Report Forms submitted by pilots and subsequent enquires by the AAIB

Synopsis

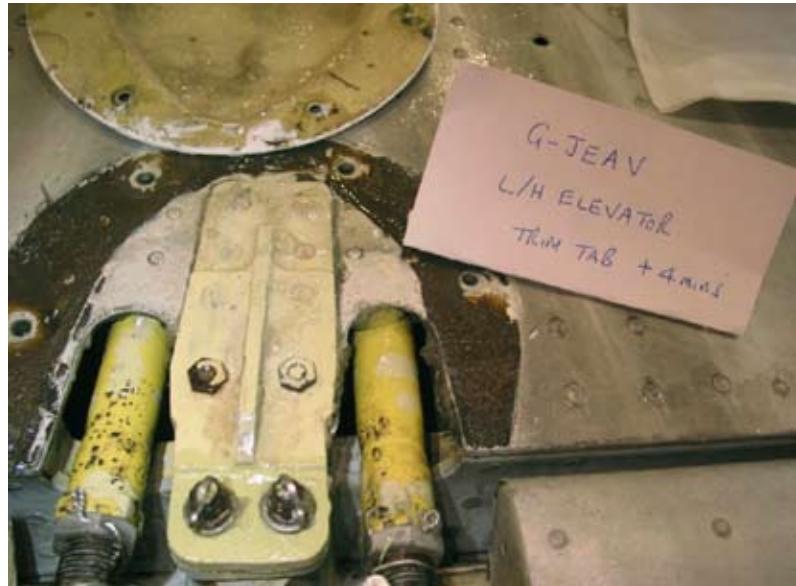
Figure 1

Aircraft Tail No / Sector	INCIDENT DESCRIPTIONS	FINDINGS
	DATE			
7	17-Jan-06	G-JEAV Southampton - Manchester	On reaching FL220, altitude was captured & locked. Flight director however continued to show a fly-up indication, which was increasing. A/c then tried to climb to follow flight director. Autopilot was disconnected & a/c flown manually. A/c wanted to pitch up & when electric trim used to compensate, on every occasion the trim returned to its original position. The control column could be held forward using about three times the normal force, but the trim could not be adjusted to hold it there. Controls returned to normal in the descent. AAIB File ref: EW/G2006/01/14.	A/c was removed from service for investigation, which involved removing the elevators. When elevator trim rod fairings removed, significant accumulations of residues of thickened de/anti-icing fluid residues were found (Figure 1). In response to these findings, the a/c manufacturer issued All Operator Message 06/001V. The operator of G-JEAV instigated a fleet-wide check to remove trim tab fairings and inspect for and remove accumulations of fluid residues.

Following the recent discovery of accumulations of thickened de/anti-icing fluid residues under the elevator trim tab rod fairings on Avro 146/RJ aircraft, Figure 1, the aircraft manufacturer issued an All Operators Message (AOM) 06/001V on 20 January 2006, recommending that operators inspect the area for fluid residues. A copy of the AOM was included in AAIB Bulletin 4/2006.

G-JEAV Left-hand elevator trim tab control rods, with fairing removed. Residues shown four minutes after re-hydration by water mist.
