## ACCIDENT

<b>Aircraft Type and Registration:</b>	Bell 206B Jet Ranger II, G-WLLY	
<b>No &amp; Type of Engines:</b>	1 Allison 250-C20 turboshaft engine	
<b>Year of Manufacture:</b>	1969	
<b>Date &amp; Time (UTC):</b>	21 December 2005 at 1015 hrs	
<b>Location:</b>	3 nm north-east of Coupar Angus, Tayside	
<b>Type of Flight:</b>	Aerial Work	
<b>Persons on Board:</b>	Crew - 1	Passengers -1
<b>Injuries:</b>	Crew - 1 (Fatal)	Passengers - 1 (Fatal)
<b>Nature of Damage:</b>	Helicopter destroyed	
<b>Commander's Licence:</b>	Airline Transport Pilot's Licence (Helicopters)	
<b>Commander's Age:</b>	48 years	
<b>Commander's Flying Experience:</b>	Approximately 15,000 hour (of which at least 2,500 were on type) Last 90 days -126 hours Last 28 days - 42 hours	
<b>Information Source:</b>	AAIB Field Investigation

## Synopsis

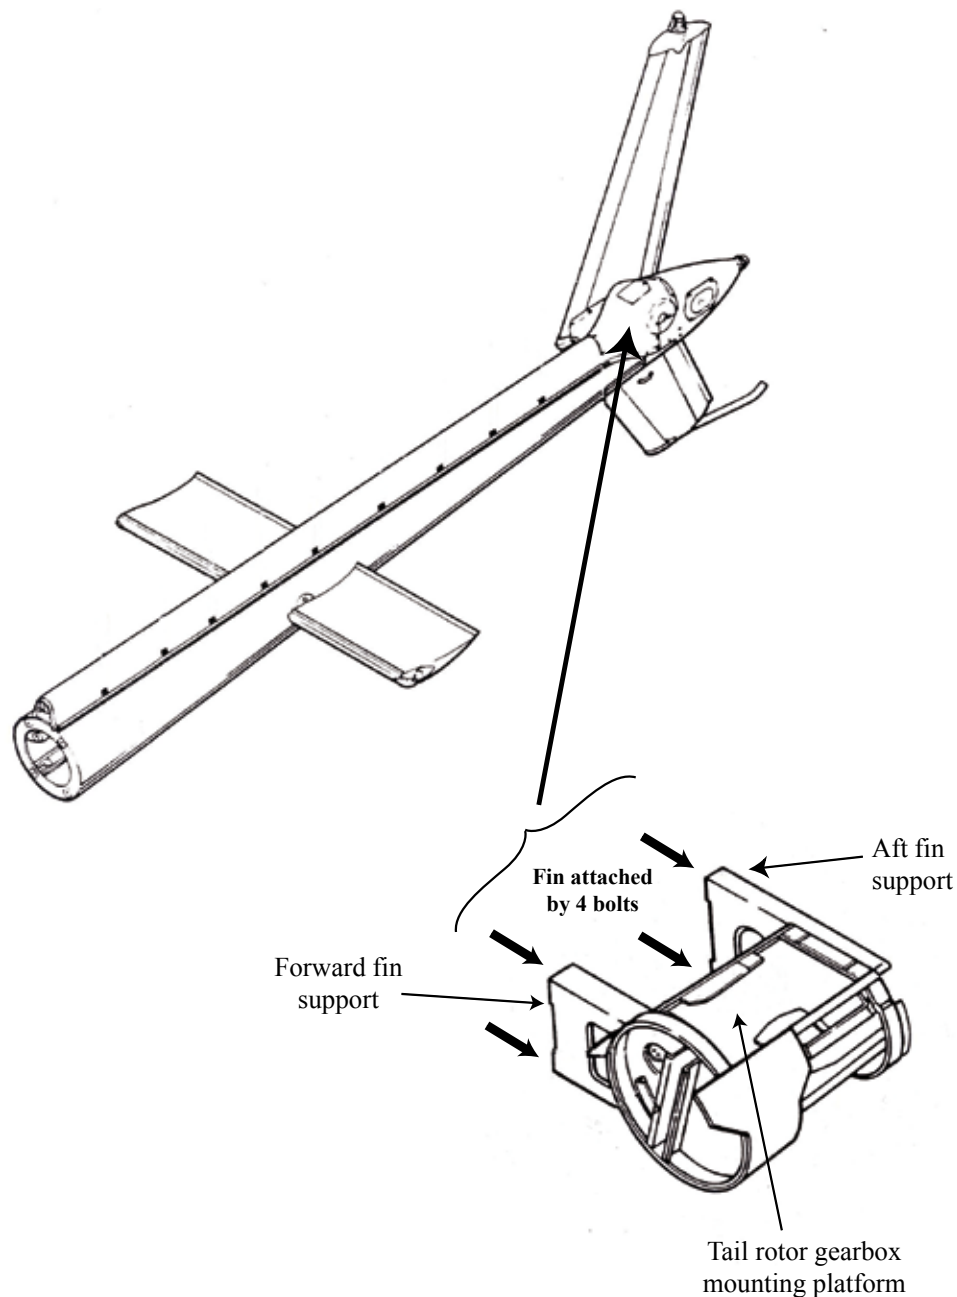
**Figure 1**

The riveted and bolted attachments of the rear and front supports on the tail boom respectively were found to be secure. The rear support had the number 206-031-418-1

Tail boom and fin support

stamped on it, which was one of several part numbers listed in the Illustrated Parts Breakdown (IPB) for this component. However it was specified for use on tail booms with the part number 206-031-426-001 (as opposed to 206-031-004-71B, the subject tail boom). The front support had no number on it; the appropriate part number in the IPB was 206-031-417-003 or -007.

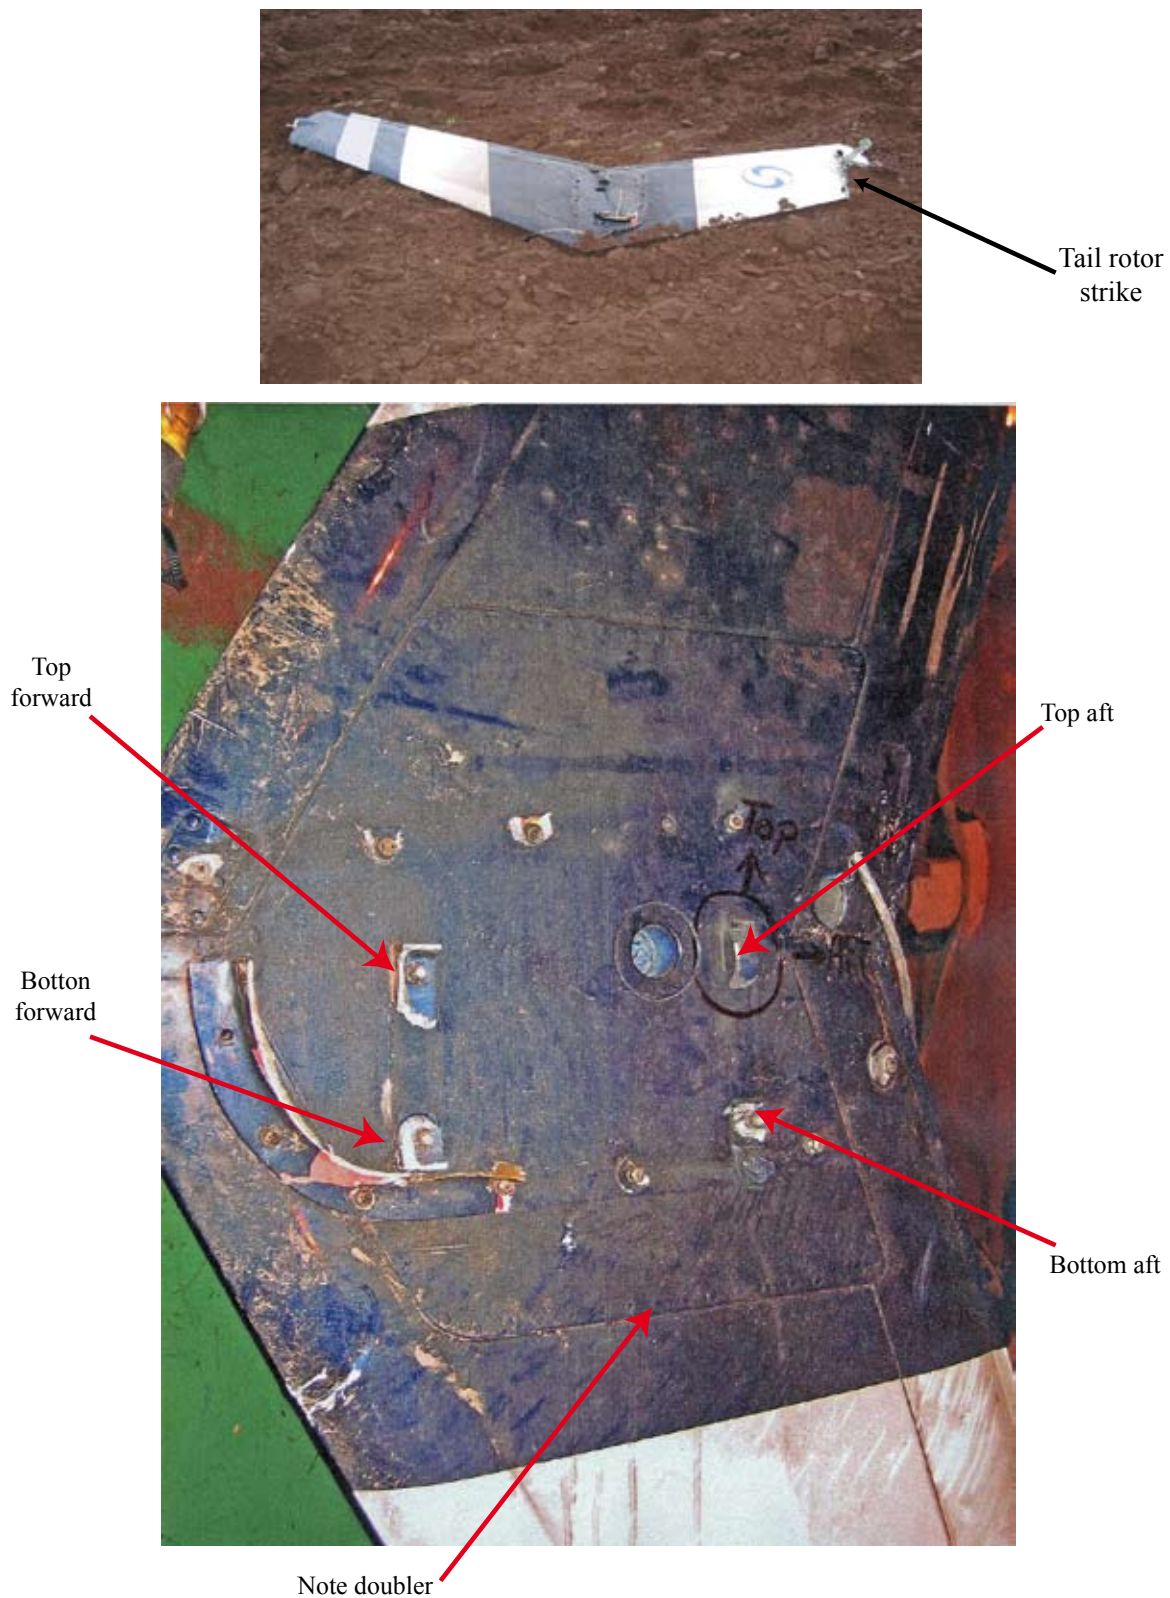
The separated portions of the fin supports had remained attached to the inboard surface of the fin (see Figure 2), which, apart from being struck by the tail rotor, had sustained relatively little damage. Before removing these, the ‘breakout’ torque for each of the nut and bolt assemblies was measured. These were as follows:

The vertical fin bore no part number, but there was a log book certificate that stated: ‘...*unserviceable fin replaced with P/N 206-020-113-011*’, dated 3 August 1990. This was found listed in an old IPB, although the current version lists only -005, -007, -009, -107, and -109. It can be seen from Figure 2 that the inboard skin had been reinforced with a doubler. This was the result

**Figure 2**  
Views of inboard surface fin showing attached portions of fin supports

of complying with Bell Service Letter 206-203, dated December 1972, which was introduced following an in-service problem of cracks developing in the fin. Later fins were manufactured with a strengthened central area, dispensing with the need for a doubler.

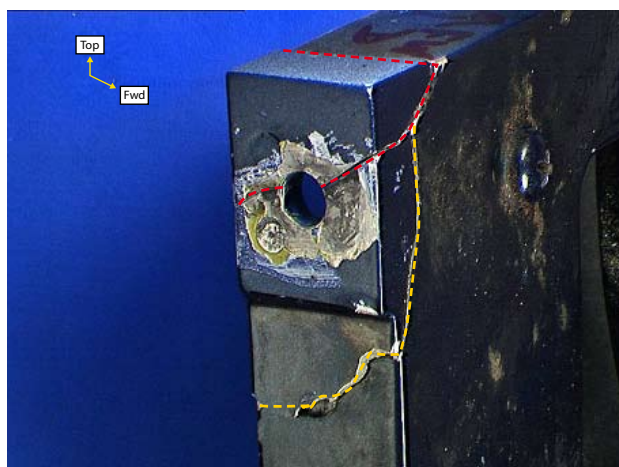
**Figure 3**

The upper fractures exhibited a considerable degree of corrosion and surface deposits. There was also evidence of post-failure mechanical damage (due to the fracture faces remaining in contact), which masked surface detail, but which indicated that the fatigue cracks had been growing over a period of time. The precise length of time could not be determined. The fracture surfaces from the lower attachments were comparatively clean.

The majority of the undamaged crack lengths in the upper attachments were due to fatigue, whereas the fractures in the bottom sections had smaller fatigue cracks in the bolt and rivet holes and larger areas of overload failure. Significantly, the cracks passed through the bolt holes at all four attachments, with origins visible on opposite sides of the outboard surface of the bore of the top forward attachment. It can also be seen from Figures 3 to 6 that, on the other attachments, the cracks passed through one of the rivet holes in each case, with origins occurring on opposite sides of the bore in the top aft attachment.

Top forward attachment

those that passed through the holes, with the others being secondary. For example, in Figure 3, the 'yellow' crack in the top forward attachment can be seen branching off from the primary 'red' crack on the front face of the forging. Consideration of all the fractures led to the sequence of the attachment failures being established as: top aft, top forward, bottom aft and bottom forward.

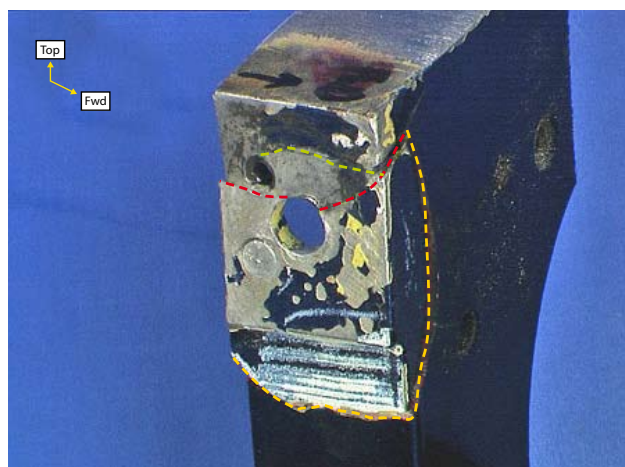
**Figure 4**

Top aft attachment

The sequence of the attachment failures was established as: top aft, top forward, lower aft and lower forward. It is probable that the top aft attachment had completely failed some time before the accident, thus increasing the load on the remaining attachments and consequently accelerating the crack progression.

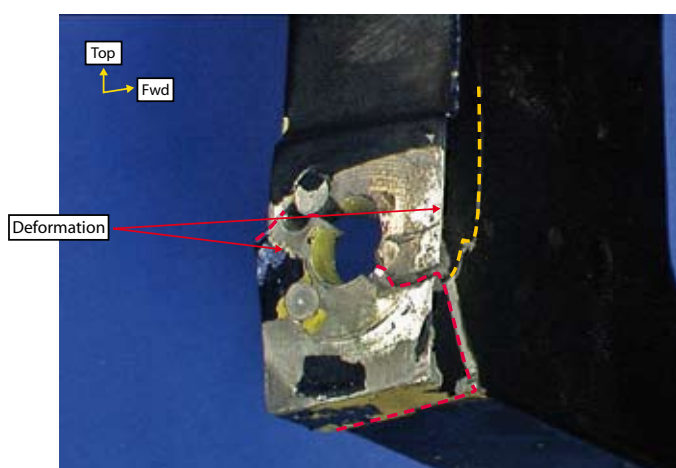
**Figure 5**

The Maintenance Manual specifies assembly torque values of 50-70 lbf.in. It should be noted that the bolt in the bottom forward attachment was found to be slightly bent; any structural joint in which plastic deformation has occurred is likely to have lost the torque figure set on assembly, thus the 15 lbf.in value was not considered reliable.

Bottom forward attachment

In both lower attachments there were fatigue origins in both the bolt and the rivet holes. The bores of all the holes were otherwise clean, with no significant features such as thread marks or corrosion pits. Figure 7 shows scanning electron microscope (SEM) photographs of a bolt hole and rivet hole, showing how the cracks initiated from the outboard edges of the bores. The cracks have then propagated away from the holes, at the same time extending through the thickness of the material to reach the inboard surface.

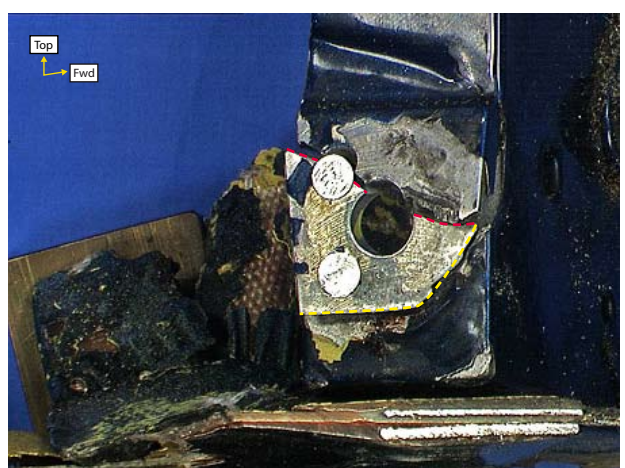
**Figure 6**

Bottom aft attachment

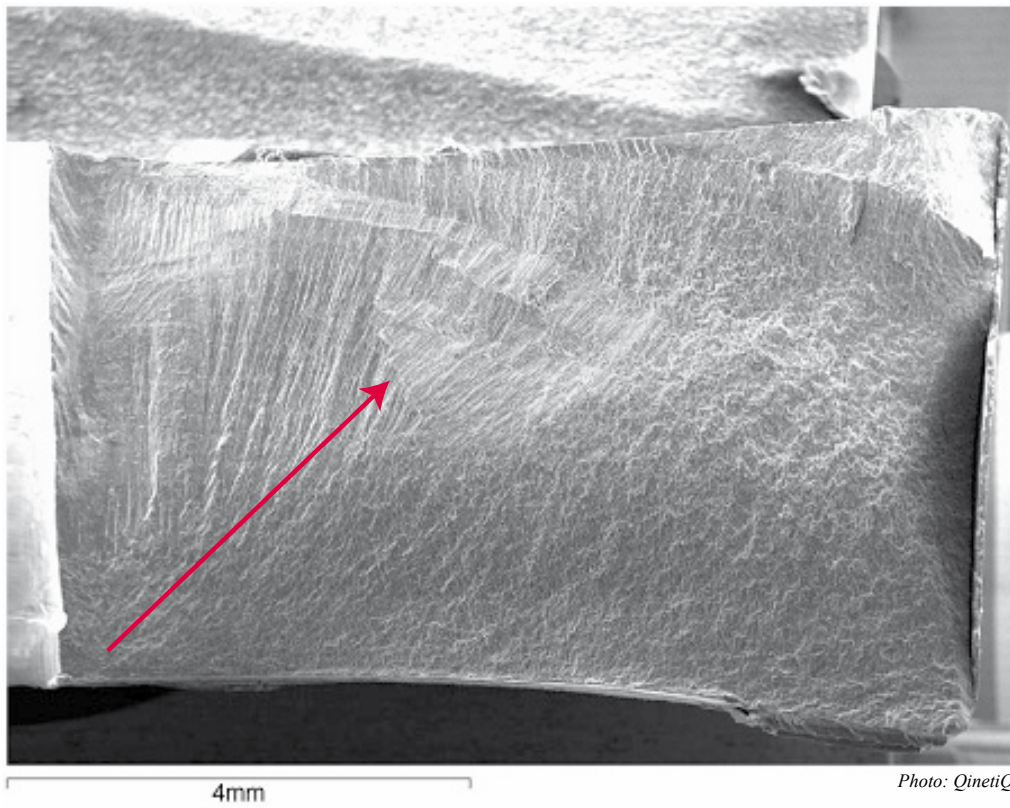
Fatigue crack originating from edge at bolt hole on stabiliser side of top forward support

**Figure 7**  
Scanning electron microscope photographs

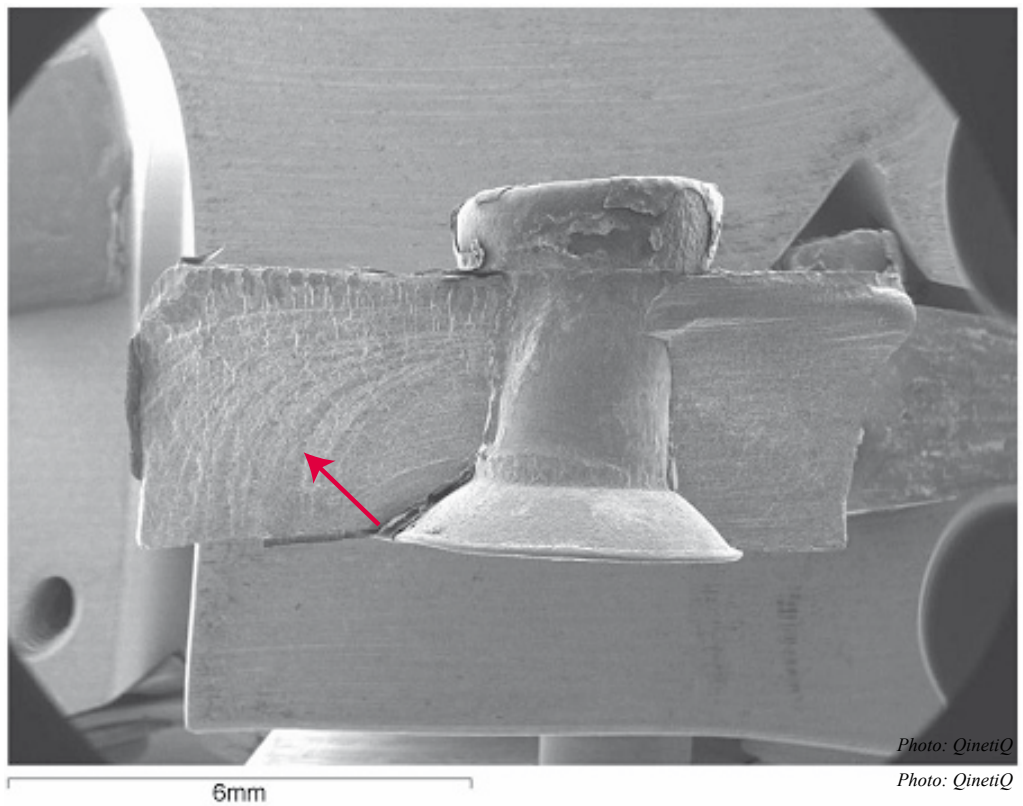
Fatigue crack originating from rivet hole on stabiliser side of bottom aft support
