SERIOUS INCIDENT

Aircraft Type and Registration:	Bombardier DHC-8-102, SX-BIO	
No & Type of Engines:	2 x Pratt & Whitney Canada PW120A turboprop engines	
Year of Manufacture:	1992	
Date & Time (UTC):	24 April 2010 at 0733 hrs	
Location:	Bristol International Airport	
Type of Flight:	Private	
Persons on Board:	Crew - 2	Passengers - None
Injuries:	Crew - None	Passengers - N/A
Nature of Damage:	None	
Commander's Licence:	Airline Transport Pilot's Licence	
Commander's Age:	38 years	
Commander's Flying Experience:	6,300 hours (of which 1,700 were on type) Last 90 days - 3 hours Last 28 days - 3 hours	
Information Source:	AAIB Field Investigation

Synopsis

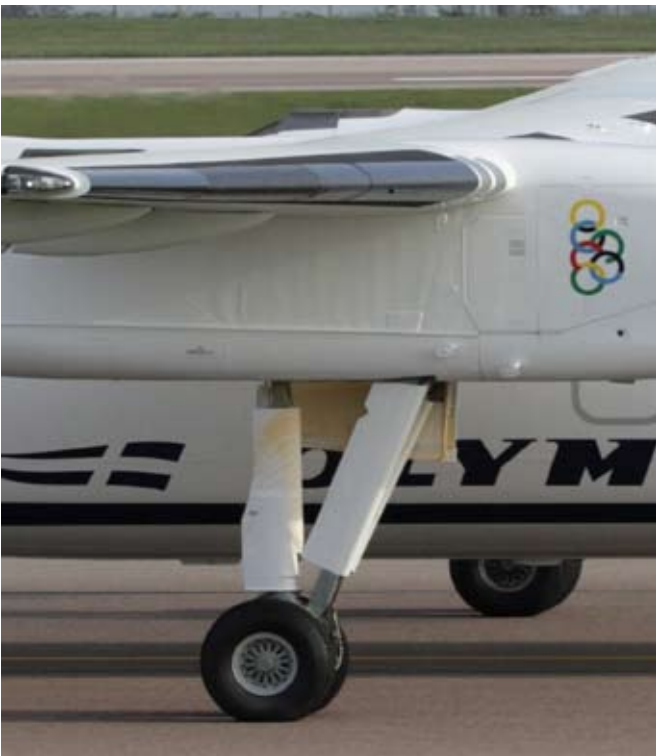
Figure 1

The start-up, taxi and departure were all described by the crew as normal. However, photographs taken by an aviation enthusiast at 0654 hrs show some signs of oil leaking from both engines as the aircraft taxied out (Figures 1 and 2).

Oil leak visible on right main gear leg during taxi at East Midlands on 24 April 2010
(photograph courtesy Dave Sturges/ AirTeamImages.com)

0654 hrs and 0658 hrs respectively the photographs shown in Figures 1 and 2 were taken by an aviation enthusiast; these clearly show oil leaking down both the left and right main gear struts.

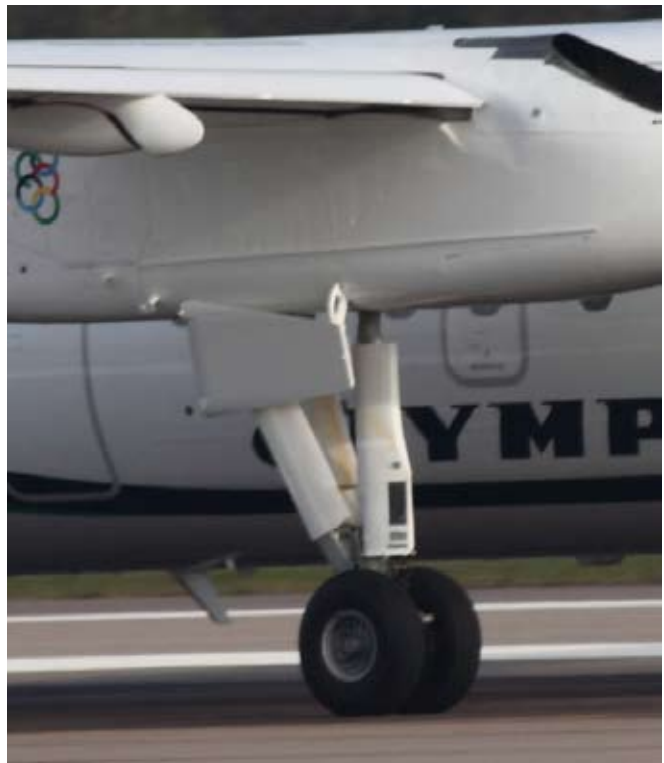
Figure 2

Oil leak visible on left main gear leg during taxi at East Midlands on 24 April 2010
(photograph courtesy Dave Sturges/ AirTeamImages.com)

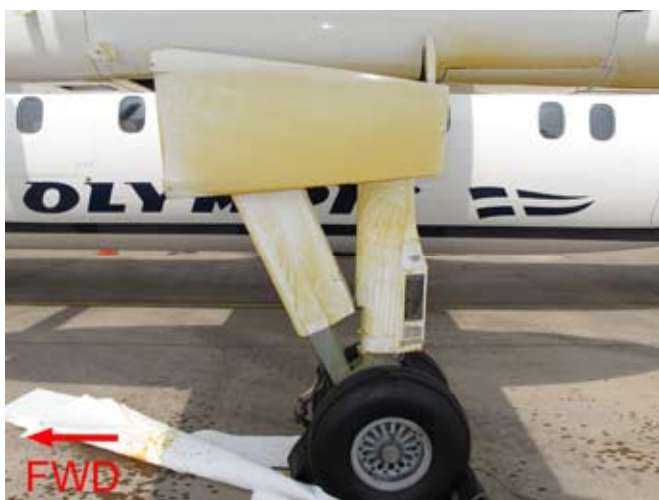
Figure 3

Left engine nacelle and landing gear leg after landing at Bristol

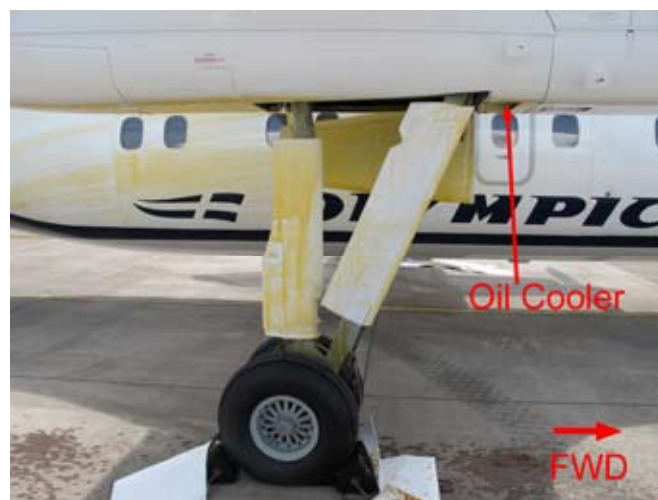
Figure 4

Right engine nacelle and landing gear leg after landing at Bristol

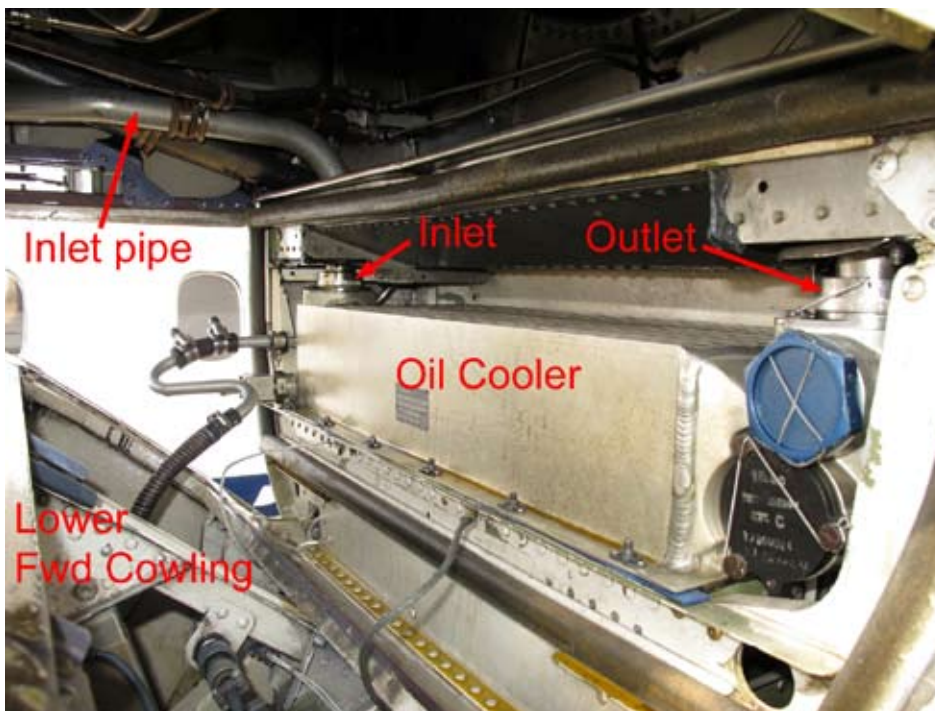
The engine cowlings were removed to identify the source of the oil leaks. The left engine oil cooler is shown in Figure 5 with the lower forward cowling lowered. There was oil along the lower forward surface of the oil cooler and along the lower forward cowling hinge line. Oil was also seen slowly weeping from around the knurled nut where the inlet pipe connects to the oil cooler. When the inlet pipe was disconnected and the oil cooler removed, it was revealed that two O-ring seals were fitted inside the groove of the pipe; the smaller O-ring was split and the larger O-ring contained a cut (Figures 6 and 7). The larger O-ring was of the correct size and type for the installation, but the smaller O-ring should not have been fitted. One O-ring, of the correct size, was fitted to the outlet pipe of the oil cooler and this O-ring was undamaged.

Left engine oil cooler with lower forward cowling lowered.
Slow oil seepage from oil cooler inlet nut

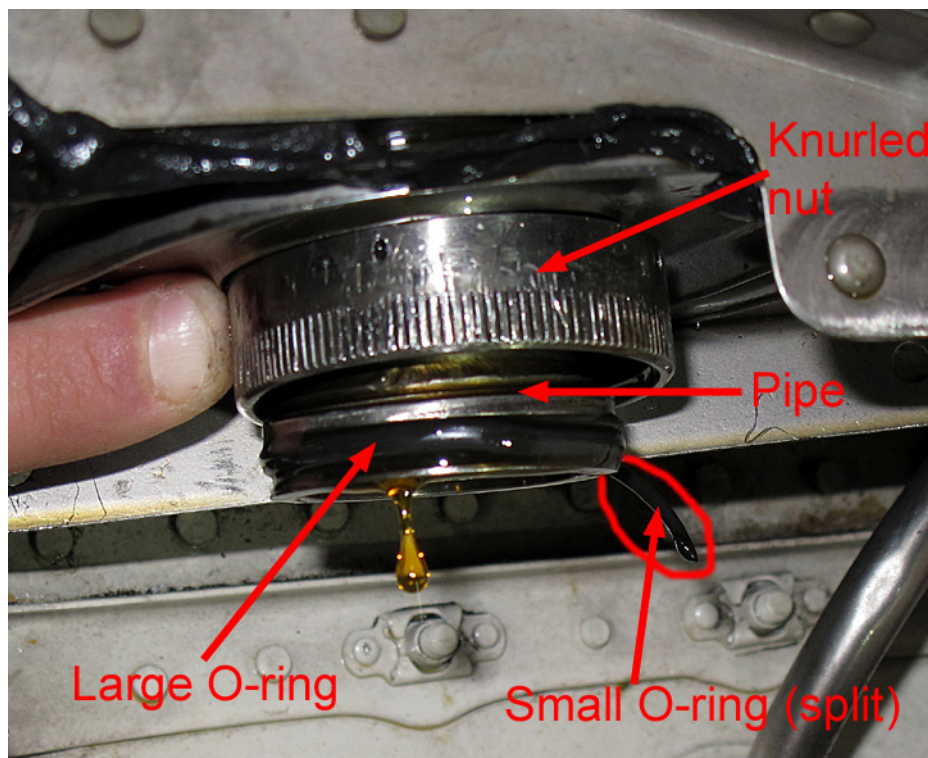
Figure 6

Left engine oil cooler inlet (inboard) pipe connector, showing large O-ring seal, which had split, part of which can be seen hanging down (highlighted in red)

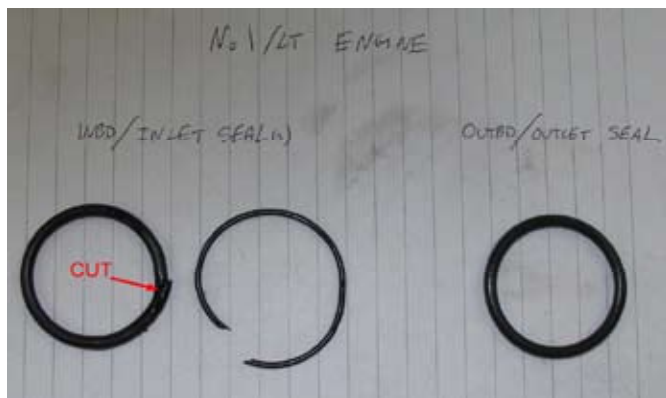
Figure 7

Left engine oil cooler inlet and outlet seals; large inlet seal contained a cut; small inlet seal was split

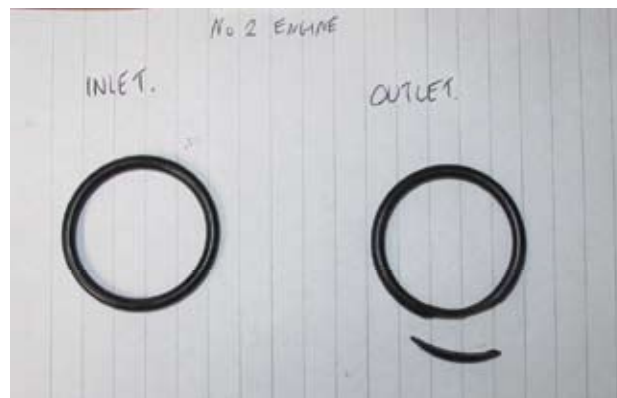
Figure 8

When the right engine lower forward cowling was lowered, oil was seen along the lower forward cowling hinge line and around the oil cooler outlet pipe, but it was not noticeably weeping. This oil cooler was also removed and its inlet and outlet pipes examined. The O-ring seal on the outlet pipe had been cut and was missing a large section from its outer circumference (Figure 8). The missing section of O-ring seal was found in a side cavity beneath the oil cooler outlet. The O-ring seal on the inlet pipe was undamaged.

Right engine oil cooler inlet and outlet seals; outlet seal had been cut; severed piece shown below it

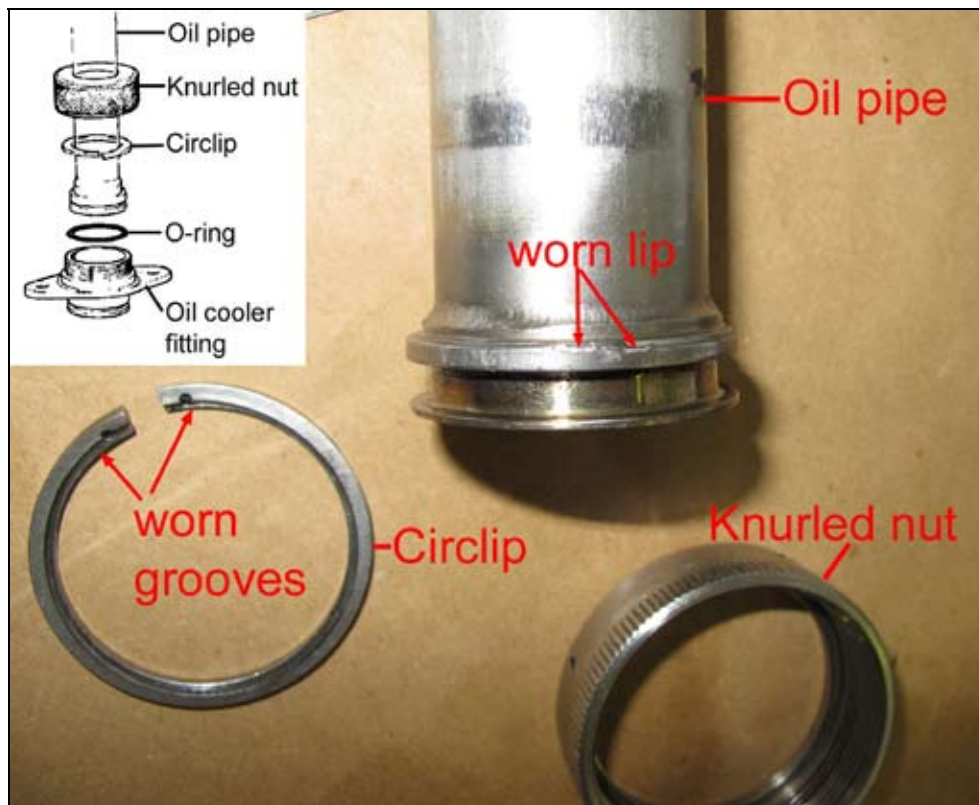
Figure 9

The circlips, which retained each knurled nut on the pipe, contained grooves where the nut had squeezed the circlip hard against the lip of the pipe (Figure 9). The knurled nuts also had score marks on their outer circumference consistent with having been tightened with a pair of grips. This was evidence that the knurled nuts on both pipes from both oil coolers had at some point been over-tightened. The maintenance manual calls for the nuts to be tightened ‘by hand’.

Worn grooves on circlip retaining knurled nut
(left oil cooler inlet pipe shown; similar wear found on the other three circlips)

It is recommended that Bombardier Inc. amend the Aircraft Maintenance Manual for the DHC-8-100 series aircraft to emphasise the correct procedure for securing the inlet and outlet pipes to the engine oil coolers, including the method for tightening the associated knurled nuts.

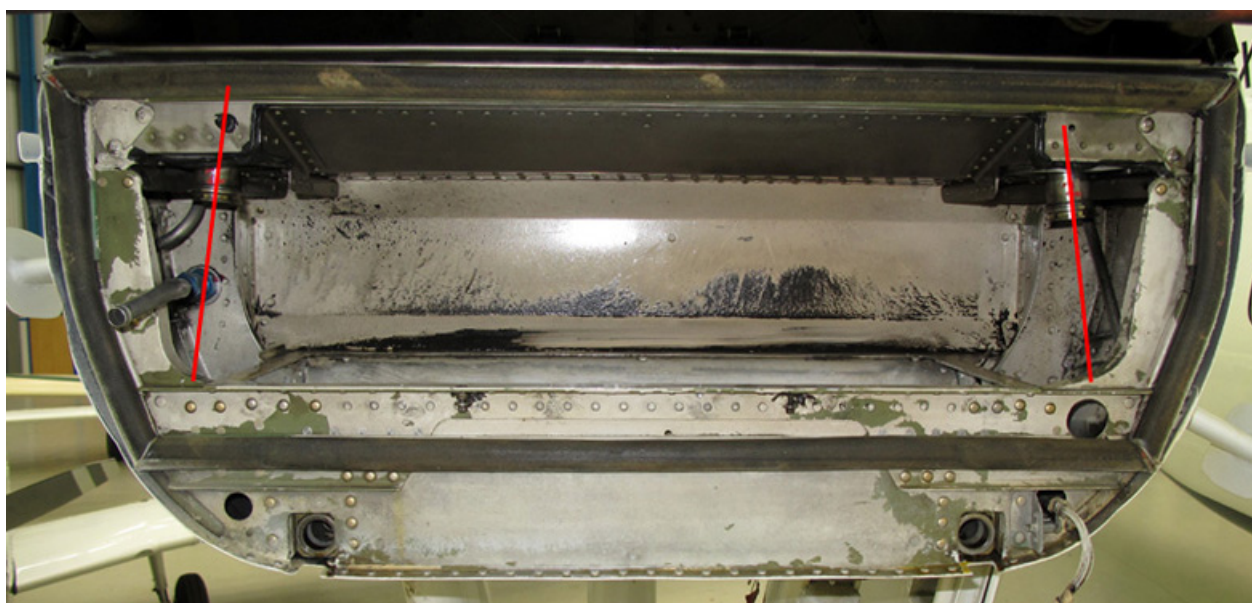
Figure 10

Following the right engine oil cooler removal, it was noticed that the inlet and outlet pipes were not aligned perpendicular to the oil cooler but were canted outwards (Figure 10). This orientation of the pipes would have

View looking aft beneath the right engine where the oil cooler had been installed.
Note that the oil cooler inlet and outlet pipes are not orientated at 90° but are canted outwards

Detaching these pipes at their forward ends (firewall station 107.81 in Figure 15) will make manoeuvring the pipes into the fittings easier and, therefore, should make it less likely that the seals will be damaged.

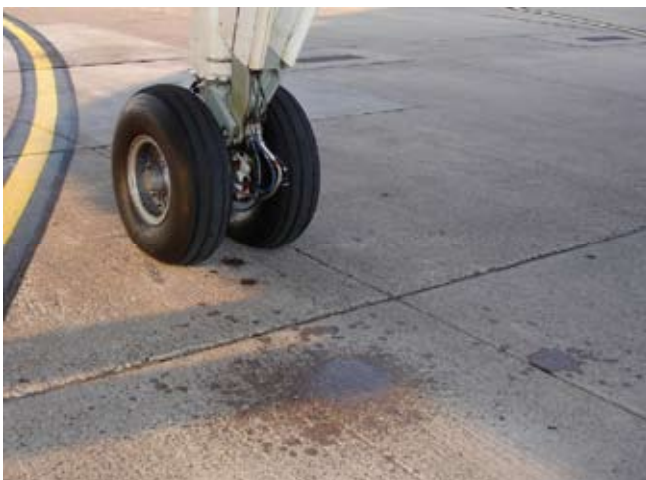
Figure 11

Oil spots on ground beneath left engine nacelle after arrival at East Midlands on 16 April 2010

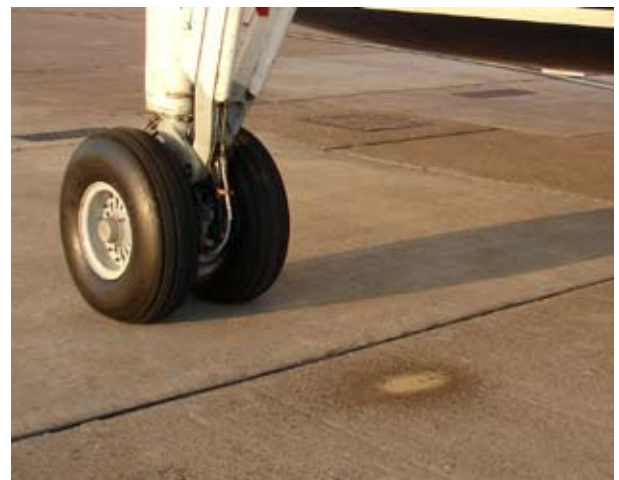
Figure 12

Oil spots on ground beneath right engine nacelle after arrival at East Midlands on 16 April 2010

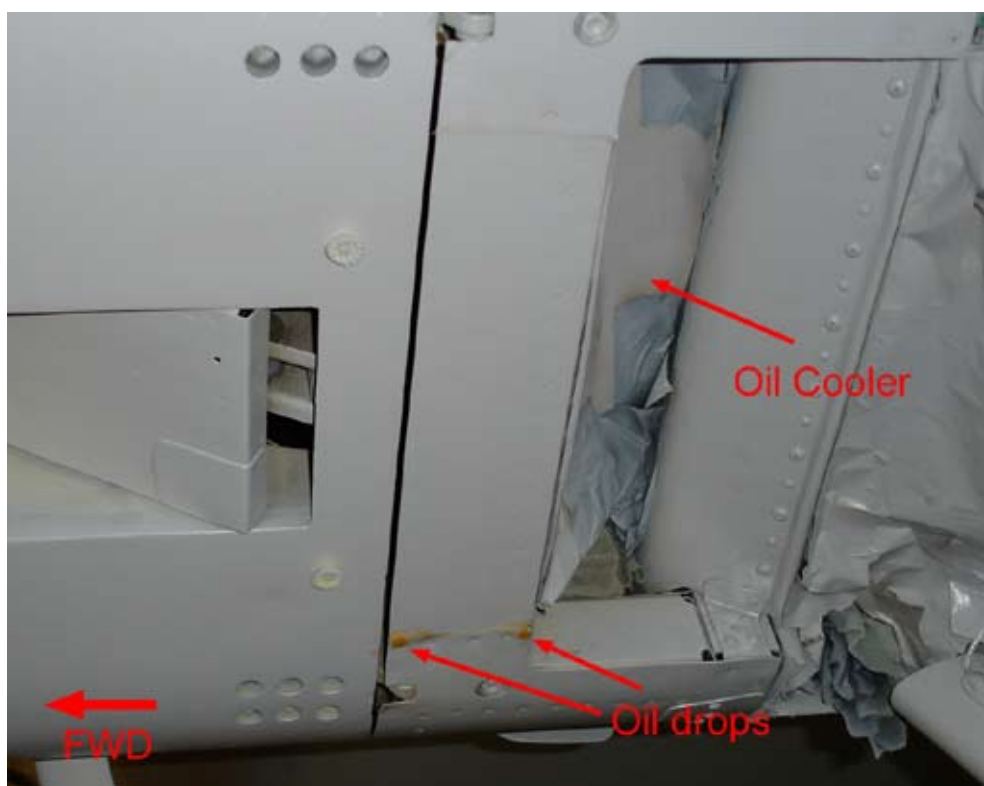
Figure 13

Oil seepage from butt joint beneath right engine oil cooler
(photograph taken on 20 April 2010 during painting at East Midlands)

The engineer at East Midlands (Sup B) who supervised the repaint provided the investigation with photographic evidence that there was slow oil seepage from both the left and right engine nacelles beneath the oil coolers (Figure 13). The need to start preparing the aircraft for paint stripping prevented Sup B from initially investigating these leaks and he was subsequently hampered by scaffolding surrounding the engine nacelles. The day when full access to the engines was finally provided coincided with the day that Sup A arrived to perform the duplicate control inspections. Sup A's dismissal of the reported oil seepage as being residual from the previous leaks at Exeter had the effect of alleviating Sup B's concerns about the seepage he had seen. Therefore, Sub B did not lower the forward cowlings and inspect the oil coolers. An additional factor may have been that the task of lowering the forward cowling requires at least two people, and preferably three. Opening the side cowls is a simple one handed task but this does not provide access to the oil coolers. On the morning before the aircraft departed East Midlands, Sup B requested that the pilots perform an engine run to check the oil levels and as a final leak check. No leaks were seen but, again, the lower forward cowlings were not lowered, so another opportunity to detect the source of the leaks was missed.

It is recommended that Flybe Aviation Services remind all staff of the importance of investigating the source of every engine oil leak.

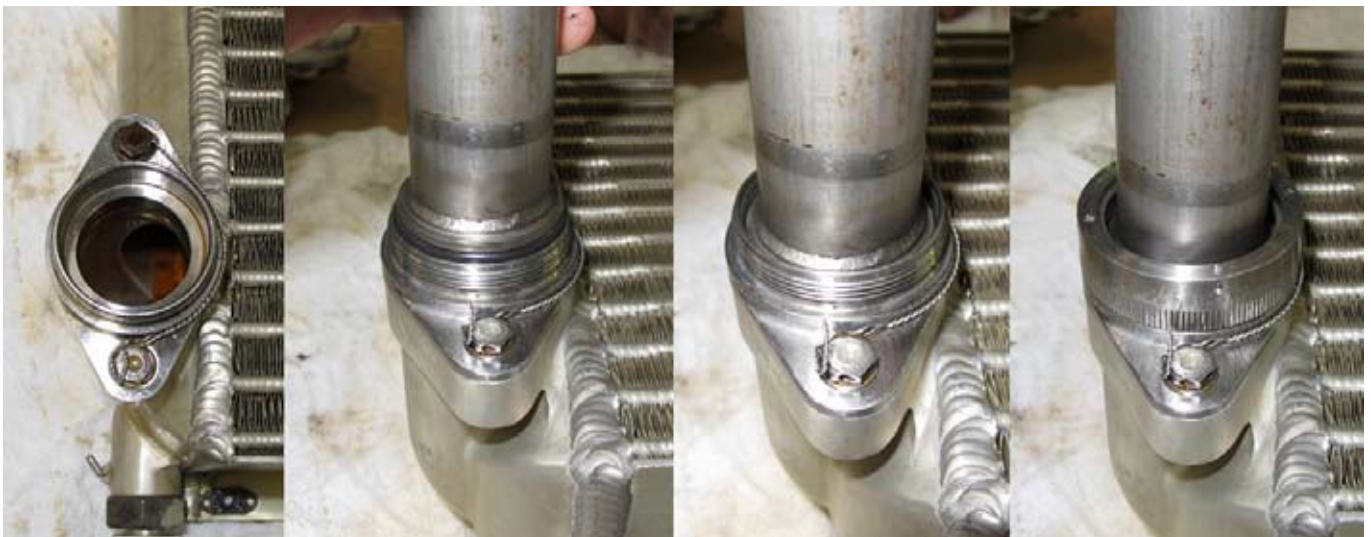
Figure 14

When the knurled nut is fully wound down, as in (4) in Figure 14, the oil pipe is free to move and can be rotated and moved up and down. The O-ring is the only barrier against oil leakage from the cooler. If the nut cannot be tightened and fully wound down by hand then this is an indication that the pipe has not been installed correctly and/or the O-ring may have been damaged. The O-ring provides the seal and no additional clamping force is provided by over-tightening the nut.

From left to right: (1) oil cooler fitting; (2) oil pipe partially inserted – O-ring seal visible; (3) oil pipe fully inserted; (4) knurled nut fully wound down, hand tight

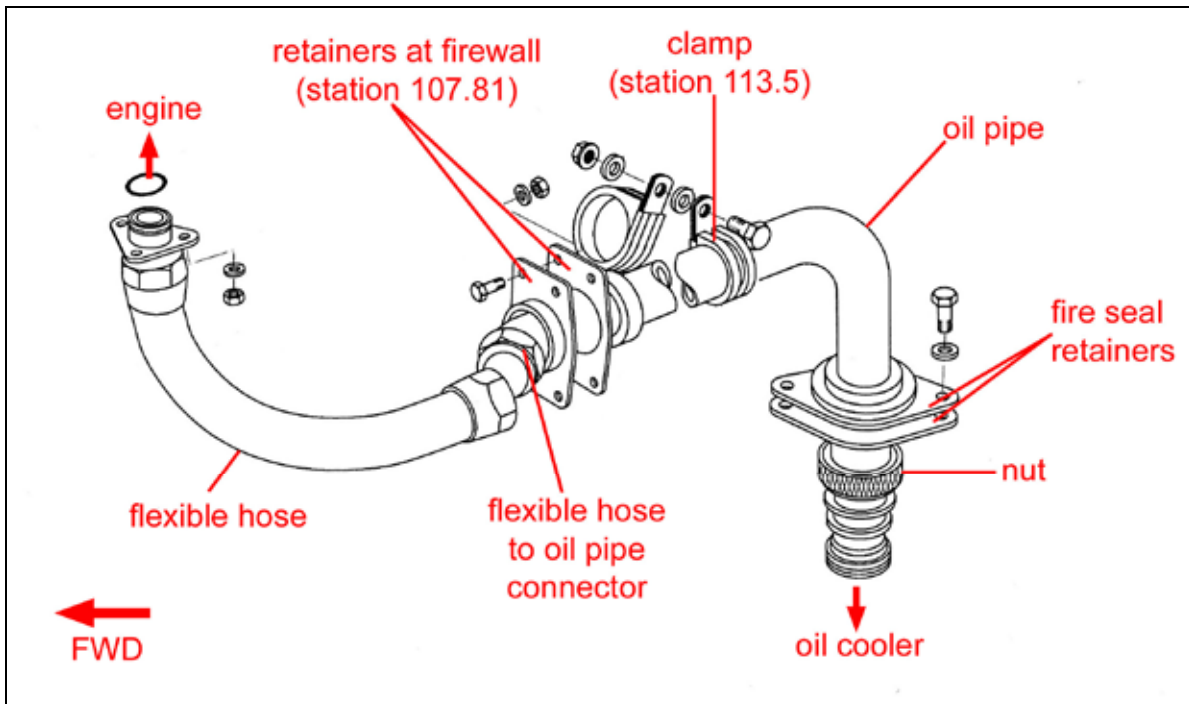
Figure 15

the pipe to the nacelle structure. The pipe then passes through a pair of retainers in the firewall and is attached to a flexible hose (Figure 15). The AMM procedure for the oil cooler removal requires the fire seal retainers to be disconnected, but it makes no reference to the clamp, firewall retainers nor flexible hose. According to the engineer and technician who undertook to re-install the oil coolers following the incident, in order to be able to rotate the oil pipe to the vertical position and easily manoeuvre it into the oil cooler fitting, they needed to loosen the clamp and disconnect the pipe from the flexible hose. They reported that the flexible hose was not sufficiently flexible to permit the pipe to be rotated to, and stay in, the vertical position, without disconnecting it from the pipe. Figure 10 shows that the oil pipes were not in the vertical position on the right engine installation.

Oil cooler oil pipe installation on the DHC-8-100
