CONTENTS

Summary of:	Air Accident Report No: 4/2010	136
	Report on the serious incident to Boeing 777-236, G-VIIR at Robert L Bradshaw International Airport, St Kitts, West Indies on 26 September 2009

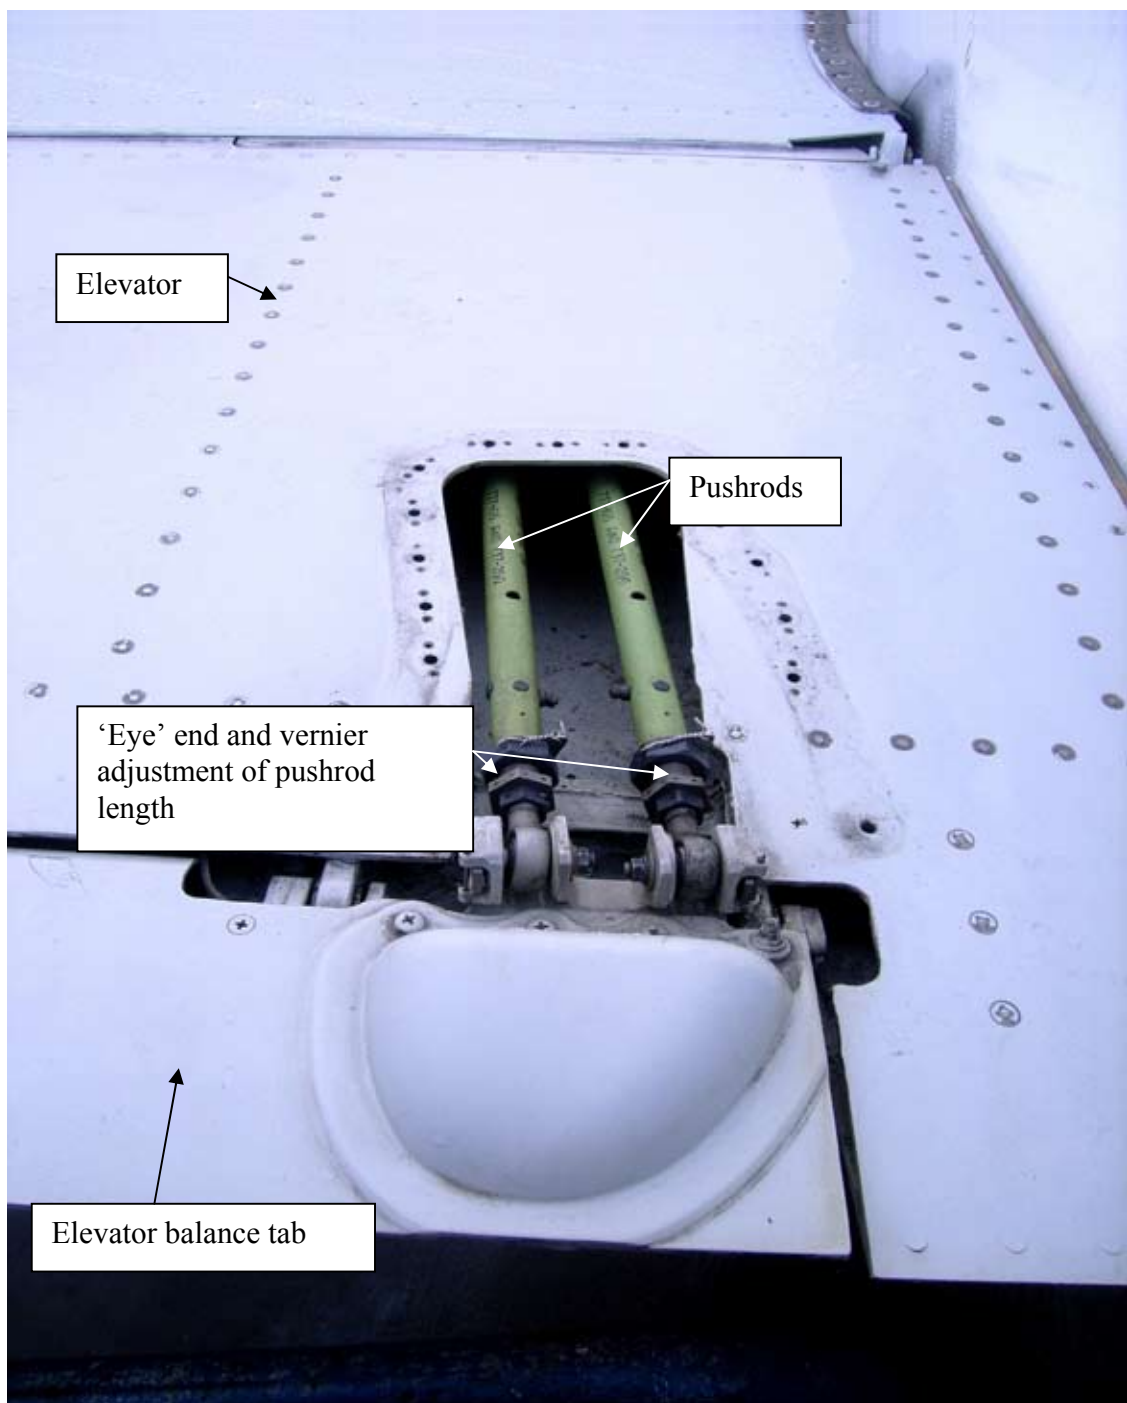
Figure 10

Based on the pilot's report, a 0.05 inch trailing edge down adjustment of the tab was required to achieve neutral trim (although the aircraft was within AMM limits). A review of the adjustment task completed by MRO B staff, as a consequence of the information provided in the customer work request, showed that they calculated an adjustment of 0.105 inch trailing edge up was necessary to achieve neutral trim. The AMM recommends that the tab is only rigged to the nearest 0.01 inch. They noted that a half turn adjustment of the rod 'eye' end gave a 0.1 inch adjustment in the tab trailing edge position, and so elected to round down to this figure to avoid the need to adjust the vernier bushing. A duplicate inspection of the task was completed in line with requirements, but this did not identify any issues. However, the difference between the required and actual adjustment of the tab trailing edge position was roughly equivalent to applying 18 nose-down turns of the trim wheel to a balanced aircraft.

Elevator tab pushrods

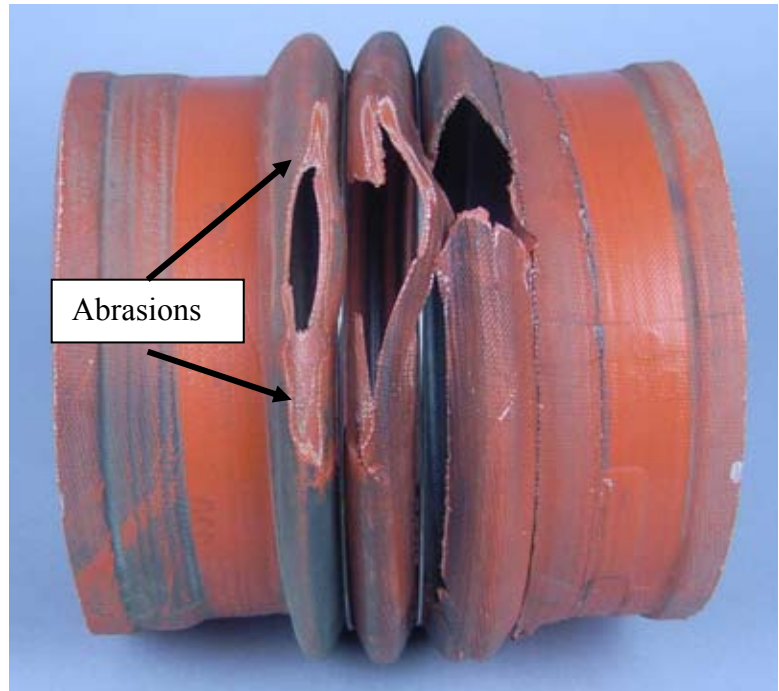
Figure 2

The flexible hose from the right pack had evidence of abrasion on the top and sides of the folds (concertinas) where the failure had occurred, (Figure 2). There was also evidence that the reinforcement metal rings had cut through the hose.

Failed flexible hose from right air conditioning pack

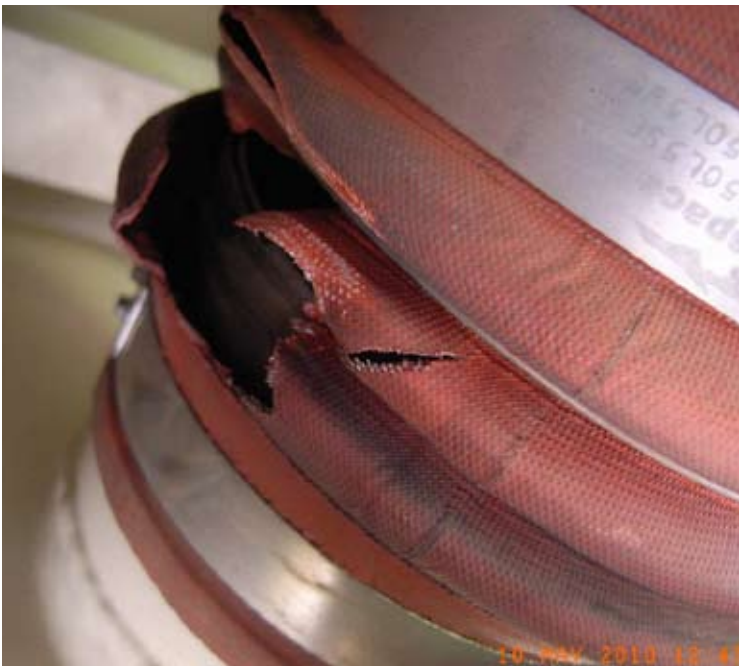
Figure 3

The hose had been correctly fitted to the pack and there was nothing in the vicinity that might have caused the abrasions, (Figure 3). It is suspected that the some of the abrasions might have occurred as a result of the folds on the hose rubbing against each other.

Flexible hose installed on the right air conditioning pack

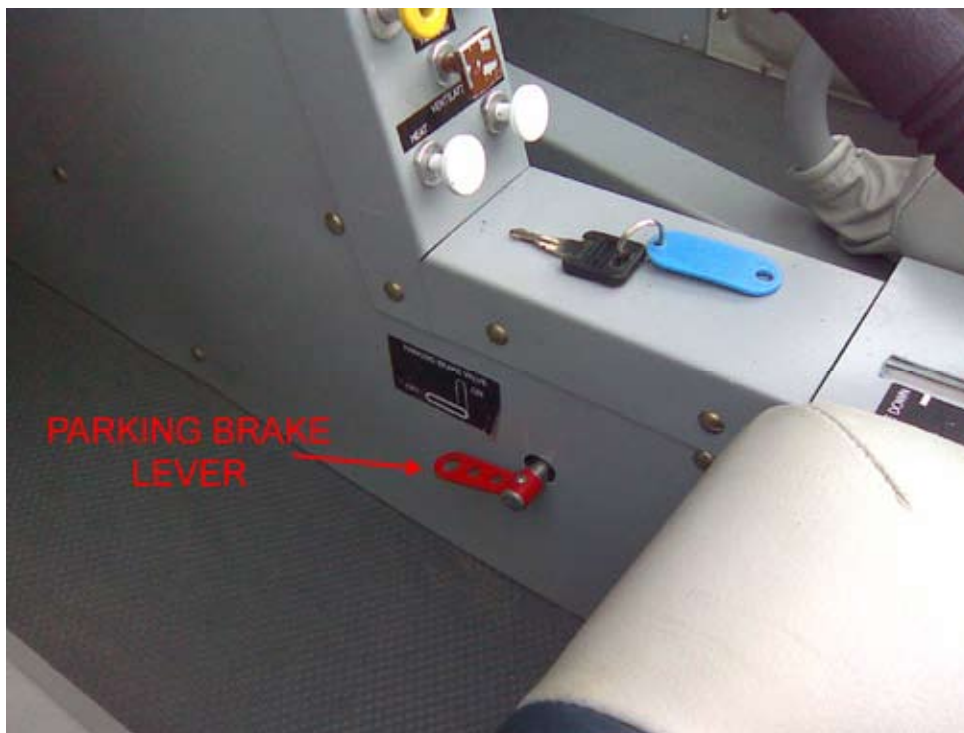
Figure 2

Parking brake lever in the horizontal OFF position; right side of left-seat footwell

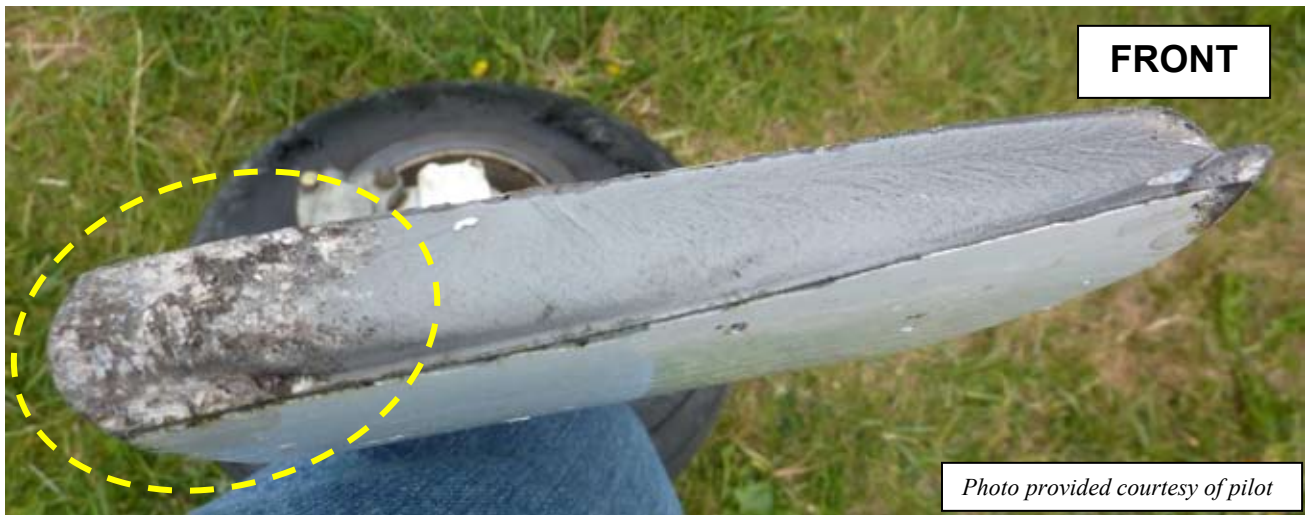
Figure 1

fracture surfaces revealed evidence of an approximately 15 mm deep pre-existing crack propagating from the rear edge of the gear leg. The crack surfaces in this region were heavily corroded (Figure 1), indicating that the crack had been present for some time prior to the failure.

Fracture surface of landing gear leg showing location of pre-existing crack (circled)

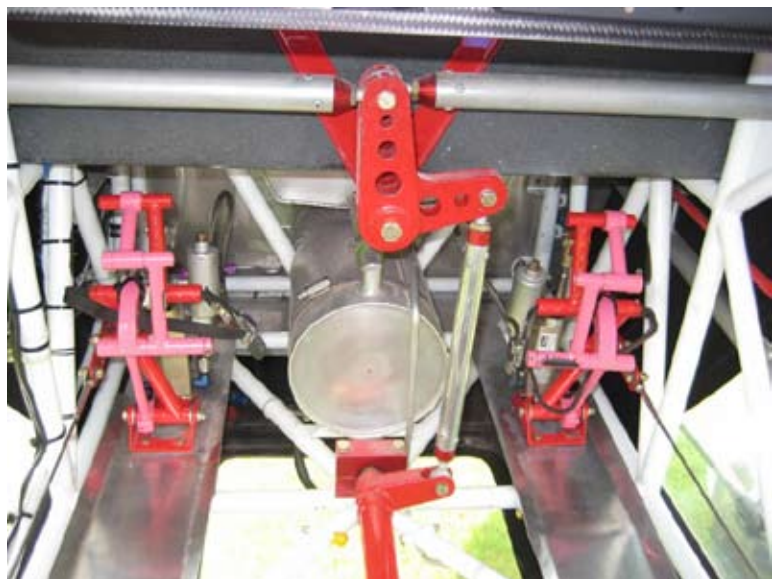
Figure 4

Rudder pedals with pedal extensions (pink) fitted

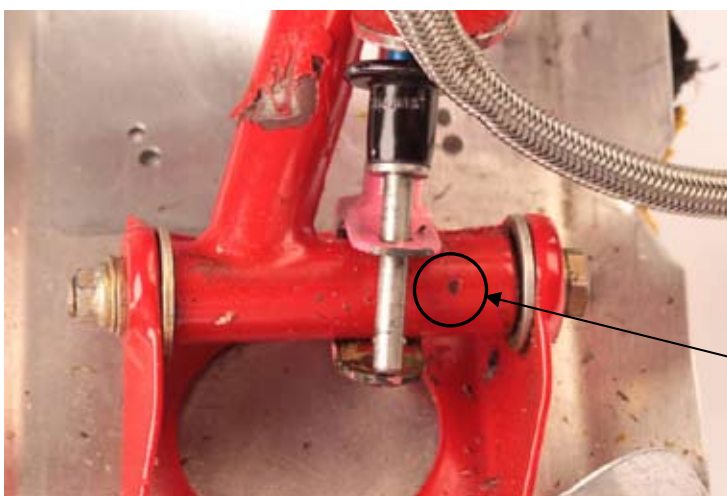
Figure 7

- a) The lower attachment of the rudder pedal extensions could be moved in a spanwise direction along the rudder pedal pivot tubes (see Figure 7).
- b) In the case of the non-extended rudder pedals, the force applied by a foot acts directly above the point at which the vertical element of

Note the witness mark on the pivot tube probably made by the pip-pin.

Front (and above) view of the left rudder pedal pivot tube
(Note that the lower attachment for the pedal extension, painted pink, can move relatively freely from left to right)

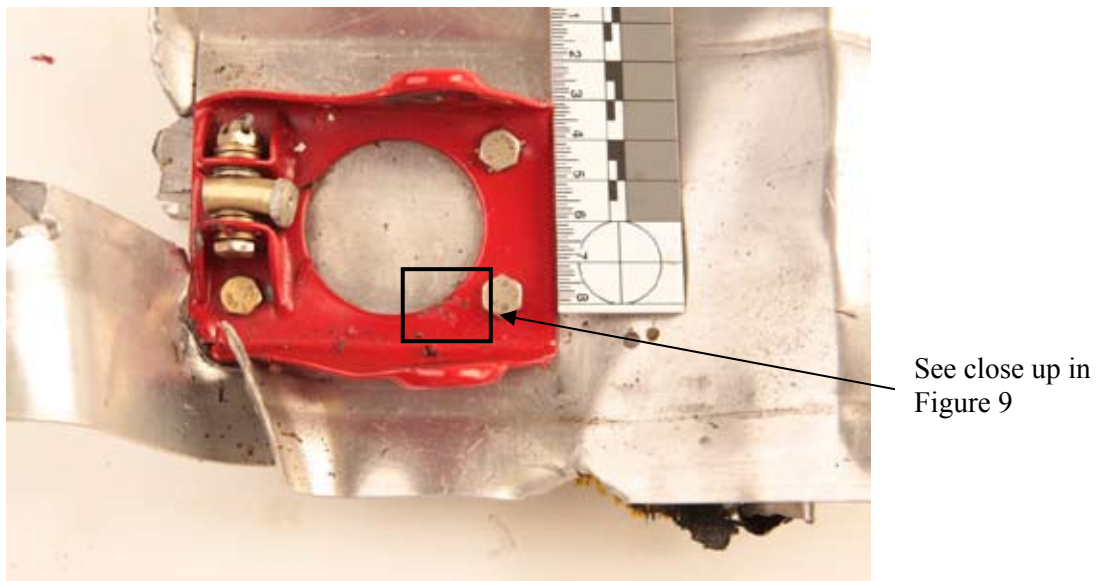
Figure 8
Base plate for left rudder pedal

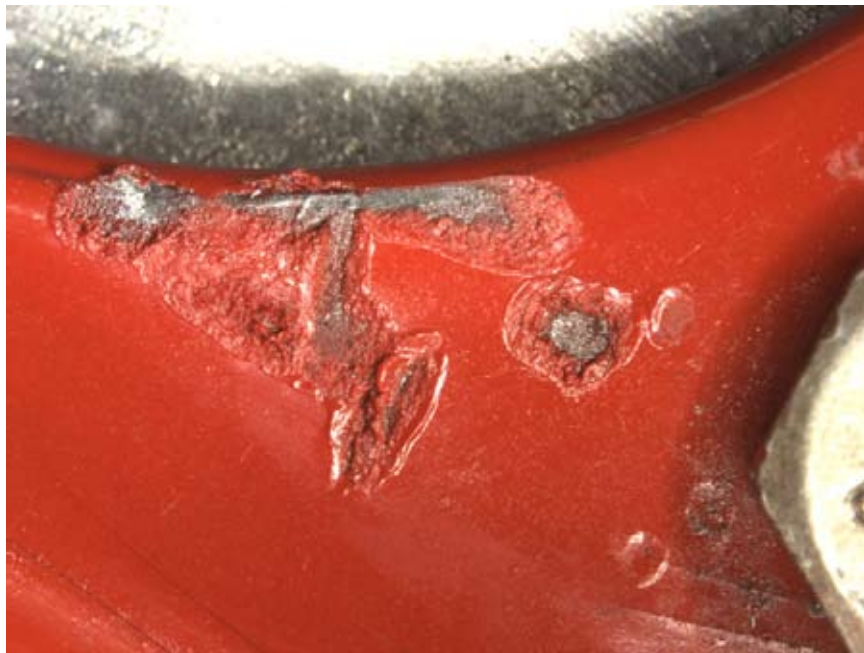
Figure 9
Close up of Figure 8 showing witness marks probably made by the end of the pip-pin

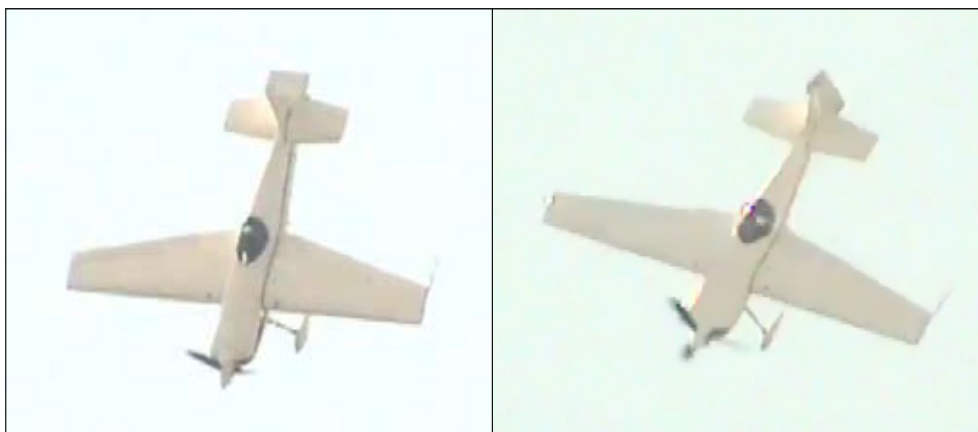
Figure 11 again shows images from the practice and accident manoeuvre, advanced nearly a full turn from the previous images, at about the point of recovery. Significant differences can be seen in terms of rudder angle and pilot's head position (the pilot was wearing a white helmet).

The point of recovery in practice manoeuvre (left) compared to the equivalent point during the accident manoeuvre

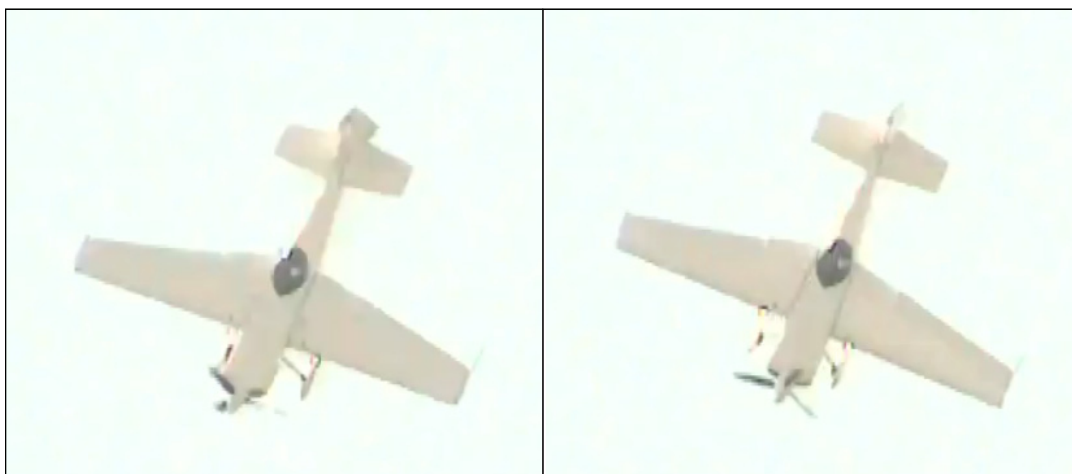
Figure 13

- a) At the point of recovery, although a brief application of rudder would have been expected to align the aircraft with the vertical, the observed rudder deflection is unusual.
- b) The aircraft is not pitched as far forward on the accident recovery as on the practice, indicating insufficient forward movement of the control column during recovery.
- c) The pilot's head would be expected to be central in the cockpit at the point of recovery, to allow the pilot to determine the correct recovery line.
- d) Left applied rudder and aileron after the point of expected recovery is unusual: the rotation would have been driven by control deflection - most probably rudder rather than ailerons, as the rotation is not axial.

Two turns after the point of expected recovery, the two images are taken from the accident sequence and only a fraction of a second apart. Note change in rudder position
