No: 8/90

Ref: EW/C1161

- (1) De Havilland DH82A Tiger Moth, G-AOZB
- (2) Piper PA-28-181, G-BNNP

Near Redhill aerodrome, Surrey

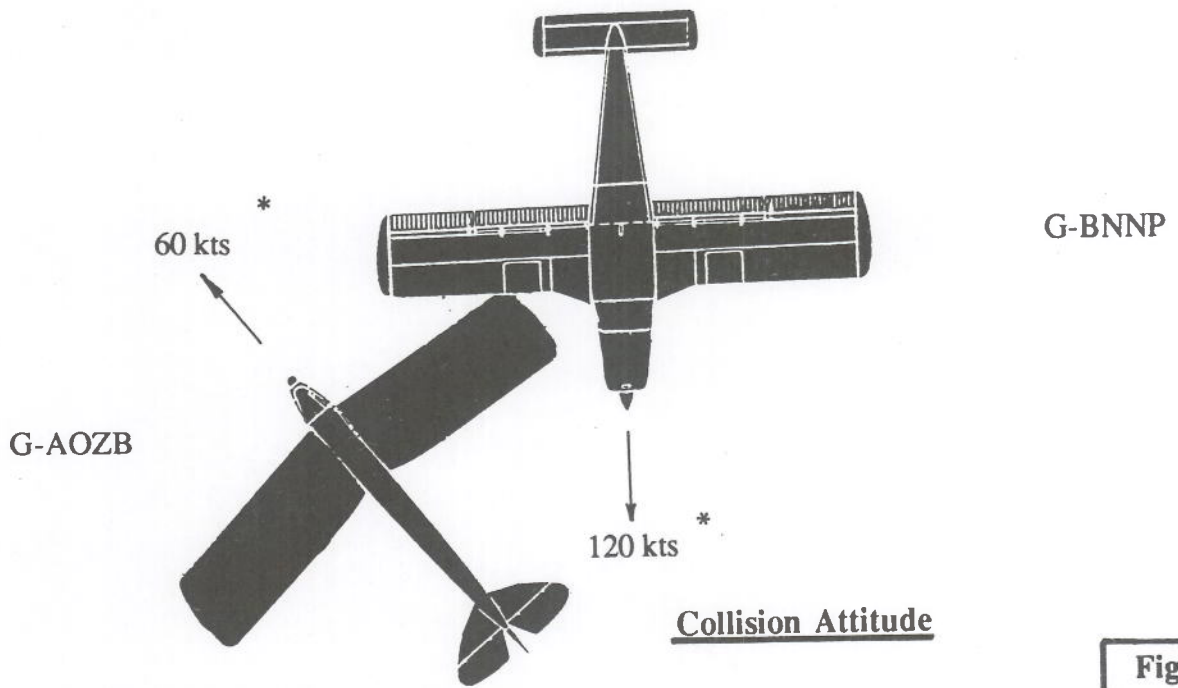
Figure 1

* - Approximate speeds

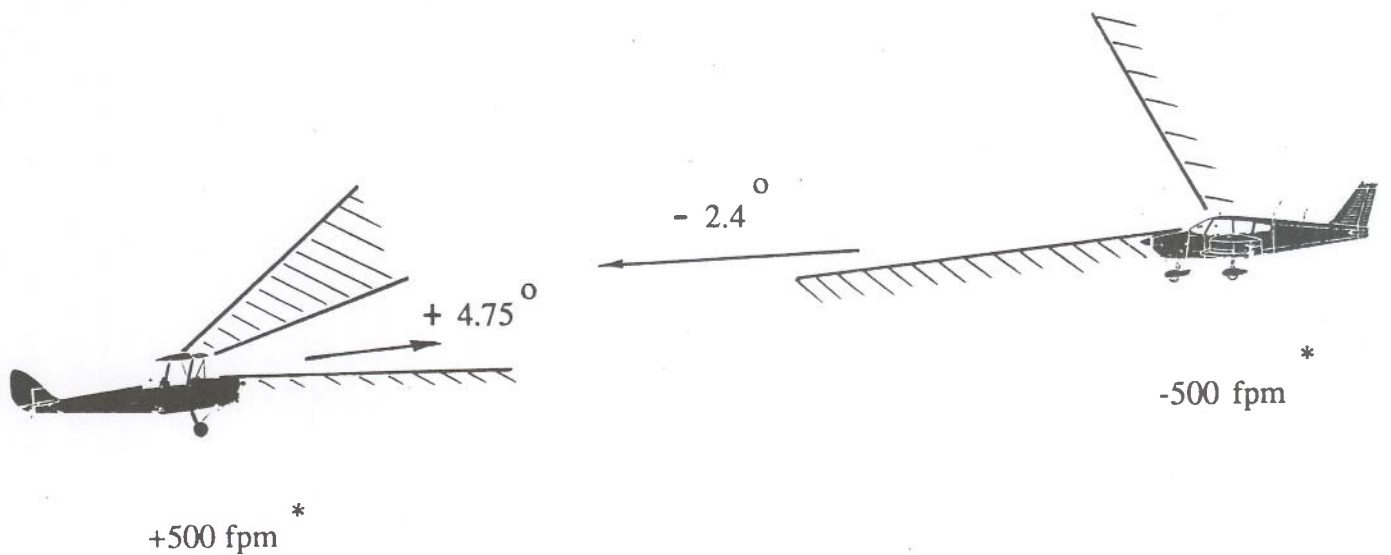
Figure 2

Likely 'dead ahead' vision cutoff and flight path angles
