ACCIDENT

Aircraft Type and Registration:	Lindstrand LBL 210A hot air balloon, G-BZDE	
No & type of Engines:	None	
Year of Manufacture:	2000	
Date & Time (UTC):	16 April 2006 at 1814 hrs	
Location:	Near Bordon, Hampshire	
Type of Flight:	Public Transport (Passenger)	
Persons on Board:	Crew - 1	Passengers - 10
Injuries:	Crew - None	Passengers - None
Nature of Damage:	Scorching and abrasion damage to balloon envelope	
Commander's Licence:	Commercial Pilot's Licence (Balloons)	
Commander's Age:	49 years	
Commander's Flying Experience:	827 hours (of which 141 were on category B balloons) Last 90 days - 12 hours Last 28 days - 6 hours	
Information Source:	AAIB Field Investigation

Synopsis

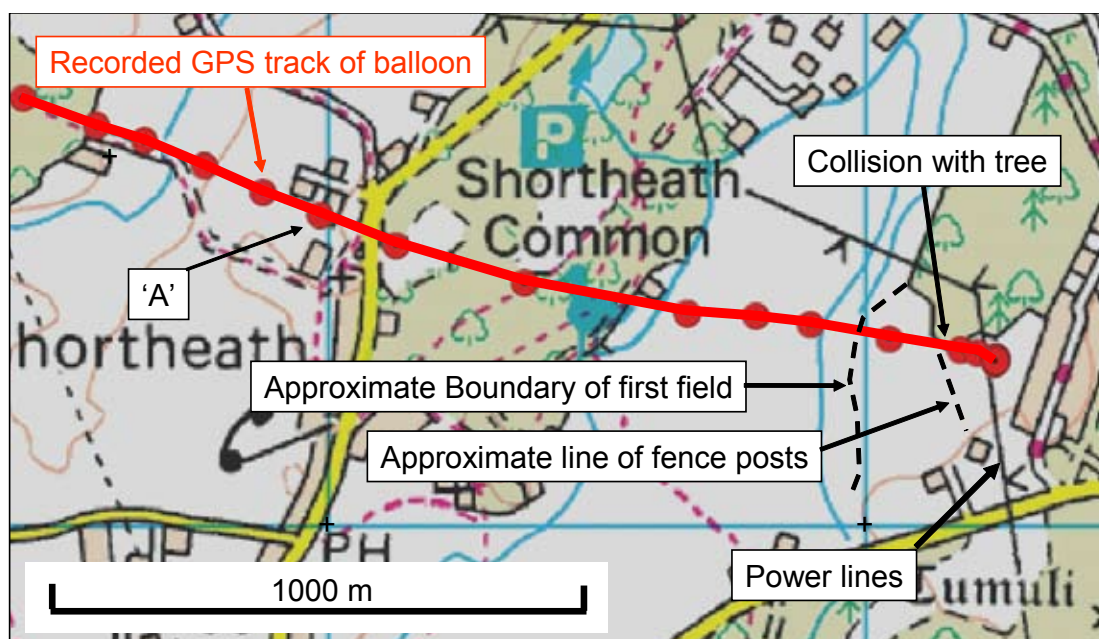
Figure 1

The accident events centred on two adjoining fields on the western outskirts of the town of Bordon (Figure 1). Originally a single field, it was divided into two by fence posts. Although this gave the appearance that the fields were physically separate, there were in fact no wires between the posts. The westerly field was the larger of the two, bounded at its western edge by a hedgerow which contained a number of moderately sized trees. A wooded area protruded into the two fields from the north, forming a 'V' shape, at the point of which was the large tree which the balloon basket struck shortly before contacting the power lines. The distance from the tree to the centreline of the power lines, in the direction of flight of the balloon, was 89 m. The protruding wooded area formed a 'neck' across the fields divided by the fence posts.

The two fields were of very different appearance, with the larger field to the west containing light coloured stubble and the smaller field to the east being mainly grass. The smaller field contained the 132 kV power lines, running approximately north-south. They were supported by one tower in the field at 32.3 m height, and another in the wooded area to the north. Immediately behind the power lines was an area of industrial buildings which formed the eastern boundary of the site. A track led into the easterly field from a minor road to the south.

'A' at Figure 1) saw the balloon pass directly overhead at low altitude. The witness reported hearing the balloon's burner, and had the impression that it had climbed slightly to clear the narrow low ridge on which his house stood. After passing, it continued at low altitude in the direction of the accident site before disappearing from view behind trees.
