No: 11/88

Ref: EW/C1069

Aircraft Type and Registration: Max Holste Broussard 1521, G-BKPU

Information Source: AAIB Field Investigation

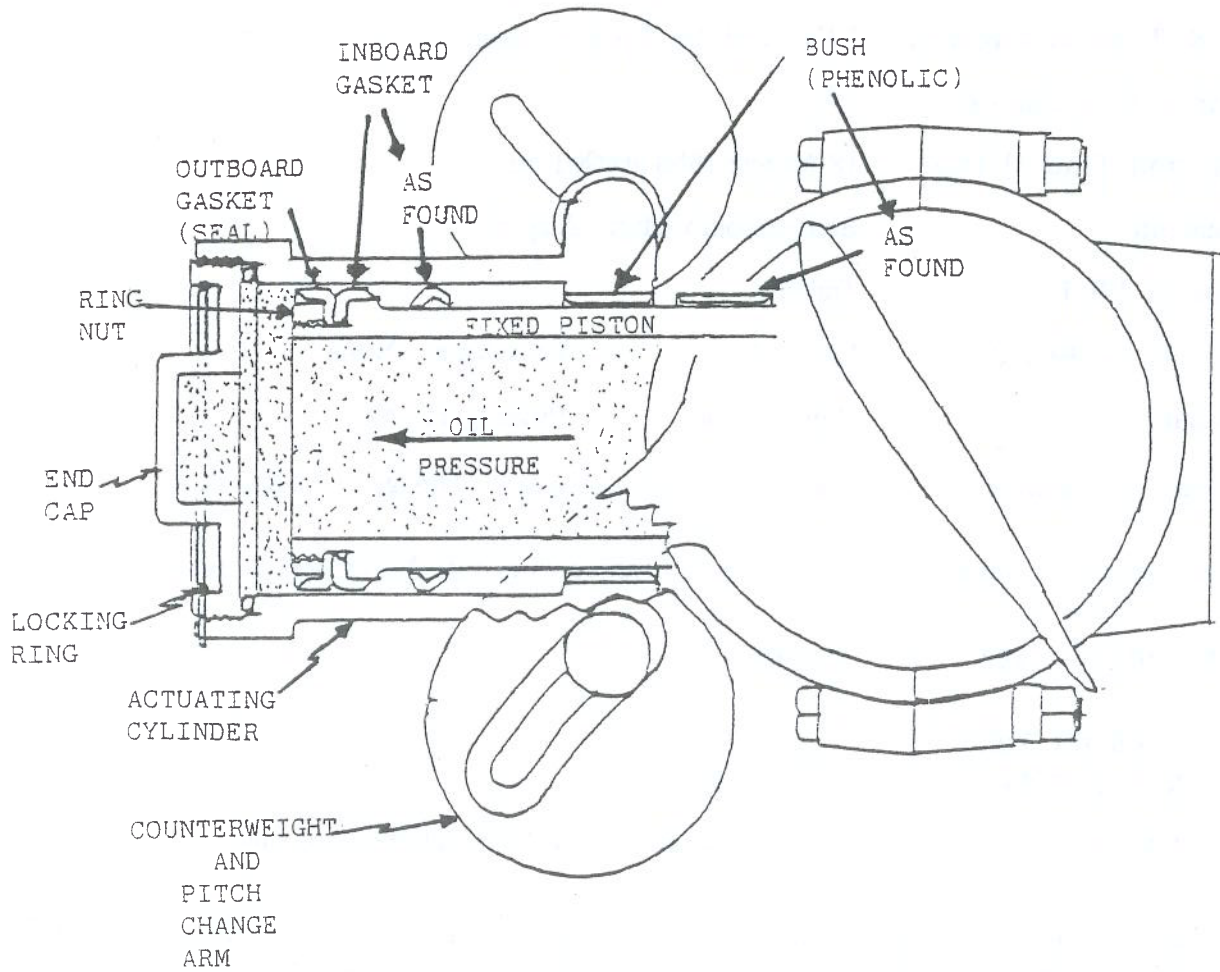
PROPELLER PITCH CHANGE MECHANISM

When the end cap of the propeller actuating cylinder was removed debris was found inside which proved to be fragments of the outboard leather gasket (oil seal). One portion was jammed between the actuating cylinder and the fixed piston on to which the gasket pair is normally clamped by a ring nut. Other portions were loose in what had been the oil filled, pressure side of the actuating system. One

When the hub was further dismantled the inboard gasket was found to be out of its locating groove having moved aft on the fixed piston. This gasket does not function as a seal but provides a sliding surface between the cylinder and fixed piston. Its sliding surface was in good condition and undamaged but the internal lip by which it would normally be clamped did show some distortion and variation of lip depth. It was considered that the gasket had been forced out of its normal position by oil pressure following loss of clamping load occasioned by the break-up of the outboard seal. The distortion seen could have been the result of the gasket being forced over the lip on the fixed piston rather than an indication of its pre-existing condition.

The phenolic bush was examined and, again, its condition suggested that it had been damaged and dislodged following the failure or partial failure of the seals. It had suffered break-up of both outboard and inboard edges most probably caused by "cocking" of the cylinder once it was not properly restrained by the leather gaskets at its forward end. The fact that this damage was evenly distributed around the circumference indicates that the bush was in position in the cylinder when this damage was sustained. The bearing surface of the bush appeared to be in good condition. Measurements showed that the bush was within wear limits and had not suffered uneven wear. Attached to the outside surface of the bush there were beads of adhesive which had been keyed into grooves in the inside surface of the cylinder. Similarly, some adhesive was still sticking to the cylinder surface and in the grooves. This evidence suggested that there had not been an initial failure of the adhesive which had allowed the bush to be displaced. It is most probable that the edge loading on the bush caused shear loads which disrupted the adhesion and, aided by the outward flow of oil, ejected the bush. The bush had suffered two, diametrically opposite, axial fractures but the above evidence on the edge damage implies that these are subsequent to that damage and were incurred when the bush was ejected from its location.

The most probable sequence, therefore, leading to the anomalies found in the propeller hub is, firstly, the break-up of the outboard leather seal, secondly the displacement of the inboard gasket by oil pressure following the loss of clamping loads and, coincident with the disruption of the gaskets, the damaging and ejection of the phenolic bush. The rest of the propeller pitch change system was examined for anything which could have caused excessive or asymmetric loading on the actuating cylinder but none was found.

An FAA approved modification is available to replace the leather seal assembly in this family of propellers with an assembly employing "O" rings.
