ACCIDENT

Aircraft Type and Registration:	Pioneer 300, G-CEEG	
No & Type of Engines:	1 Rotax 912ULS piston engine	
Year of Manufacture:	2006	
Date & Time (UTC):	9 June 2007 at 1431 hrs	
Location:	Oban Airport, Strathclyde, Scotland	
Type of Flight:	Private	
Persons on Board:	Crew - 1	Passengers - 1
Injuries:	Crew - None	Passengers - None
Nature of Damage:	Broken propeller, slight damage to engine cowling, landing gear jacks buckled	
Commander's Licence:	Private Pilot's Licence	
Commander's Age:	56 years	
Commander's Flying Experience:	1,450 hours (of which 90 were on type) Last 90 days - 87 hours Last 28 days - 32 hours	
Information Source:	AAIB Field Investigation

Synopsis

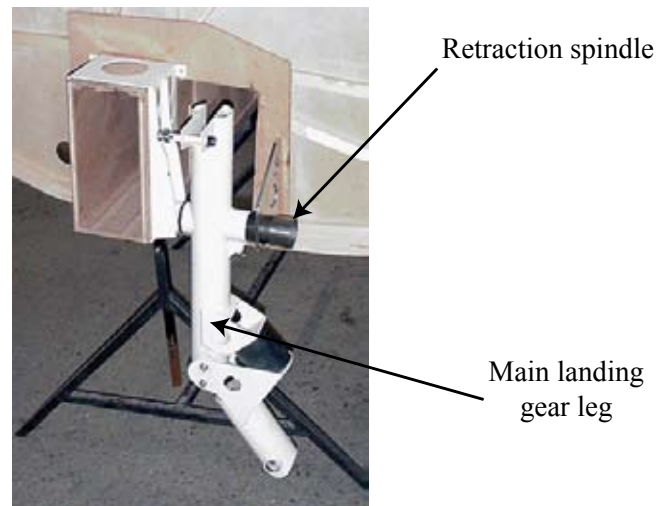
Figure 1

The owner of the aircraft, who was also the pilot on the incident flight, reported that the right main landing gear screw jack and nose leg locking rod had buckled, which had caused the nose and right landing gear to collapse. The owner removed the right landing gear screw jack and retraction mechanism and attempted to rotate the right main leg about the retraction spindle (see Figure 1). However the leg could not be easily rotated about the spindle and remained jammed at an angle of approximately 50°.

Main landing gear leg
