ACCIDENT

Aircraft Type and Registration:	Robinson R44 II Raven, G-OSSI	
No & Type of Engines:	1 Lycoming IO-540-AE1A5 piston engine	
Year of Manufacture:	2004	
Date & Time (UTC):	3 August 2007 at 1836 hrs	
Location:	4 miles SSE of Kendal, Cumbria	
Type of Flight:	Private	
Persons on Board:	Crew - 1	Passengers - 3
Injuries:	Crew - 1 (Fatal)	Passengers - 3 (Fatal)
Nature of Damage:	Aircraft destroyed	
Licence:	Pilot 1: Private Pilot's Licence Pilot 2: Private Pilot's Licence	
Age:	Pilot 1: 39 years Pilot 2: 37 years	
Flying Experience:	Pilot 1: 100 hours (of which 45 were on type) Last 90 days - 8 hours Last 28 days - 2 hours Pilot 2: 91 hours (of which 8 were on type) Last 90 days - 4 hours Last 28 days - 2 hours	
Information Source:	AAIB Field Investigation

Synopsis

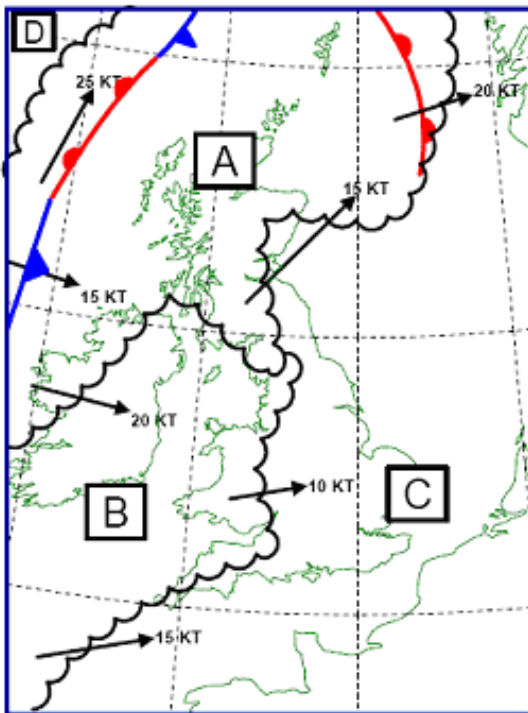
Form F215

unlikely to be suitable for VFR flying from where the helicopter entered the Lake District up into the Lockerbie area. It is not known whether the pilots involved in this flight were aware of the contents of the F215 or the Airmet, but it was not normal practice at the flying school for pilots to check these forecasts.

The Met Office Form 215, and the Airmet forecast, reproduced below, provided the area forecast for the whole of the UK. This indicated that the weather was

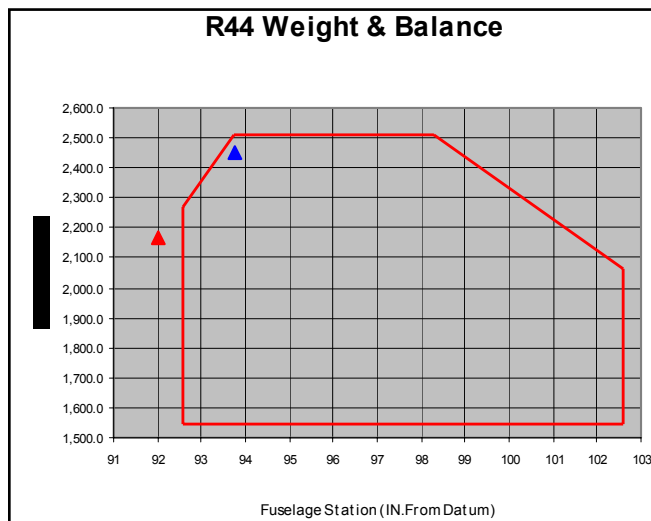
Takeoff from Leeds

Weight and balance calculations were completed by Pilot 2, using estimated weights for the occupants. These calculations underestimated the weight of the pilots, and no allowance was made for the overnight bags which were carried by all of the occupants. The following calculations were made by the AAIB using accurate occupant weights.

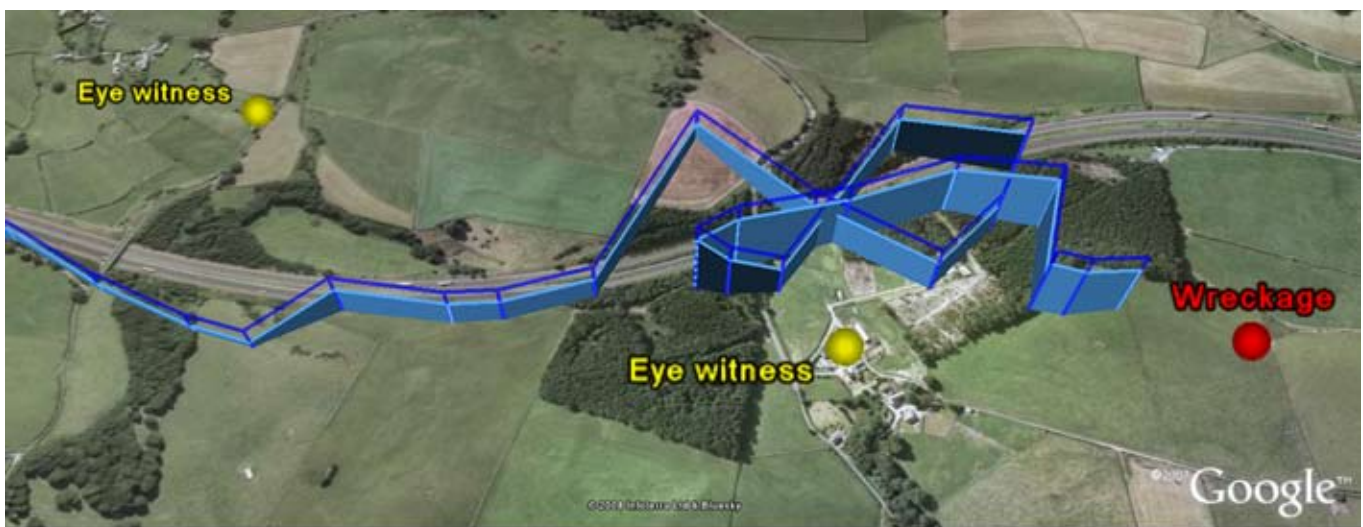
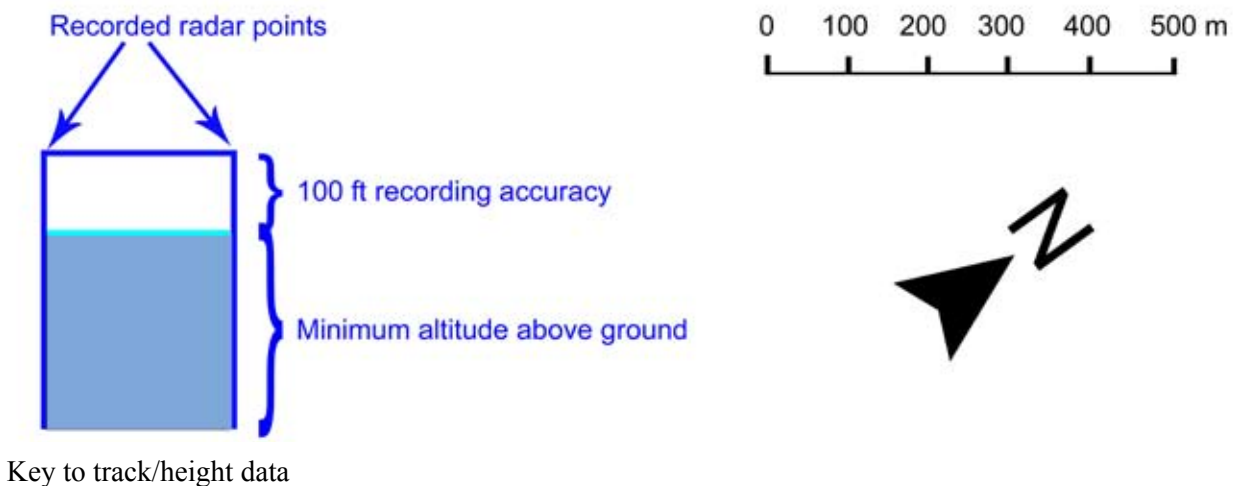
Figure 1
G-OSSI - Track/height plot prior to the accident (Radar Data)

The terrain along the M6 increased in elevation as the helicopter progressed northwards and its separation from the ground reduced to less than 200 ft. It then climbed and carried out circling manoeuvres; the radar recording ended just to the south of the accident site and the subsequent final GPS track point, recorded at 1836:46 hrs, was just to the west of the site. Figure 1 shows the last part of the accident flight as recorded by radar.

In the very poor weather conditions, control of the helicopter appears to have been lost. It seems likely that the pilots either inadvertently allowed it to enter cloud, or that the pilot lost his external references. It could not be established whether the cabin heating/windscreen demisting system was selected on at the time. Should the cabin conditions have been conducive to windscreen misting, then this most likely occurred shortly after the second passenger boarded. That passenger's clothing may have been damp, requiring heating/demisting to be selected, once warm air was available from the engine. Nevertheless, this, the possibility could not be fully dismissed that a misted windscreen might have been a factor in the accident.

The helicopter entered a descending turn but flew into the ground in a level attitude. It could not be determined with certainty, but it is considered that the pilot was either attempting to recover to controlled flight using the instruments, or had become visual with the ground at a low height and was attempting to recover from a dive. As can be seen from the load and balance sheets, when the aircraft lifted from Arkholme, it was overweight by approximately 80 lbs, and the centre of gravity was outside the limits. This would have the affect of making the aircraft slightly more difficult to fly, particularly at low speeds.
