Department for Transport

AAIB Bulletin S1/2012

ACCIDENT

Aircraft Type and Registration:	BAE Systems Jetstream 31, G-CCPW	
No & Type of Engines:	2 Garrett Airesearch TPE 331-10UGR-5164 turboprop engines	
Year of Manufacture:	1987	
Location:	Runway 26, Isle of Man Airport	
Date & Time (UTC):	8 March 2012 at 1757 hrs	
Type of Flight:	Commercial Air Transport (Passenger)	
Persons on Board:	Crew - 2	Passengers - 12
Injuries:	Crew - None	Passengers - None
Nature of Damage:	Right main landing gear yoke pintle fractured, right engine and propeller blades damaged	
Commander's Licence:	Airline Transport Pilot's Licence	
Commander's Age:	58 years	
Commander's Flying Experience:	About 6,000 hrs (of which about 1,500 hrs were on type)	
Information Source:	AAIB Field Investigation

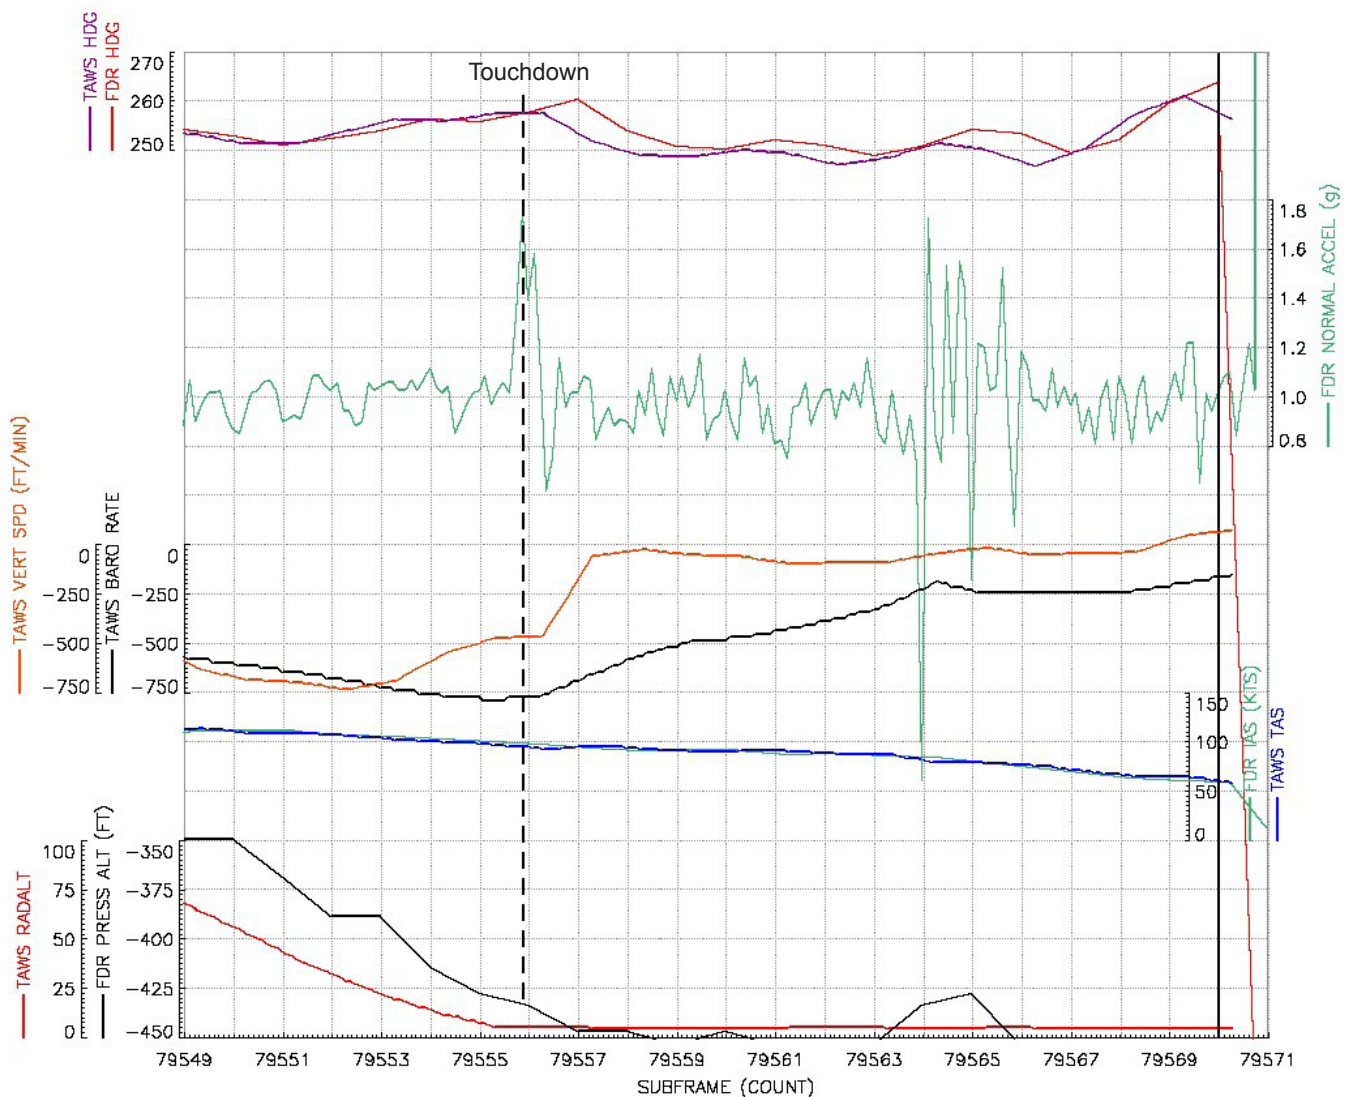
Figure 1

The aircraft was equipped with a 25 hour continuous-loop Digital Flight Data Recorder (DFDR) that recorded five parameters: time, pressure altitude, indicated airspeed, normal acceleration and heading. The normal acceleration at touchdown, after adjusting for maximum accelerometer drift of 0.04 g, was established as 1.72 g. This was the highest value recorded during the 20 flights recorded on the DFDR.

Additionally, a Terrain Avoidance Warning System (TAWS) installed in the aircraft recorded 30 separate parameters including Radio Altitude (Rad Alt) and pressure altitude at a higher sampling rate than the DFDR. From this altitude information it was established that the rate of descent, just prior to touchdown, was 463 ft/min (7.7 ft/sec). This is within the landing gear limit load defined for a touchdown with a rate of descent of 10 ft/sec at the maximum landing weight of 14,900 lb (6,758 kg).

Data recorded during the landing

The information from the DFDR, TAWS and CVR has been combined and is shown in Figure 1.

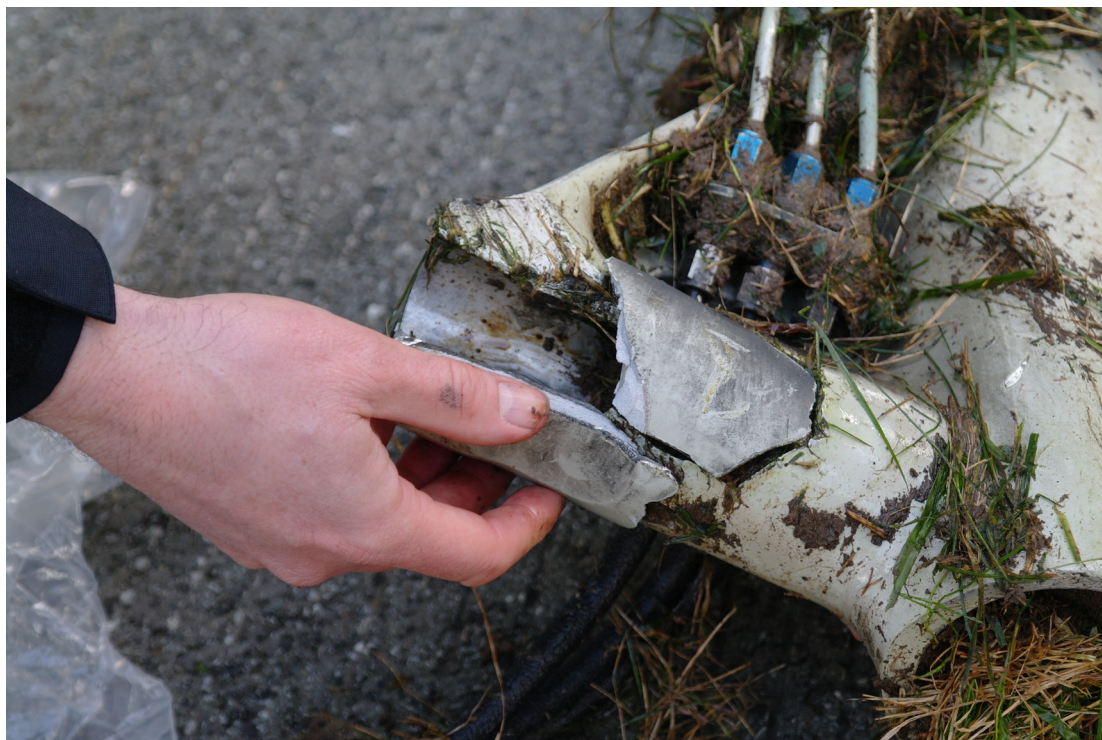
Figure 2

The right landing gear had broken away from its trunnions as a result of a failure of the forward yoke pintle housing (refer to Figure 2). However, the landing gear remained attached to the aircraft by the radius arm (retraction jack) and hydraulic pipelines. The downlock

Right main landing gear yoke forward pintle

The main landing gear is manufactured from DTD 5094 aluminium alloy, which is known to be susceptible to Stress Corrosion Cracking (SCC). The landing gear is attached to the airframe by trunnions that fit into steel spigots that are bolted to the inside of the yoke pintles. The upper surfaces of the pintles have been machined to introduce a weak link that, in the event of the landing gear being subjected to a force outside of its design limits, will fail and allow the gear to detach from the aircraft without damaging the fuel tanks. During the accident sequence the forward yoke pintle had failed with three large segments breaking away from the landing gear.

It is recommended that the European Aviation Safety Agency review the effectiveness of Airworthiness Directive G-003-01-86 in identifying cracks in the yoke pintle housing on landing gears fitted to Jetstream 31 aircraft.

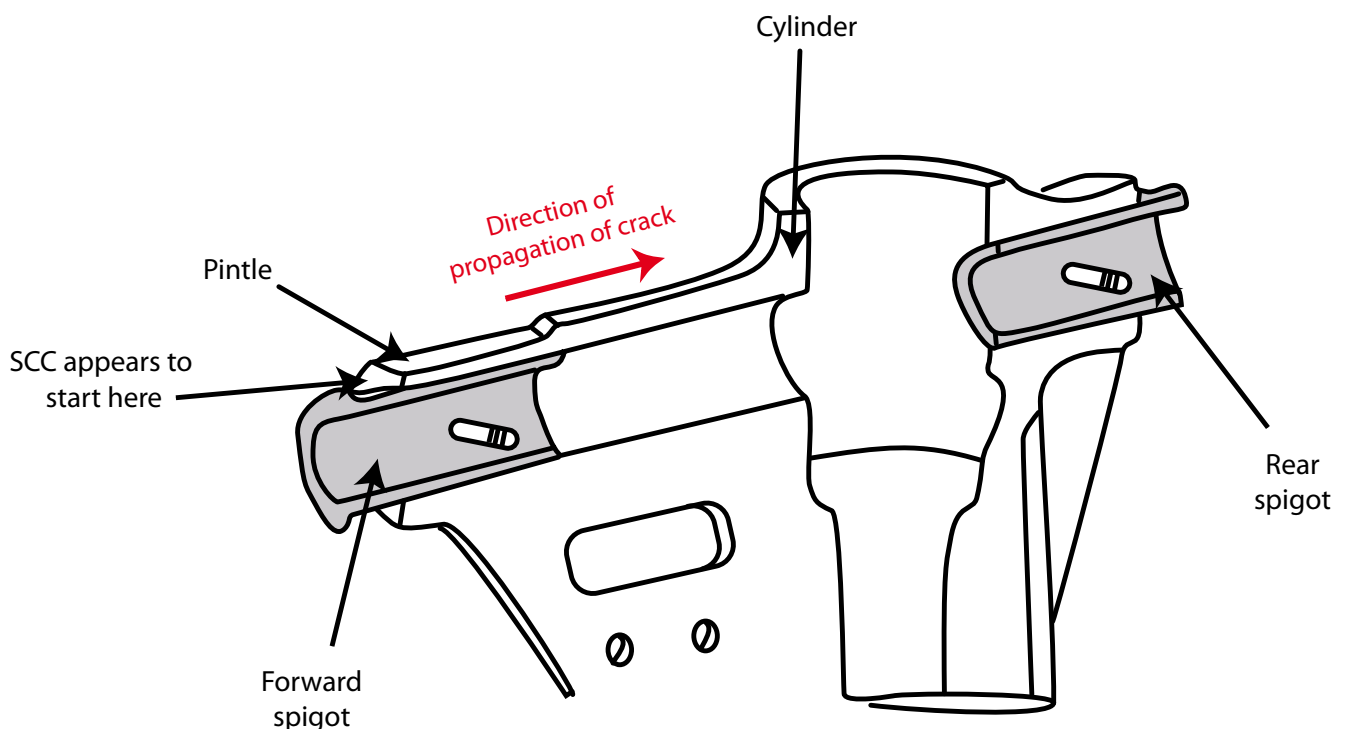
Figure 3
Main landing gear diagram

Examination established that the failure initiated at the top outer edge of the forward yoke pintle (see

Figure 3) and the crack extended along the top of the pintle for approximately 120 mm before final failure occurred. The first 10 mm of the crack was heavily corroded and lighter deposits of corrosion were found along the remainder of the crack. Scanning Electron Microscopy (SEM) of the first 10 mm of the crack showed evidence of inter-granular failure consistent with SCC. A microsection through the first 35 mm of the crack identified branching crack growth which is a characteristic of SCC. The remainder of the crack showed a combination of both ductile overload and patches of SCC. Corrosion was also found on the steel spigot. Energy-dispersive X-ray spectroscopy (EDX) of the fracture surface of the crack in the yoke pintle identified the presence of cadmium that had leached into the crack from the corroded steel spigot.

The metallurgy determined that a crack, emanating from the top edge of the forward yoke pintle, grew to approximately 120 mm before the remainder of the pintle failed in ductile overload. The first 10 mm of the crack occurred as a result of SCC and the heavy corrosion deposits indicated that this damage had been present for some time. The failure mechanism of the remainder of the crack is less clear. The patches of ductile overload and SCC, and the presence of cadmium in the crack, suggest that the crack grew over a period of time. Whilst the investigation has not yet determined how long the crack took to grow to failure, the amount of corrosion in the crack and on the steel spigots suggests that it was present during the last visual inspection carried out 11 days earlier and may have been present during the last eddy current inspection undertaken ten months earlier.
