2 Analysis

2.1 Catastrophic failure

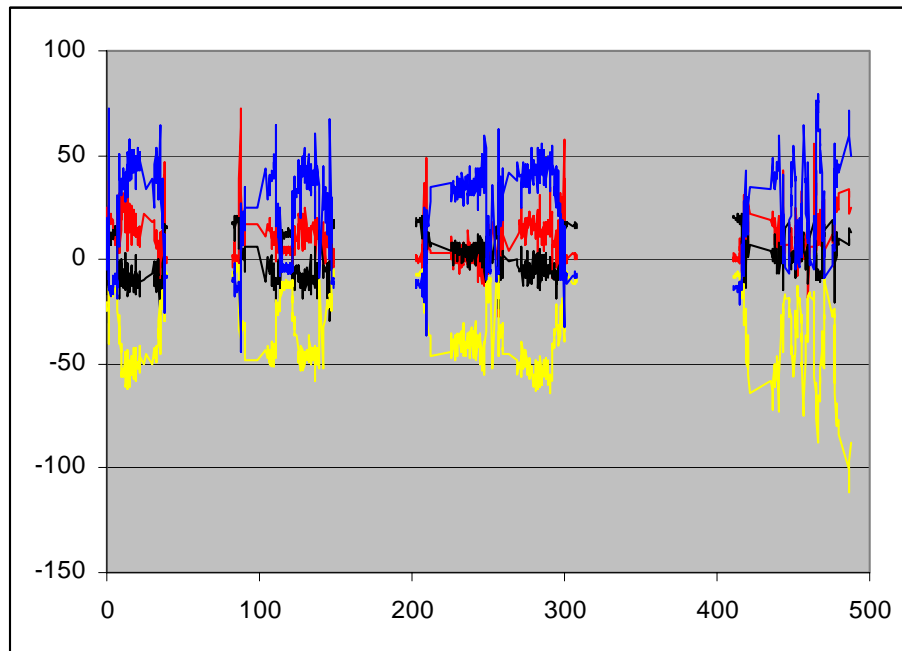
Annex K Figure 4 - Track Data (mm) from FDR vs Pseudo Time (min)

Figure 4 of Annex K (reproduced below) shows little difference in the track of the yellow colour-coded blade during the first three flights on the graph (the second, third and fourth flights of the day) but a change is unmistakable during the fifth and final multi-sector flight. These changes must be related to spar crack size and so the crack was growing rapidly during this flight.

The rapidity of the crack growth during the final five sectors of the last flight is also illustrated by Figure 7 on page 15 of Annex K which shows the yellow blade track changing during each sector departure. This graph also suggests that something significant happened to the blade between the third and fourth sectors; this could, however, have simply been the change in payload from zero to eight and then nine passengers and their baggage for the last two sectors (see Table 2).

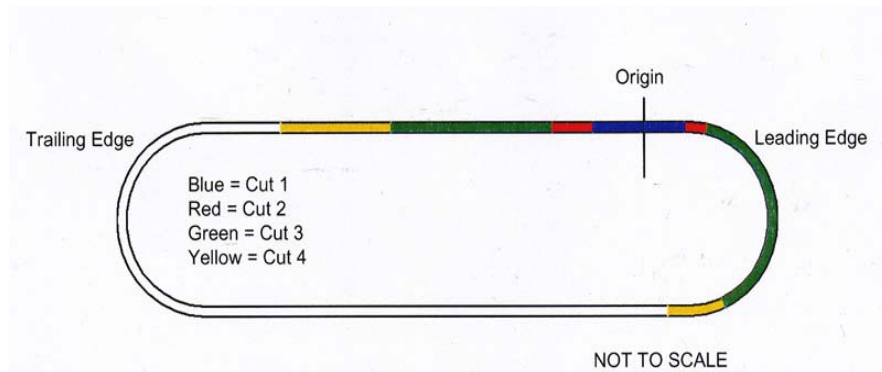
Figure 8 – Crack growth simulation

The major part of the crack was in the upper surface and leading edge of the spar. The trial report at Annex R contains a colour-coded diagram of saw cuts used to simulate the crack size at various stages; this diagram is repeated in Figure 8.

Coloured band(s)	Crack length (mm)	Flight time before failure
Blue	30	9 hrs 30 mins
Blue and red	41	7 hours 35 mins
Blue red and green	102	2 hours
Blue, red, green and yellow	142	0 mins

The amalgamation of the coloured bands in Figure 8 illustrates the approximate size of the crack at failure. The flight times in the third column have been amended (relative to those in Appendix Q) to conform to the combined data curves in Appendix O.

The data show the spar crack did not reach the underside of the spar until the day of the accident. Had the crack initially formed in the underside of the spar, flight loads would have tended to open the crack and the spar would probably have failed much earlier due to bending loads in the upper surface.

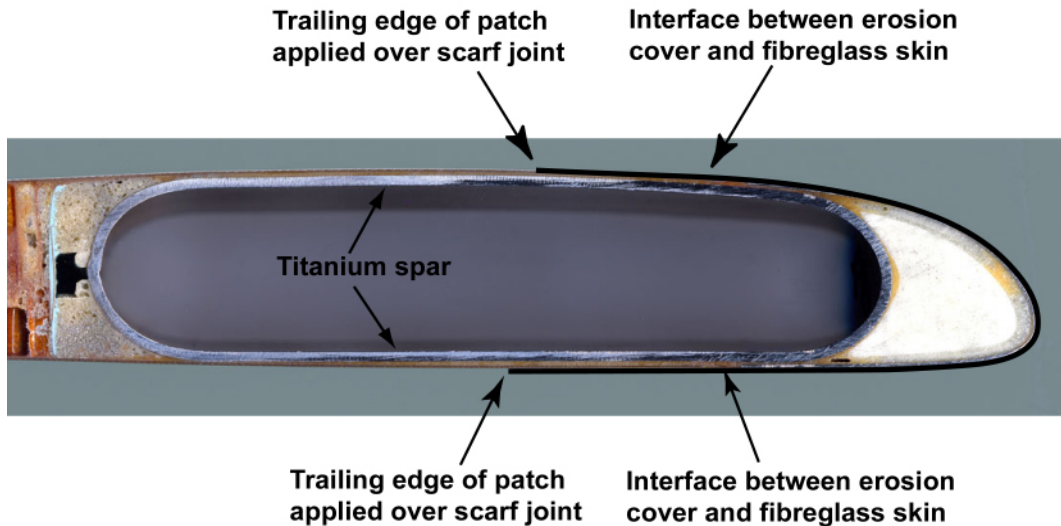
Figure 9 – Approximate extent of polyurethane patch over scarf joint

The patch extended about 35 mm rearwards from the trailing edge of the upper surface of the erosion cover and 42 mm rearwards from the lower trailing edge of the erosion cover. An illustration of the approximate extent of the patch relative to the titanium leading edge erosion cover and its interfaces with the upper and lower fibreglass skins is shown below at Figure 9.

The spar fatigue origin was 6.7 mm forward of the rear edge of the erosion cover so, on the upper surface of the blade, the patch extended at least 41 mm rearwards from the spar crack origin. The graph on page 6 of Annex P shows that at the time of the Daily Inspection, 6.25 flight hours prior to the final failure, the spar crack had progressed approximately 30 mm rearwards from its origin. The crack relationship test showed that any associated skin crack was unlikely to be longer than the spar crack. Consequently, if a skin crack existed at that time, it was invisible.

The graph suggests that the rearward extent of any skin crack did not progress aft of the patch until about 4.3 flight hours before the accident, which encompasses the last three pre-flight checks. Given the inspection difficulties and the few opportunities to see an external crack aft of the patch, if it existed it is not surprising that its existence went unnoticed.
