## ACCIDENT

Aircraft Type and Registration: YAK-50, G-YAKK

**Date & Time (UTC):** 10 April 2010 at 1142 hrs

**Location:** Bothel, Cumbria

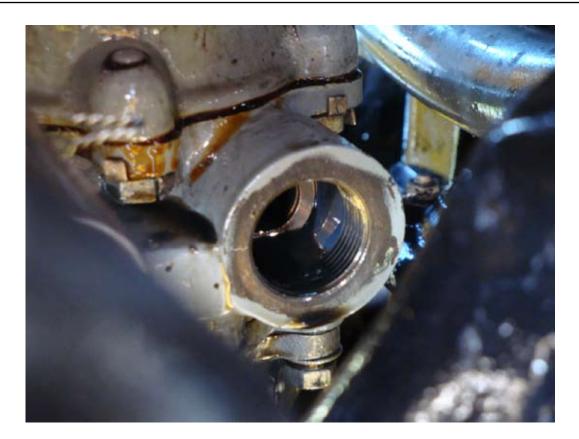
Figure 1

On examining the engine, the pilot identified that the oil pressure adjustment valve was missing from the oil scavenge pump housing (Figure 1). It was found in the

lower cowling with no evidence of the expected wire locking. He believed that the valve had worked loose and fallen out during the accident flight, causing the oil loss. The aircraft had recently undergone extensive maintenance which included an overhaul of the oil scavenge pump assembly. Initial flights following this work revealed a small oil leak in the area of the pump, which at the time, was thought to be have been remedied by an engineer tightening the small vertical bolts adjacent to the pressure adjustment valve.

Photograph of oil scavenge pump showing missing oil pressure adjustment valve
