DC10-30 N83NA AT LONDON, HEATHROW, 16 SEPTEMBER 1980

DC 10-30, N83NA, REJECTED TAKE -OFF AT LONDON, HEATHROW ON 16 SEPTEMBER 1980
Corrected Flight Data Recorder Information

DC 10-30 N83NA AT LONDON, HEATHROW, 16 SEPTEMBER 1980 REJECTED TAKE-OFF

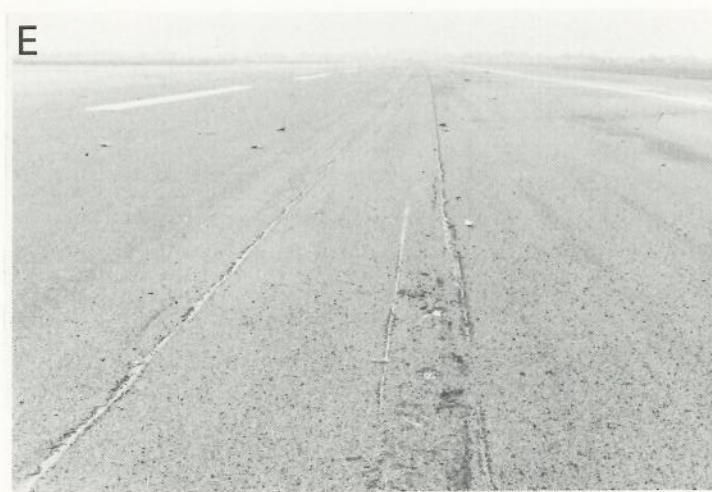
At right No. 8 wheel rim break up, at left No. 7 wheel rim marks after break up

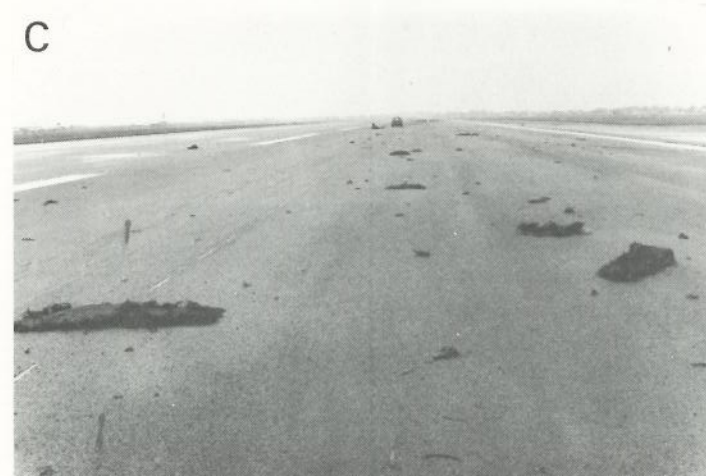
Pieces of No. 8 tyre carcass and general tyre debris

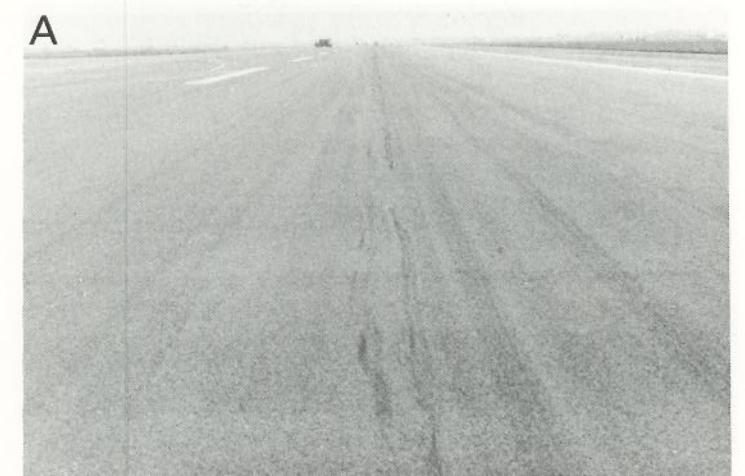
The deflated No. 8 tyre marks

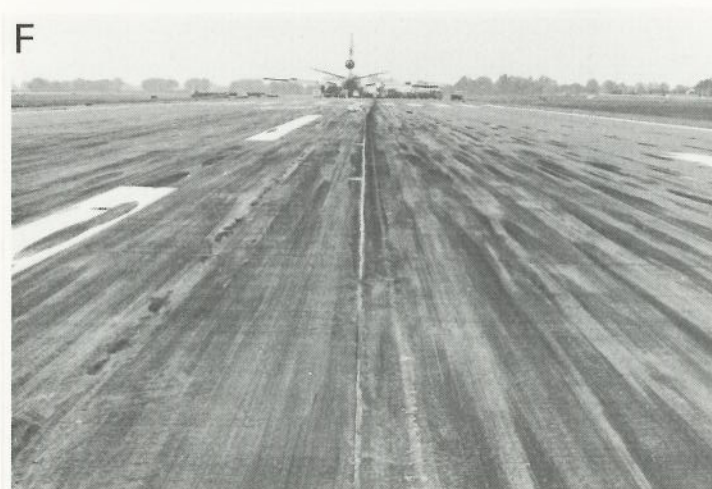
At centre No. 4 tyre skid mark

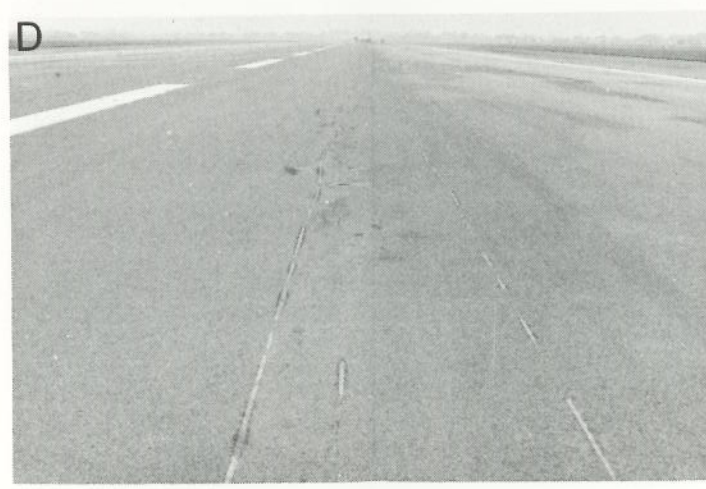
At left No. 7 wheel rim break up, at right No. 8 wheel rim contact marks

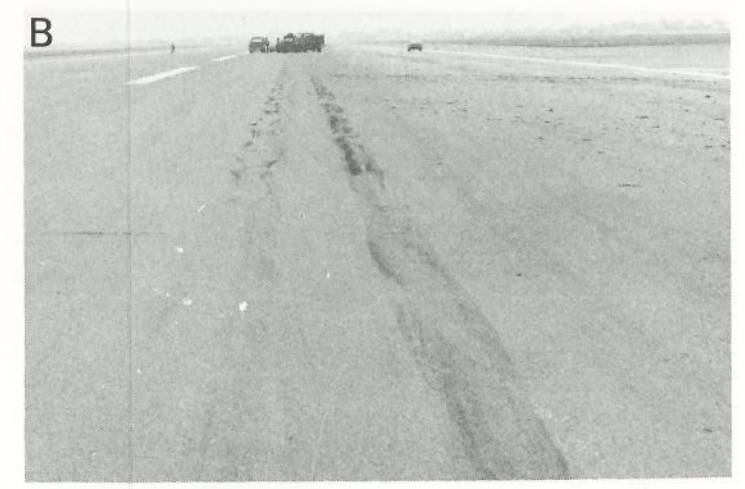
At left No. 7 tyre marks, at right No. 8 tyre marks

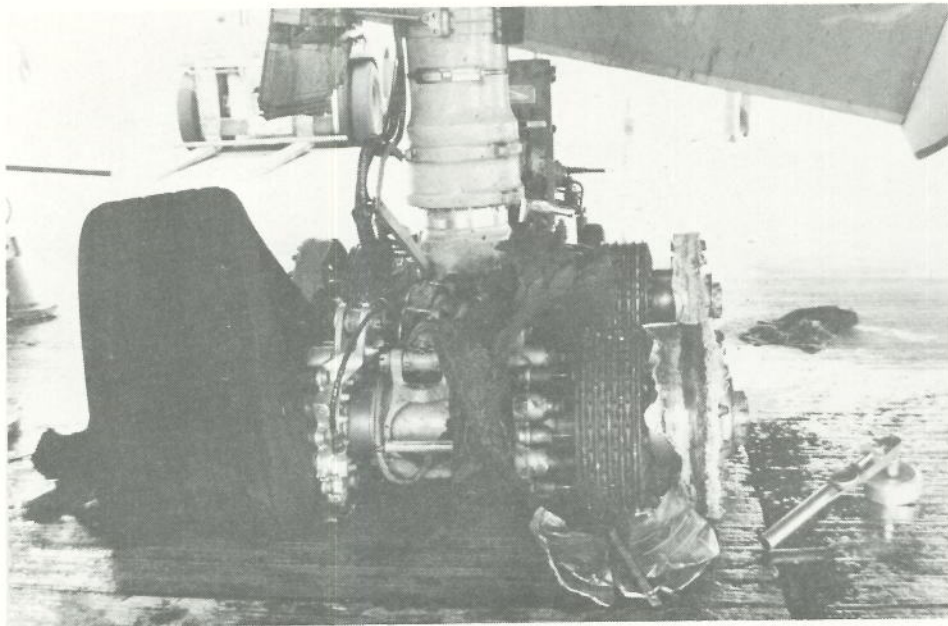
FIGURE 3

At left no.4 tyre/wheel and
at right no.3 wheel ,brakepack
& tyre beads

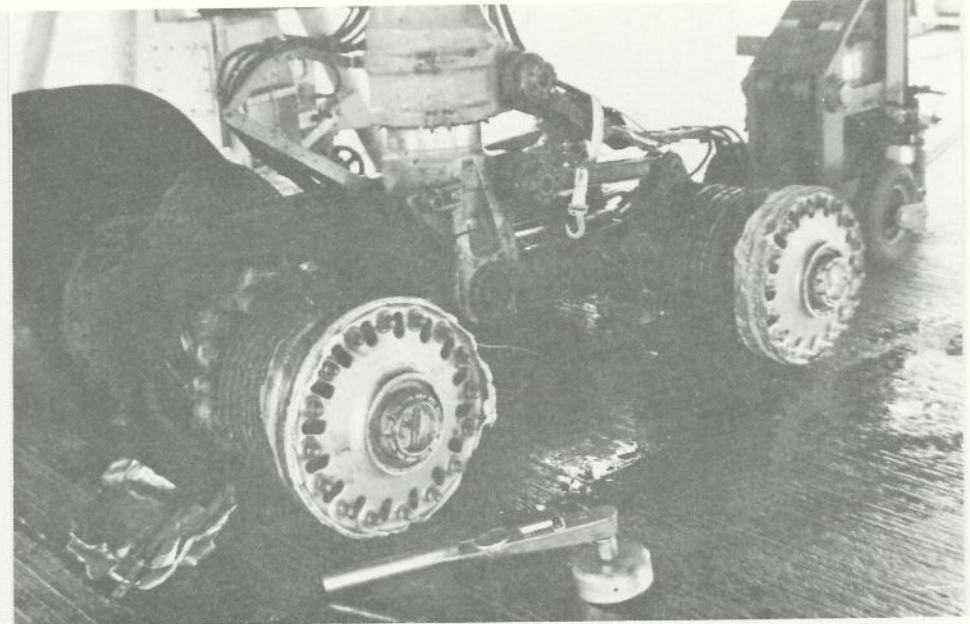
At left no.3 wheel,brakepack
& tyre beads and at right
no.7 wheel and brake pack

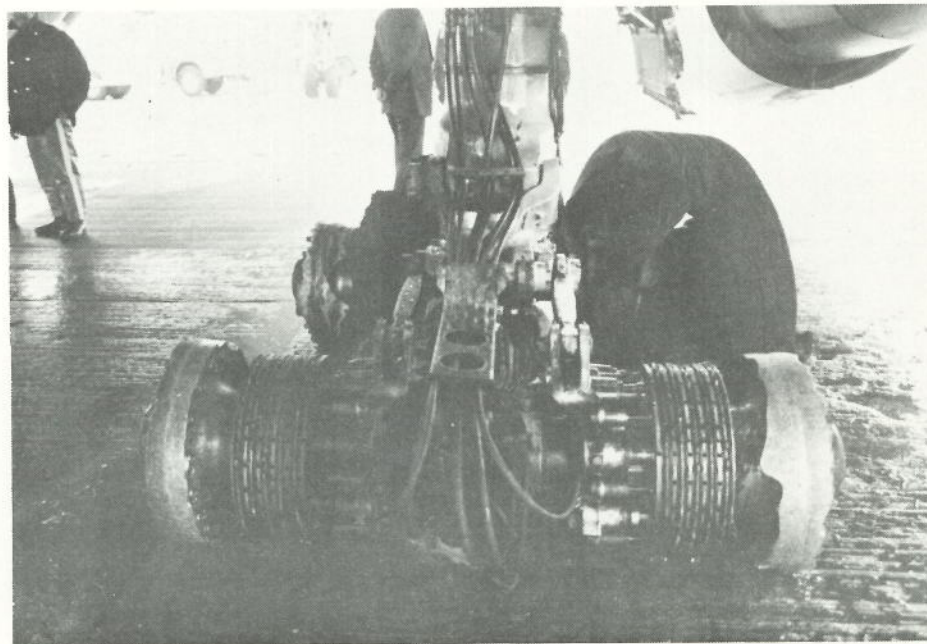
At left no. 7 and at right no.8
wheels and brakepacks

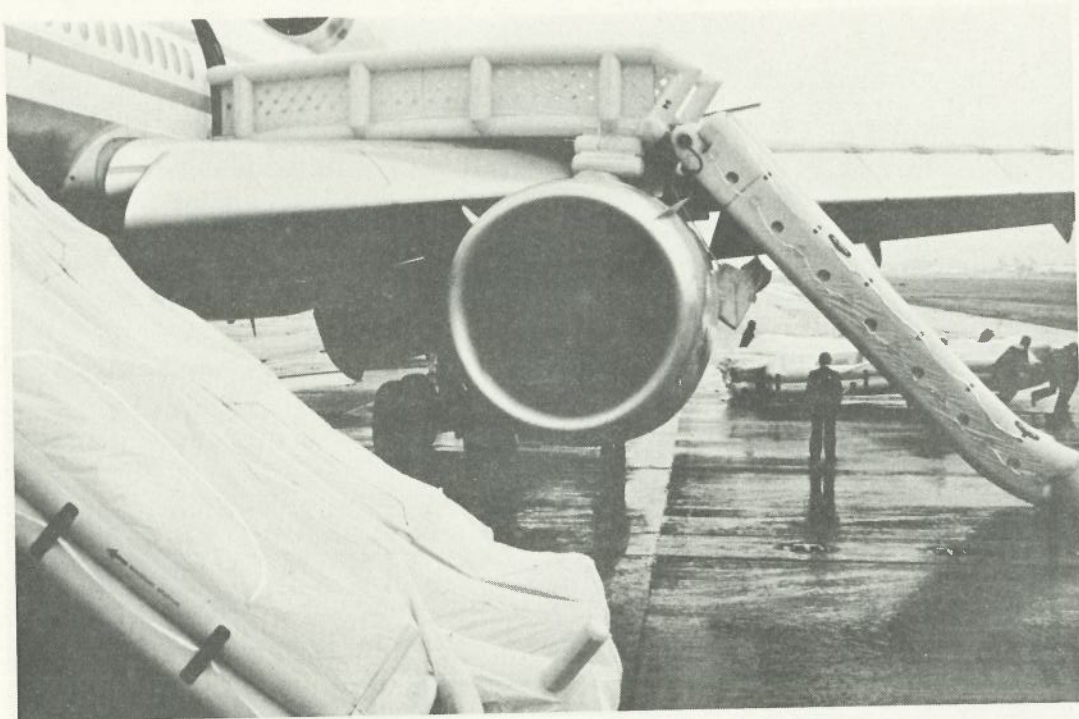
FIGURE 4

No.3 (The overwing) slide deployed , with no.2 in the foreground

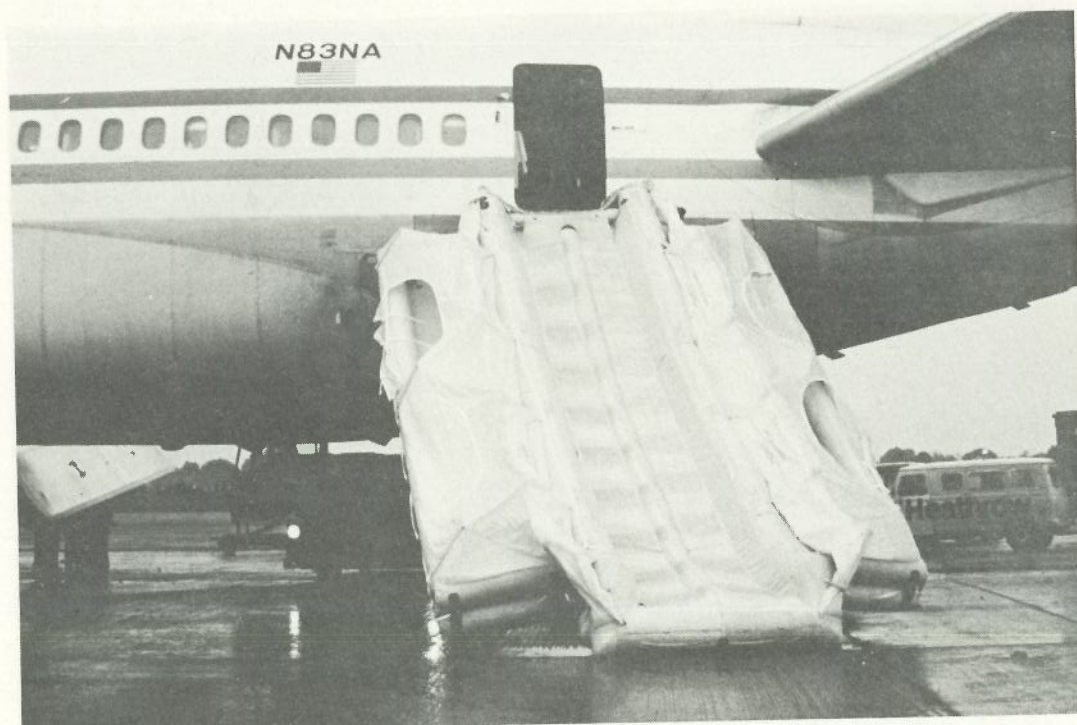
No.4 Slide/raft deployed

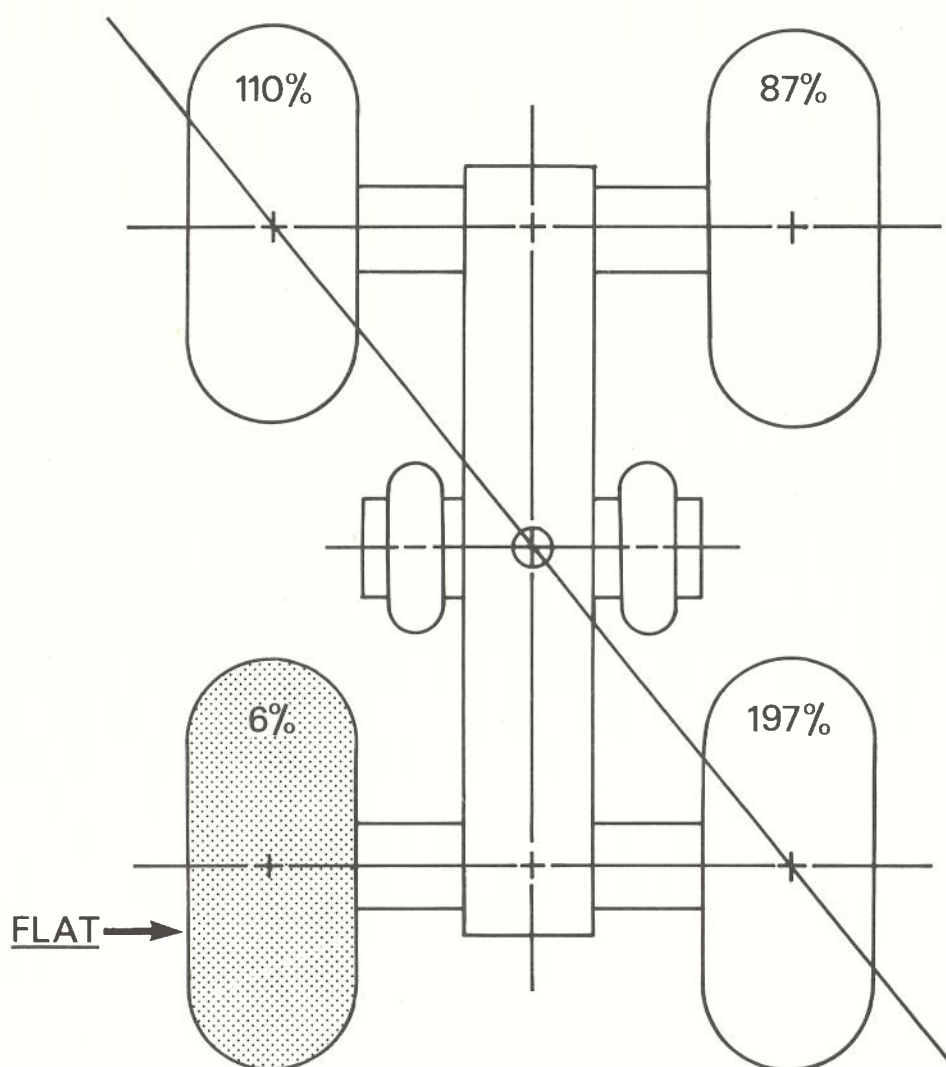
FIGURE 5

DC 10-30 MAIN BOGIE SINGLE WHEEL LOAD DISTRIBUTION (Flat Tyre Case)

Note: Moments do not balance because of unmeasured forces caused by the soft tyre.
