Relative position of Cormorant 'A' and 'Safe Supporter'

ACCIDENT TO AS332 G-TIGR NEAR CORMORRANT ALPHA ON 14TH MARCH 1992

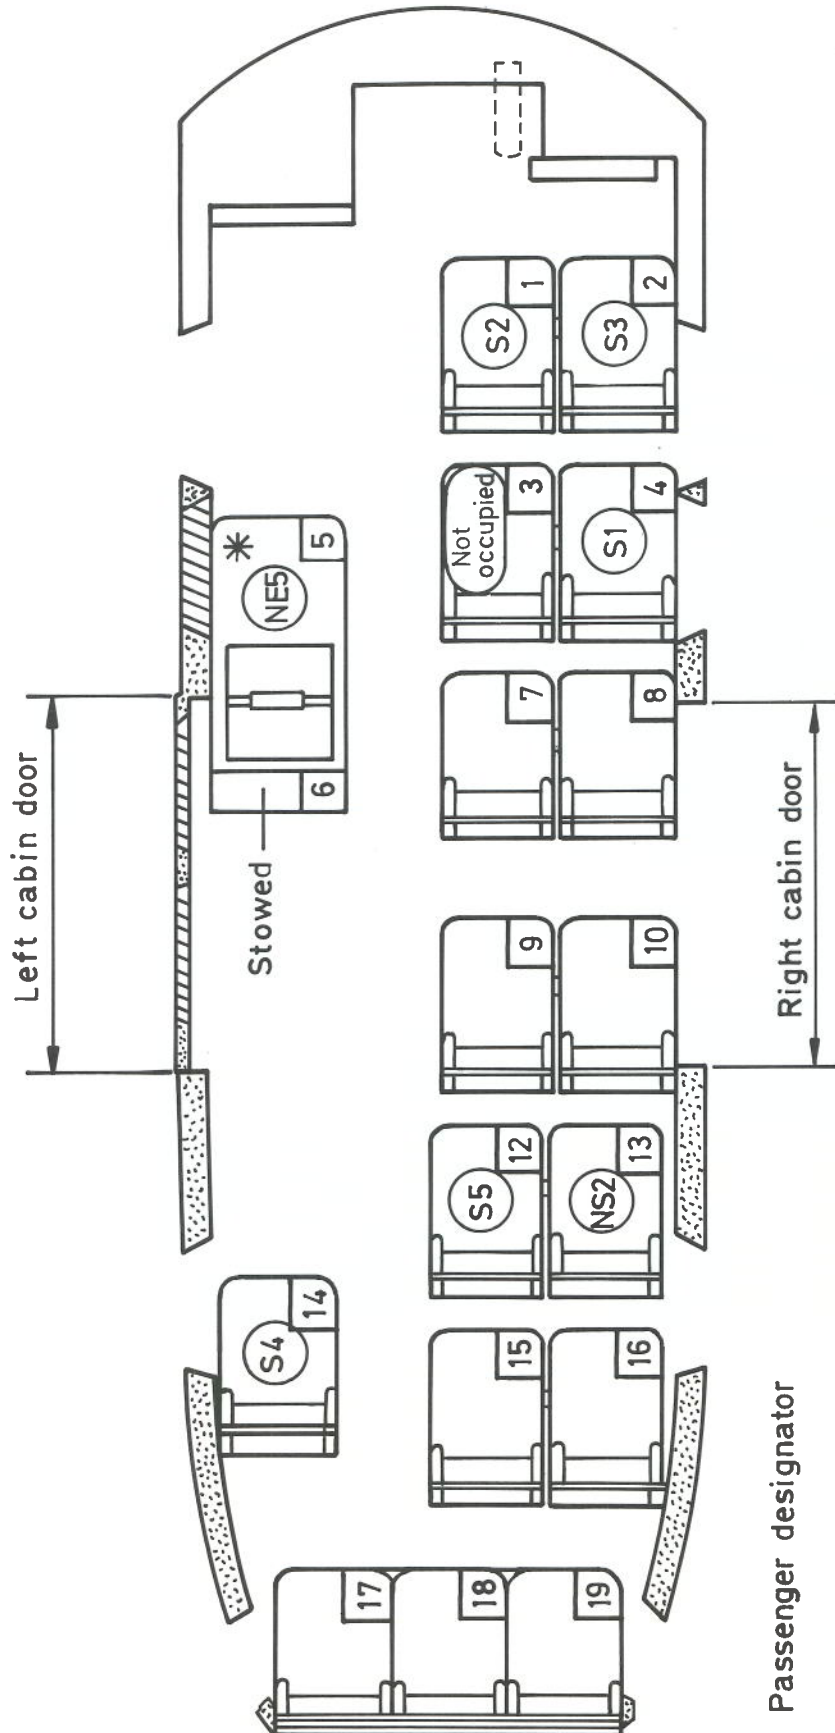
Cabin seating arrangement

S2 and S4 escaped from the left side of the cabin. Shortly after escaping S4 was very close to two other passengers; one, NS3 with whom he linked himself and the other NS4 who was apparently dead. In the conditions prevailing, it would have been unlikely for passengers who had escaped from different sides of the aircraft to have been so close to each other at this early stage, so it is probable that NS3 and NS4 also escaped from the left side.

The body of NE4 was found lying across the rear bench seat. The escape windows either side of this seat have a relatively small aperture and a restriction is imposed on the size of occupants of the seat. The stature of NE4 was considered to be such that it would have been possible for him to pass through the aperture.

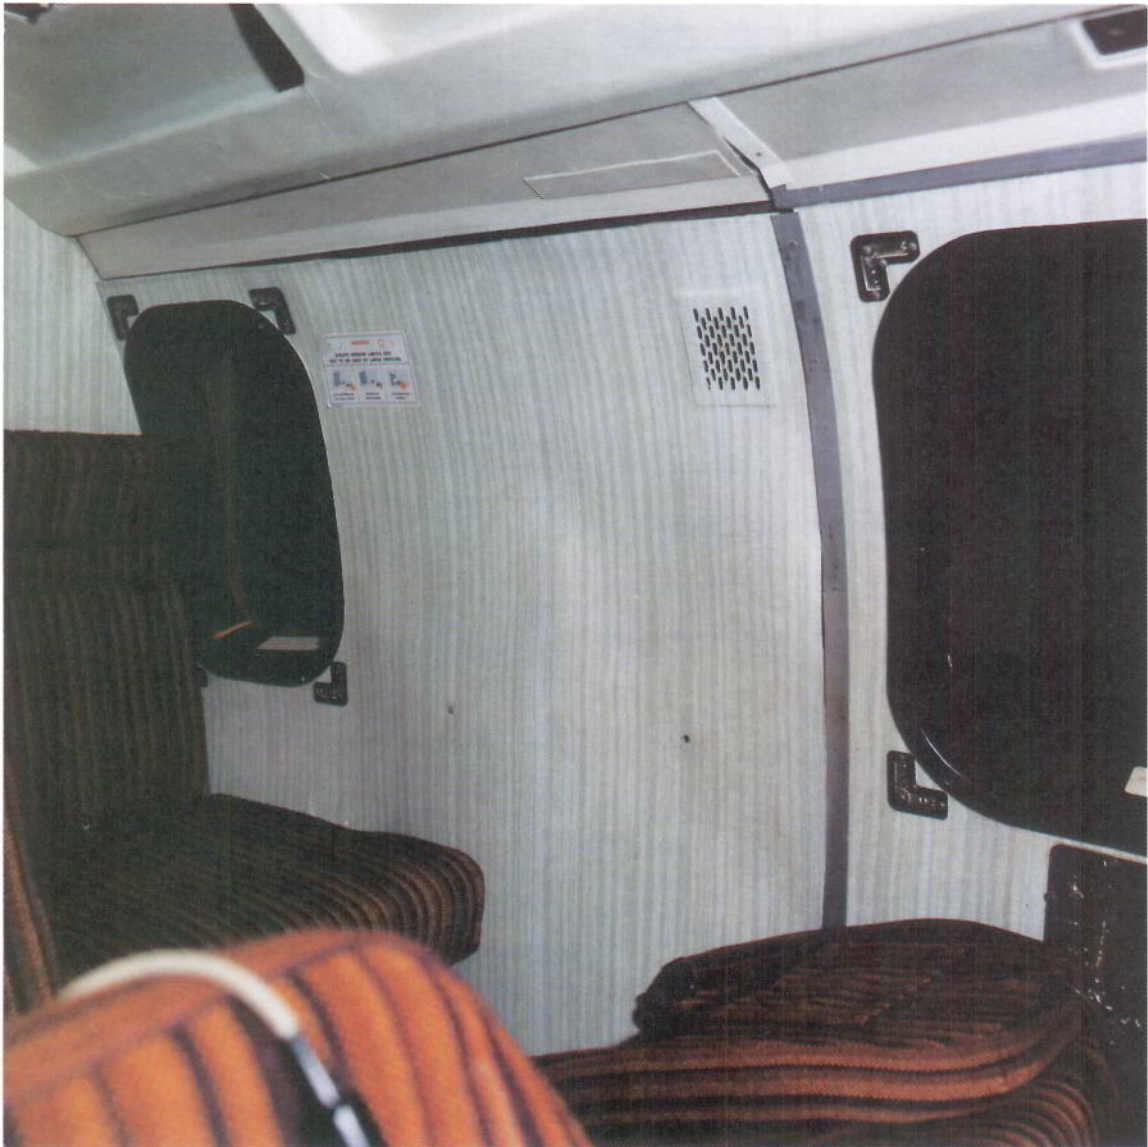
Figure C1

AS 332L 'escape' window EXIS lighting

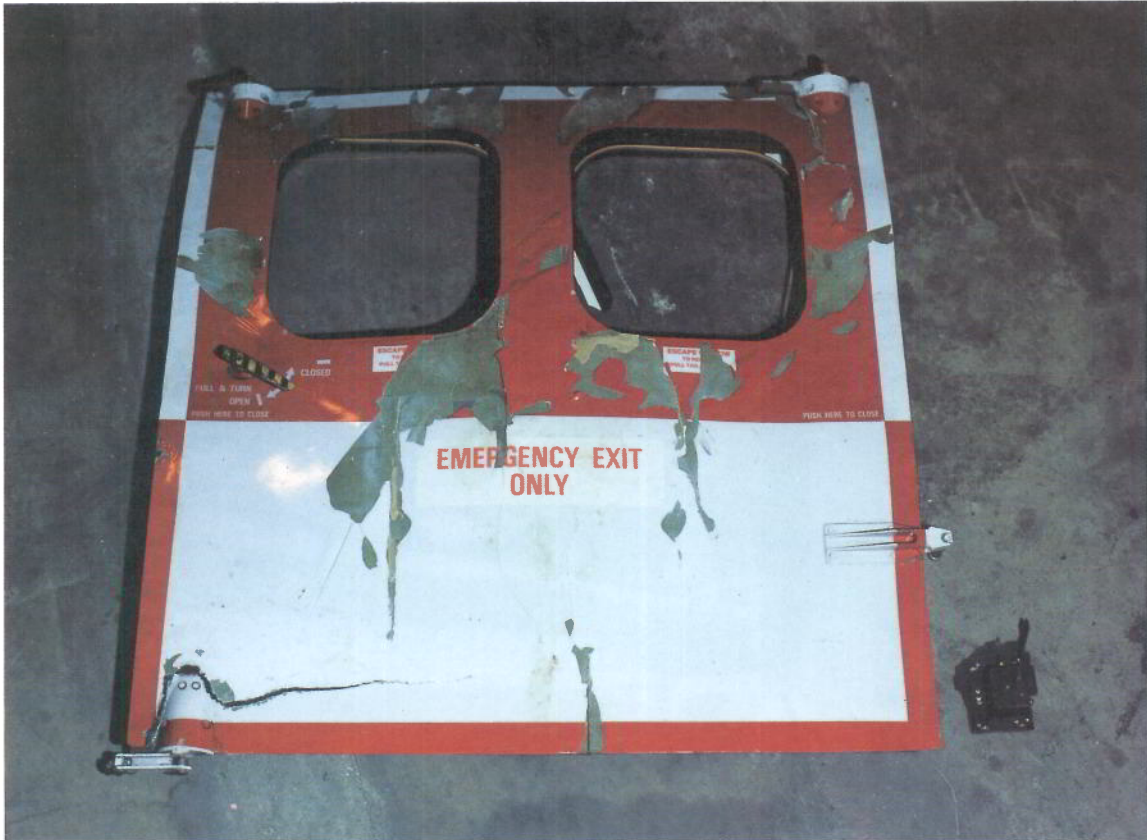
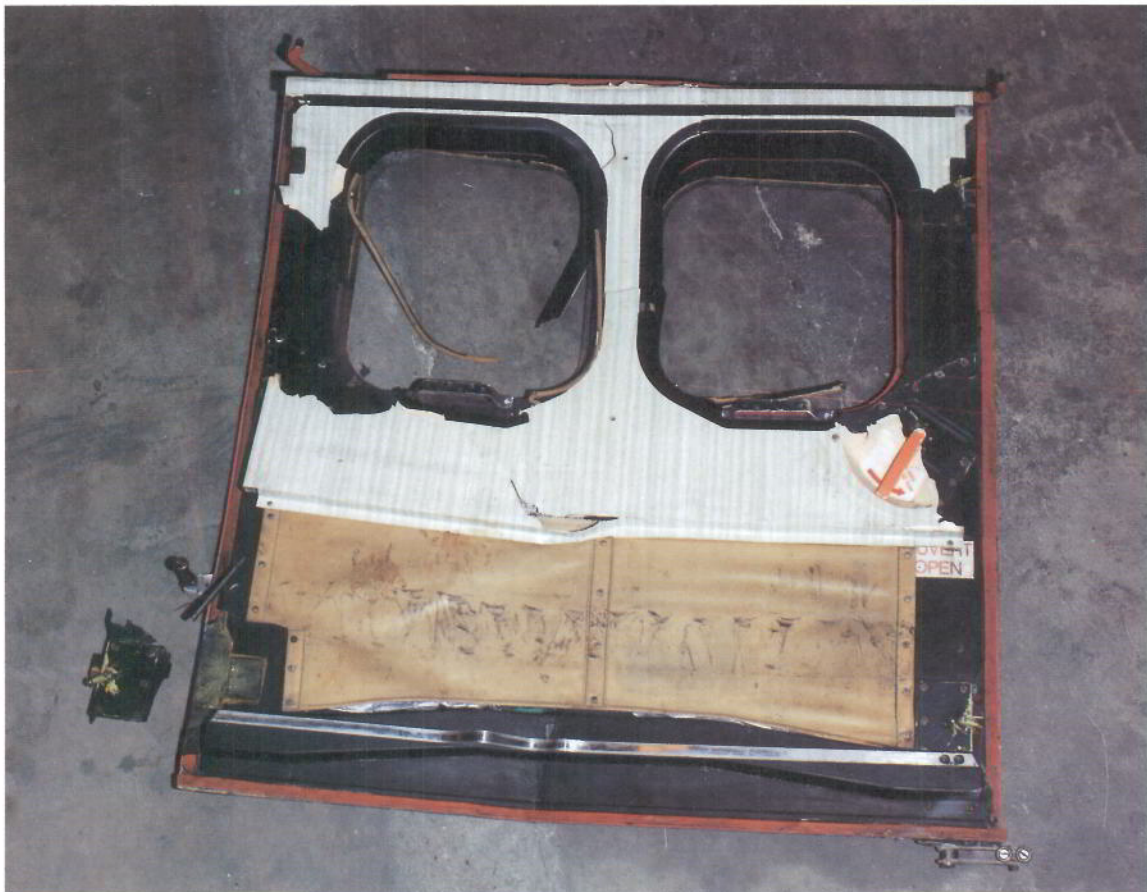
Figure C2
Right cabin door G-TIGH

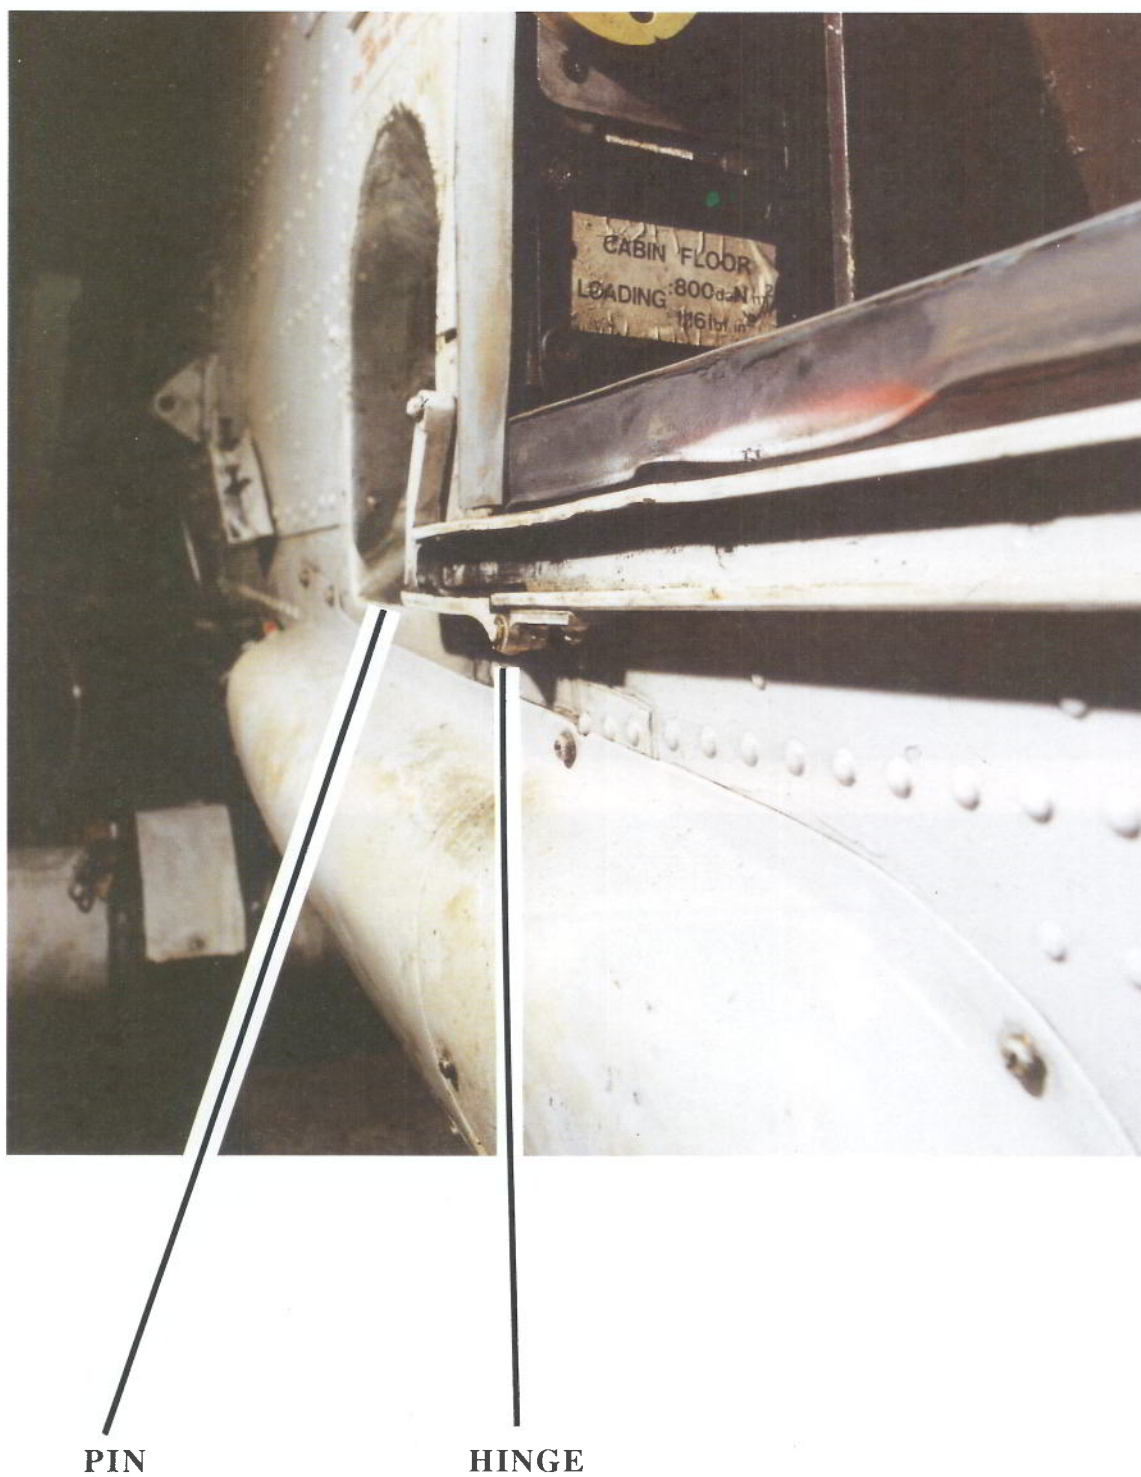
Figure C3

G-TIGH right cabin door, bottom attachment
showing emergency jettison mechanism

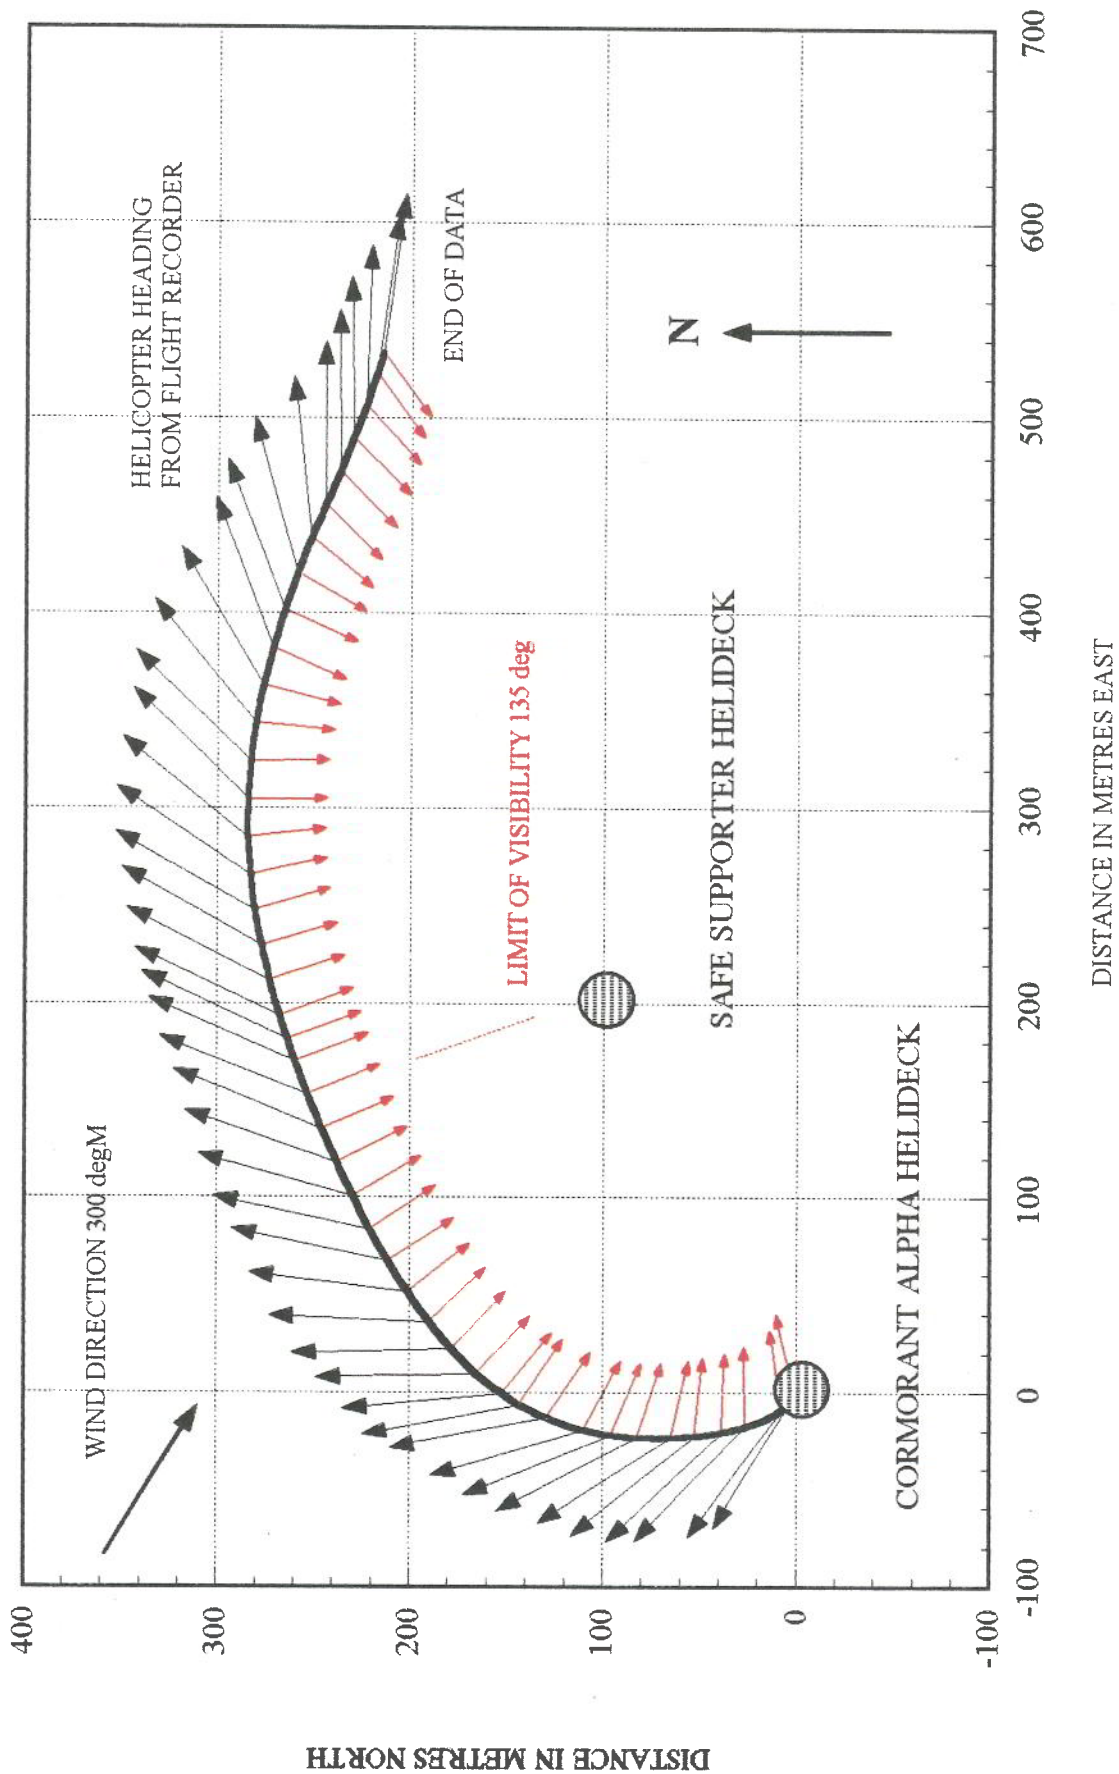
FIG F3 G-TIGH TRACK PLOT SHOWING HEADING AND LIMIT OF VISIBILITY

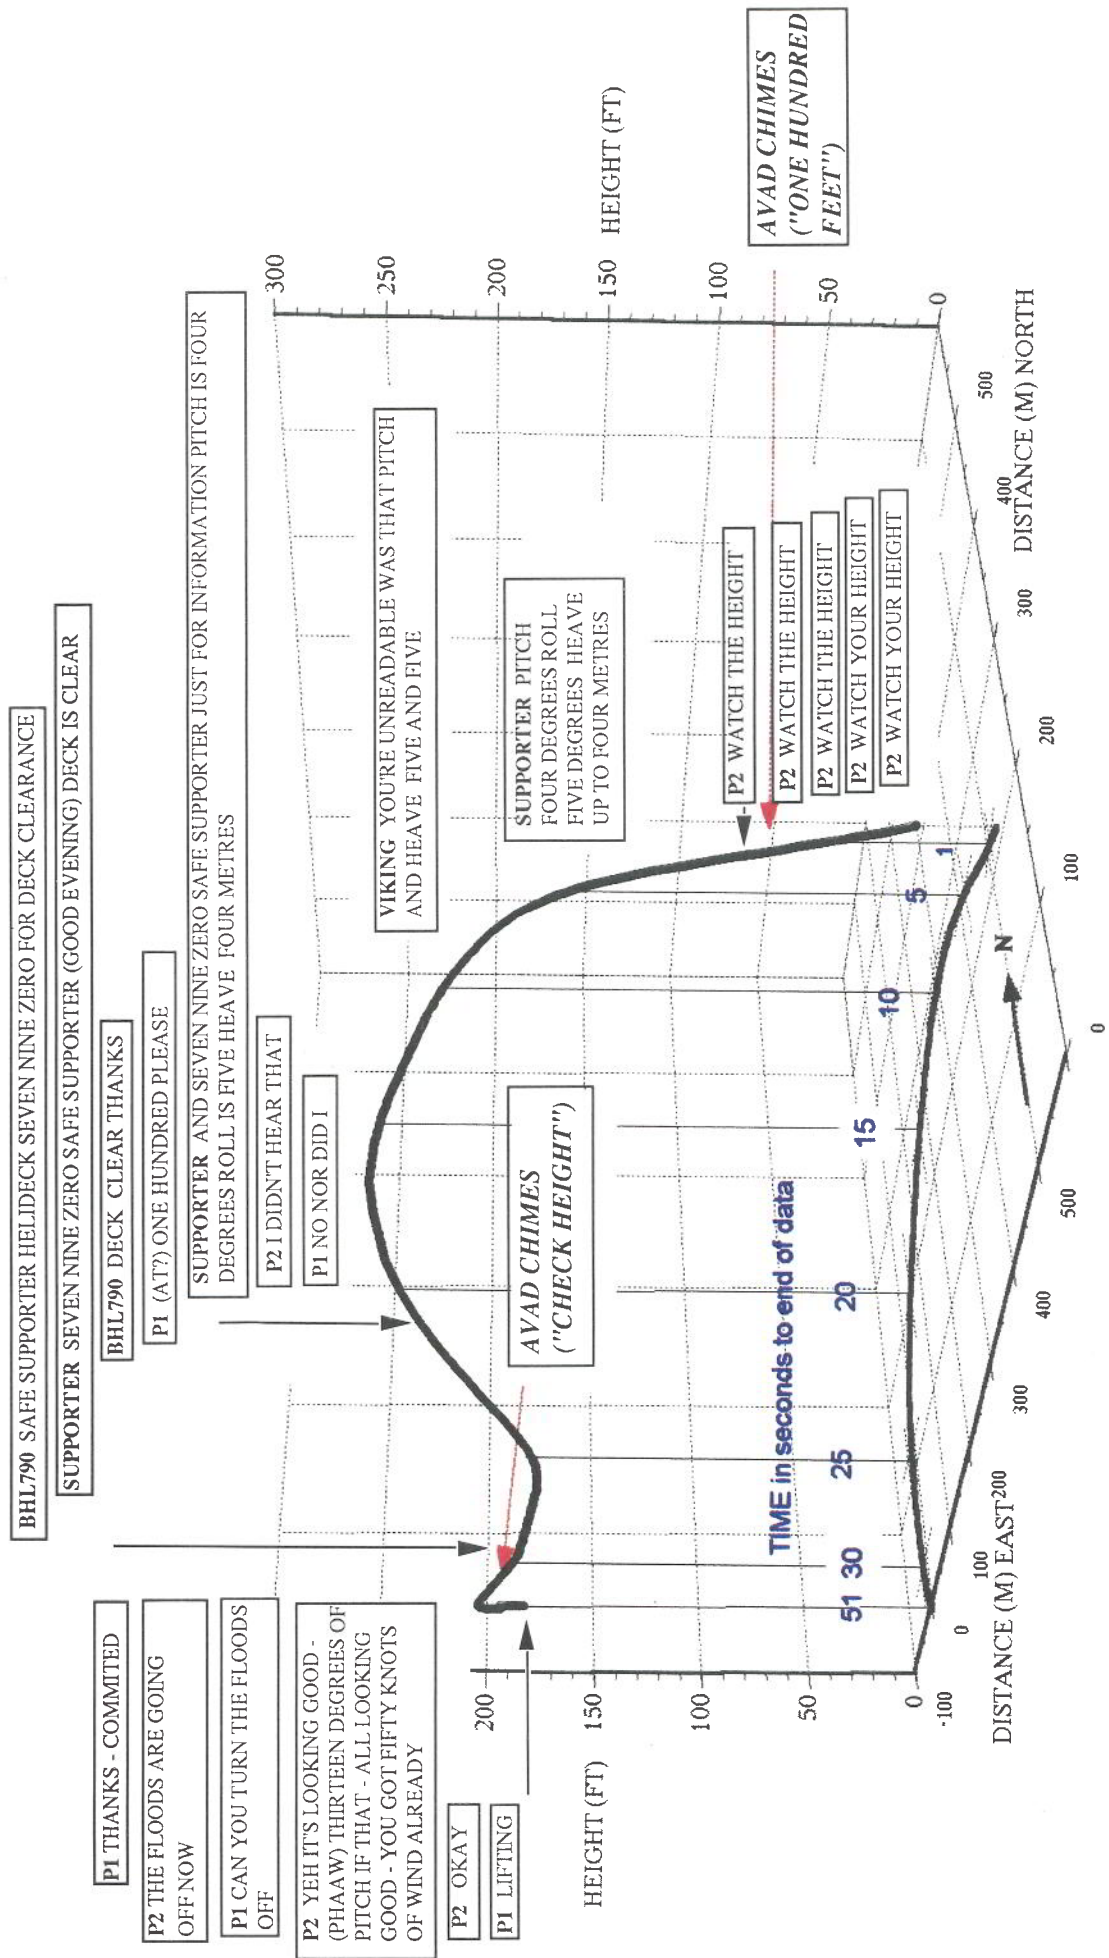
FIG F4 3-D FINAL FLIGHT PATH TRAJECTORY WITH CVR COMMENTS

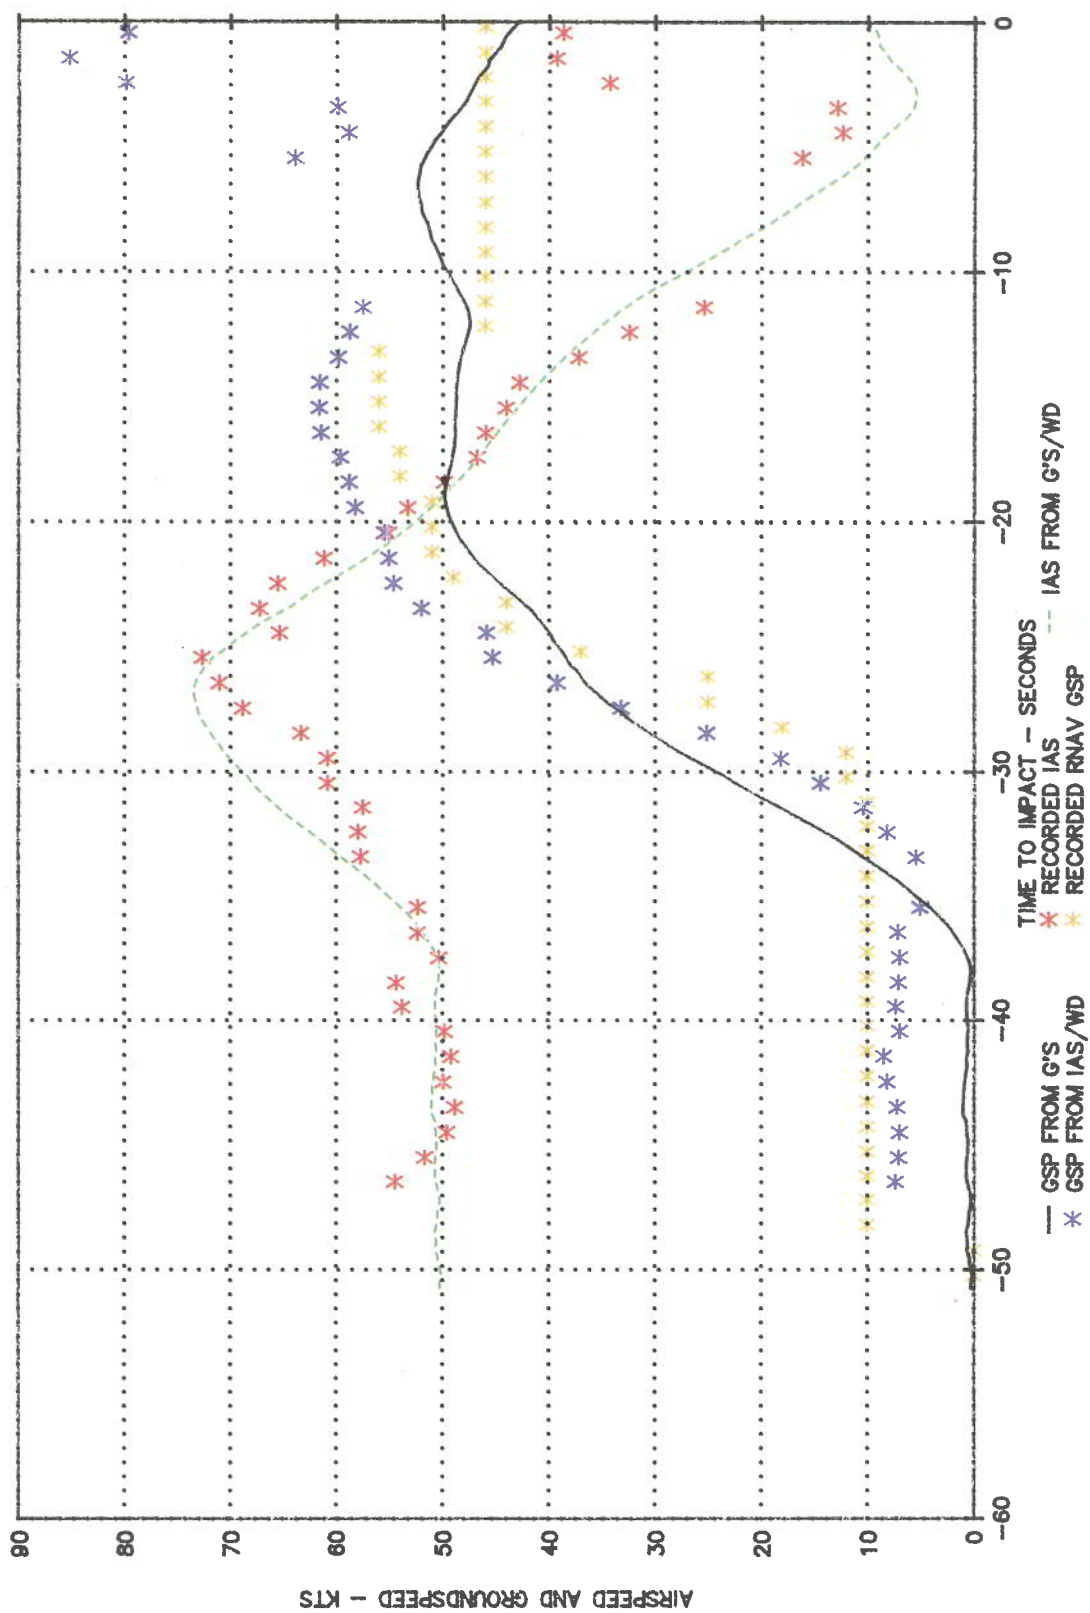
FIG F5 G-TIGH GROUNDSPED & AIRSPEED

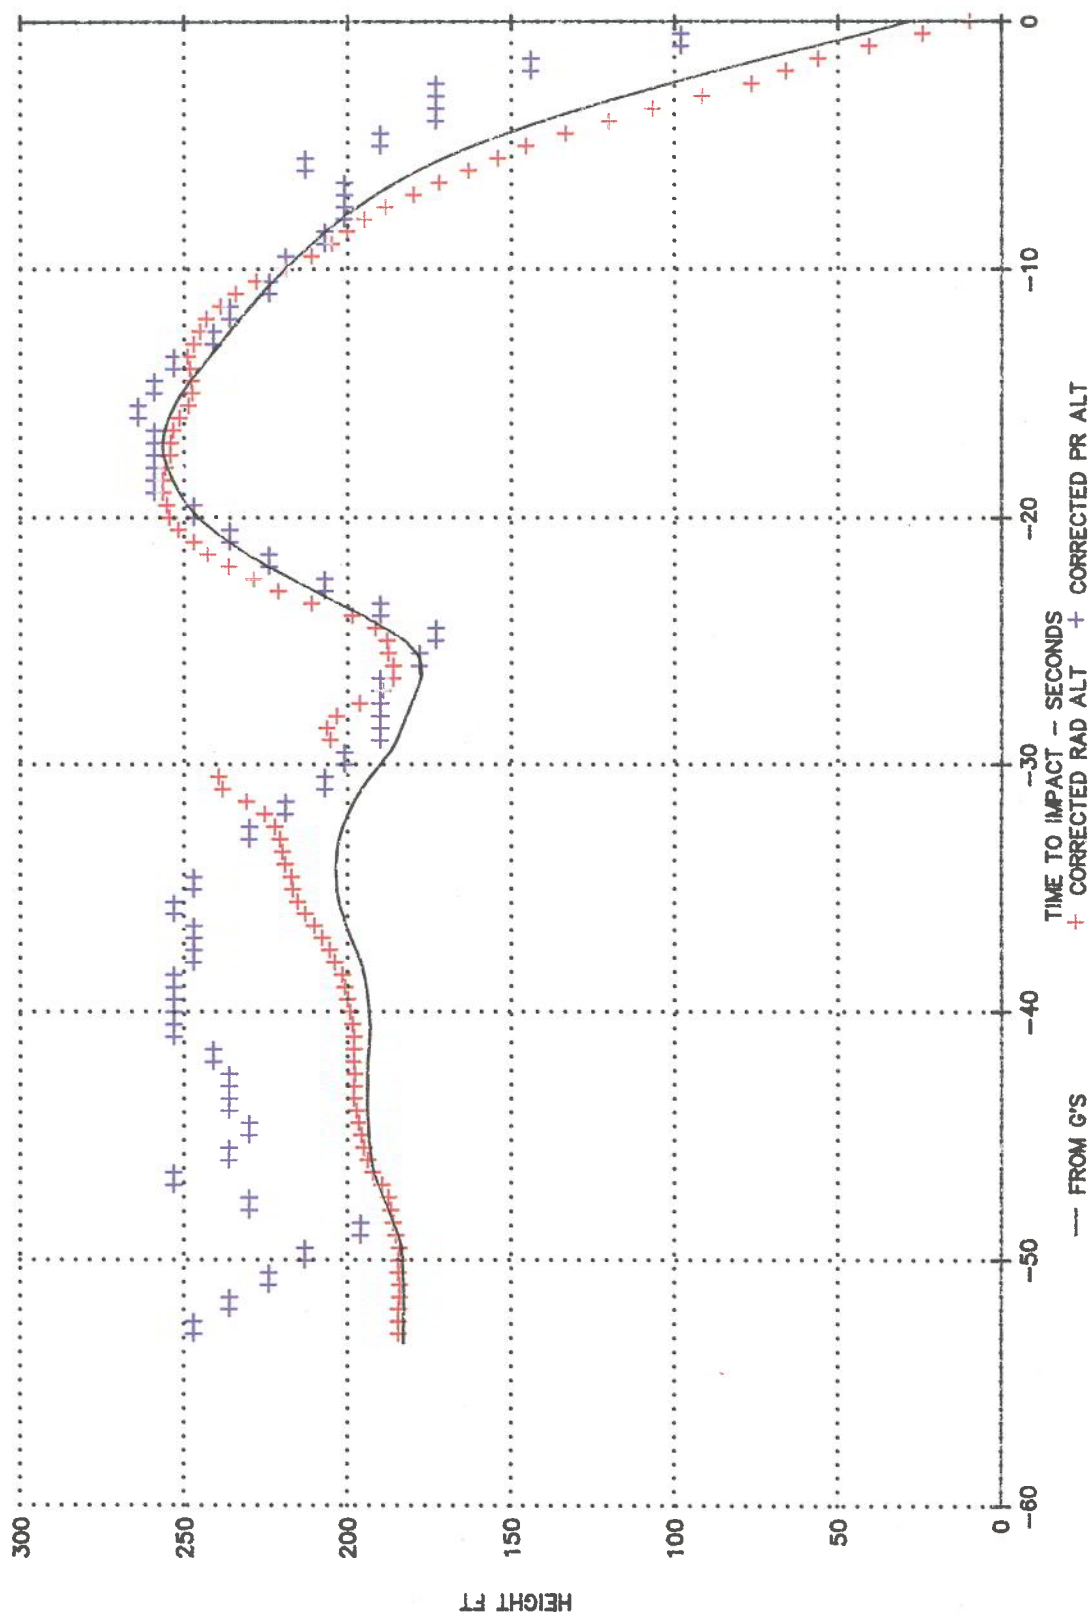
FIG F6 G-TIGH VERTICAL PROFILE

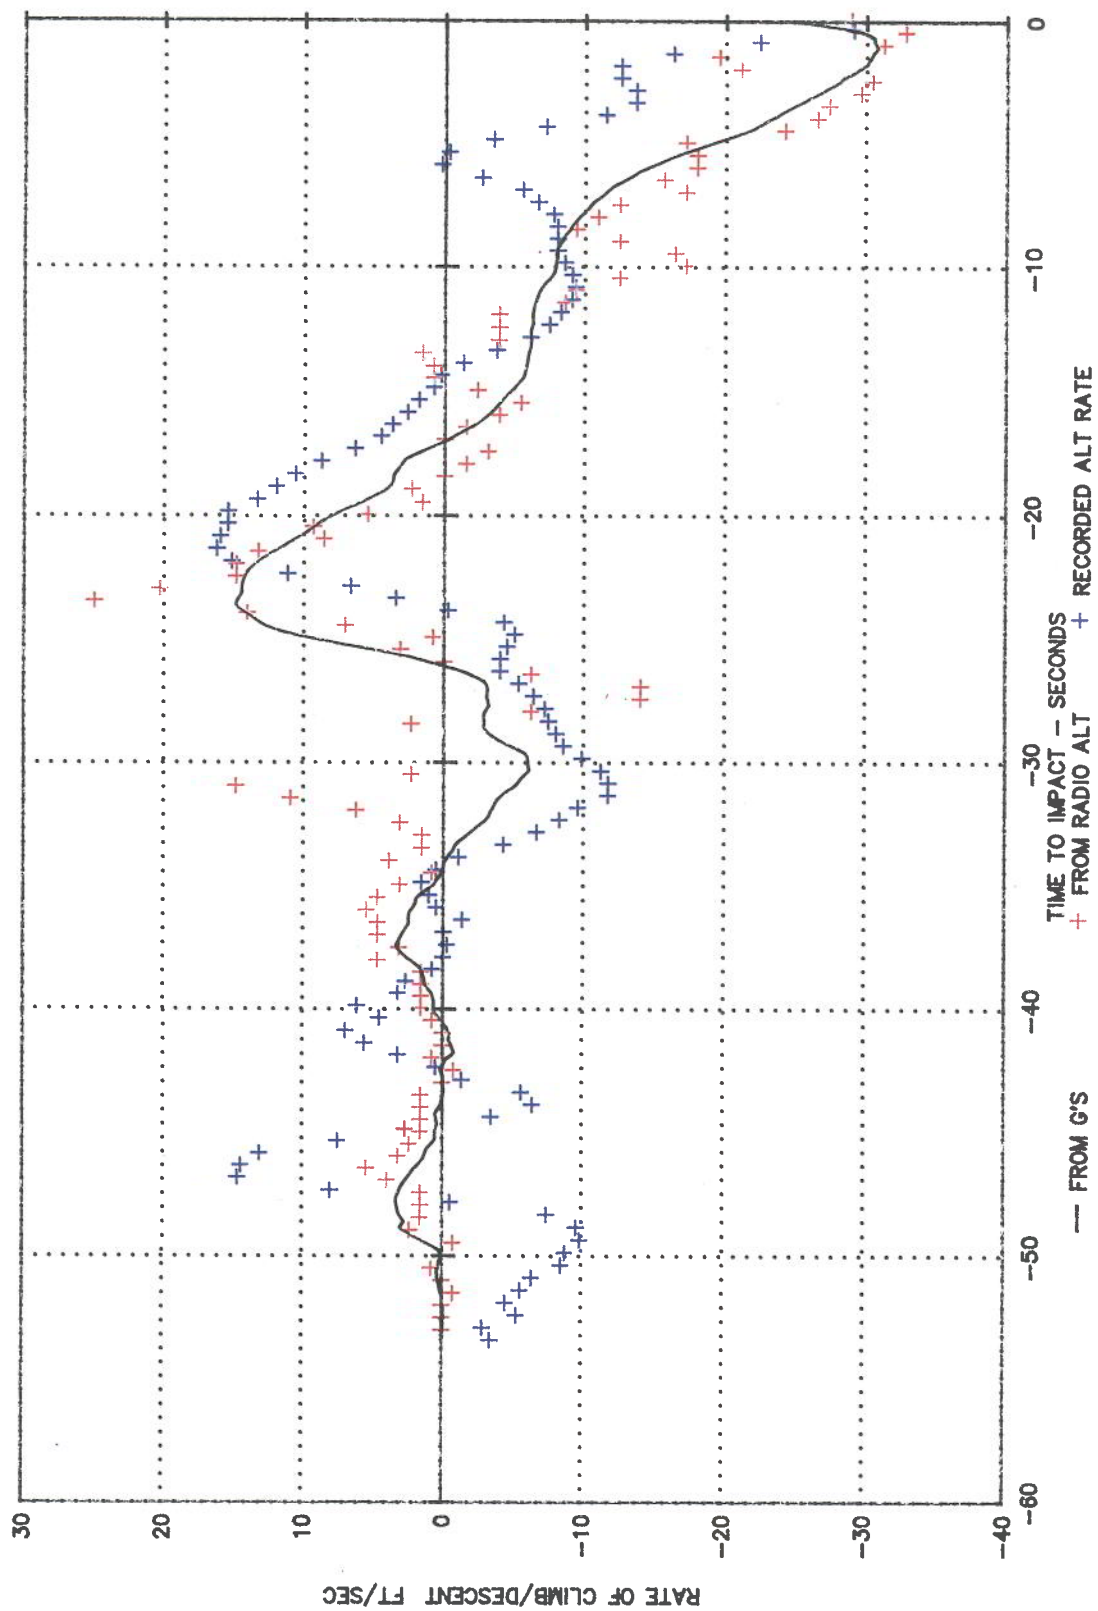
FIG F7 G-TIGH VERTICAL SPEED
