Air Accidents Investigation Branch

**Report on the serious incident to
Boeing 737-3Q8, registration G-THOF
on approach to Runway 26
Bournemouth Airport, Hampshire
on 23 September 2007**

Aircraft Accident Report No: 3/2009 (EW/C2007/09/12)

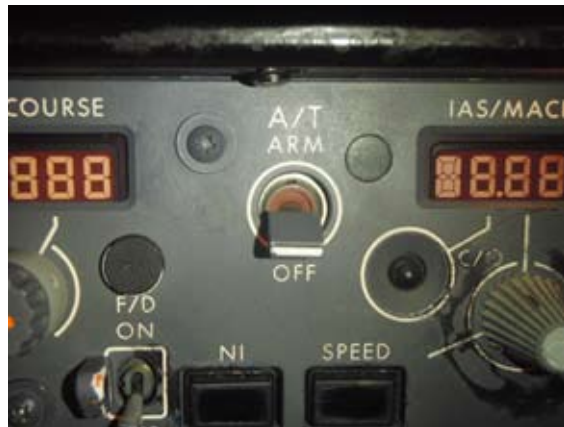
Figure 1

Autothrottle switch

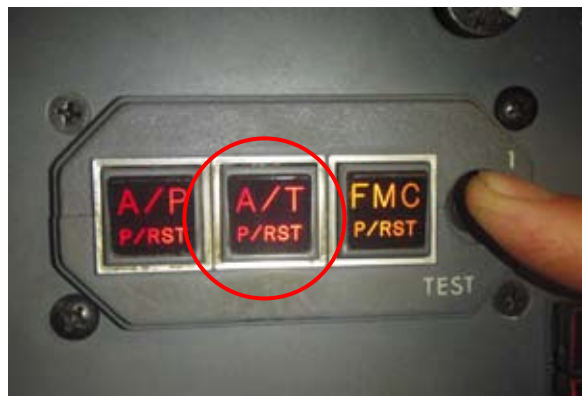
Figure 2

Autothrottle red warning of disengagement

It is recommended that Boeing, in conjunction with the Federal Aviation Administration, conduct a study of the efficacy of the Boeing 737-300/400/500 autothrottle warning system and if necessary take steps to improve crew alerting. (**Safety Recommendation 2009-043**)

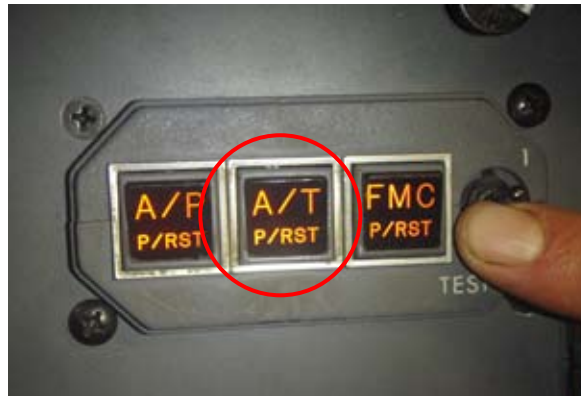
Figure 3

The AT/WARN autoflight status annunciator will illuminate with a flashing amber light (Figure 3) if the autothrottle is not holding the target speed. There are three conditions when this light will flash; the airspeed is 10 kt above the target speed and not decreasing, the airspeed is 5 kt below the target speed and not increasing, or the airspeed has dropped to alpha floor (a factor of 1.3 above the stall speed) during a dual channel autopilot approach. On approach, with the aircraft decelerating, the caption will routinely flash for extended periods.

Autothrottle amber off speed caution

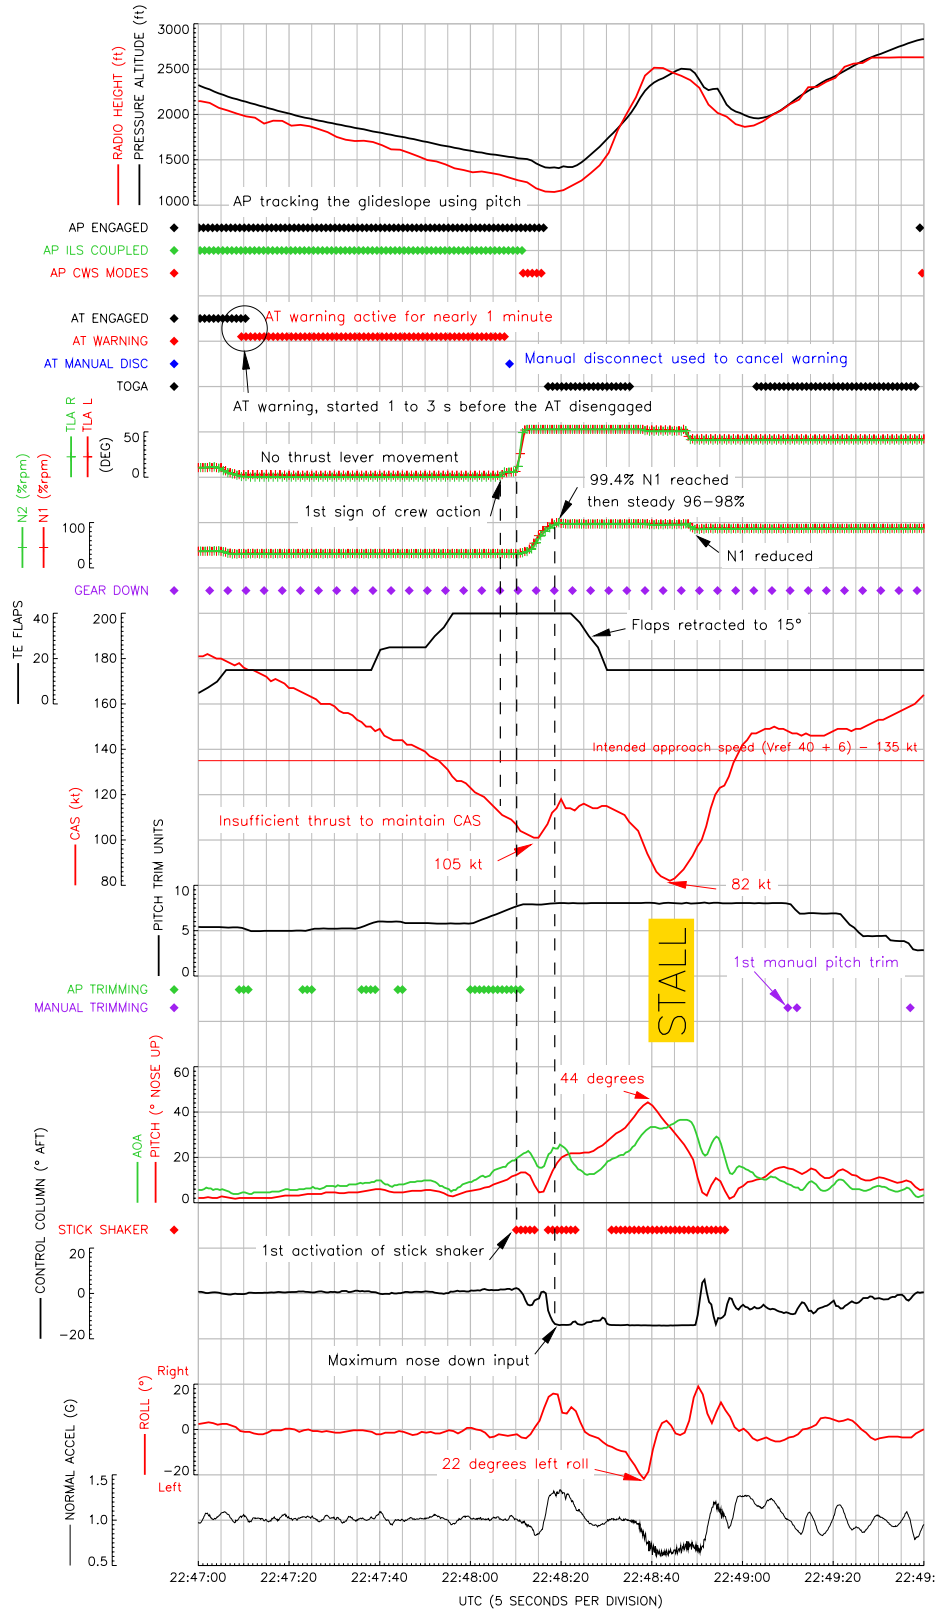
Figure 4

The autopilot remained engaged and continued to track both the localiser and the glideslope. The aircraft's speed decayed at about one knot per second, in line with the PF's expectations for the approach. As the speed decreased below 150 kt, flap 25 was selected. The autopilot tracked the glideslope accurately, gradually increasing the pitch of the aircraft to minimise glideslope deviation and adjusting the stabiliser angle to keep the aircraft in trim. Temporary reductions in pitch were evident during flap position transitions.

The PF increased the illumination of his maplight to check the placard speed for the selection of flap 40, turned his light back to its previous level and called for flap 40. The commander moved the flap lever and the PF then selected 135 kt on the MCP. The commander observed the flaps move to the flap 40 position and then completed the landing checklist by calling "FLAPS". The PF checked the flap gauge showed 40 and responded "FLAP 40 GREEN LIGHT⁵". Recorded data shows the flaps had reached the flap 40 position when the airspeed was 130 kt (Final Approach Speed -5 kt) and the aircraft was slowing at approximately 1.5 kt per second. The commander stowed the checklist on top of the instrument panel and when he looked down he saw an IAS of 125 kt. He called "SPEED", the PF made a small forward movement with the thrust levers and the commander called "I HAVE CONTROL". The commander moved the thrust levers fully forward and called "GO-AROUND FLAP 15 CHECK THRUST".

Quick Access Recorder data depicting the accident

13. The thrust levers remained at full thrust for 26 seconds and N_1 exceeded the target N_1 for 31 seconds.
14. The flaps retraction did not materially affect the event.
15. The stall recovery techniques recommended in the manufacturer's Flight Crew Training Manual (FCTM) were not fully applied.
16. Forward trim was not used during the stall recovery.
17. A reduction in thrust lever position to a go-around (GA) thrust setting occurred 40 seconds after the go-around was initiated, which allowed sufficient nose-down elevator authority to control the pitch-up couple.
18. The speeds and pitch angles were outside the flight test envelope and outside the validated flight modelling envelope.

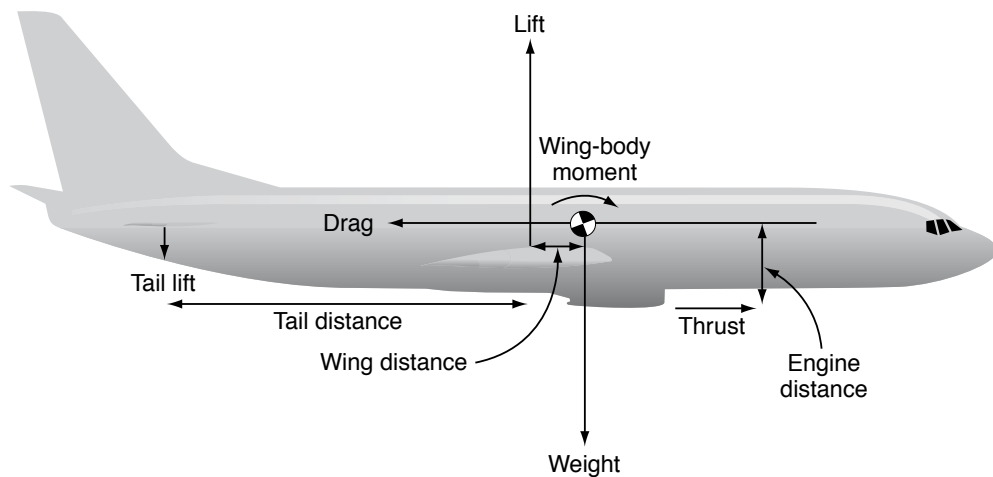
Turbofan aircraft with underslung engines will tend to pitch nose-up as the thrust is increased as the thrust line is below the centre of gravity of the aircraft. Conversely, as power is reduced the aircraft will pitch nose-down.

The application of go-around thrust on the Boeing 737-300 will cause a nose-up pitching moment. This is counteracted by applying nose-down elevator. The stabiliser on the Boeing 737, as is common on large transport aircraft, is a moveable surface, the position of which is selected by the trim system. When the autopilot is engaged it automatically trims the aircraft for the present speed using the stabiliser. As the aircraft decelerates, the autopilot applies more nose-up trim to keep the aircraft in a trimmed state. However as the elevator is attached to the trailing edge of the stabiliser, this increasing trim effectively reduces the amount of pitch authority available. The size of the elevator is carefully calculated to be as small as possible while still giving sufficient control authority at go-around thrust.
