INCIDENT

Aircraft Type and Registration:	Boeing 747-436, G-BNLG	
No & Type of Engines:	4 Rolls-Royce RB211-524G turbofan engines	
Year of Manufacture:	1989	
Date & Time (UTC):	20 February 2005	
Location:	En route from Los Angeles International Airport to London (Heathrow) International Airport	
Type of Flight:	Public Transport (Passenger)	
Persons on Board:	Crew - 18	Passengers - 352
Injuries:	Crew - None	Passengers - None
Nature of Damage:	Major damage to No 2 engine	
Commander's Licence:	Airline Transport Pilot's Licence	
Commander's Age:	48 years	
Commander's Flying Experience:	12,680 hours (of which 1,855 were on type) Last 90 days - 212 hours Last 28 days - 75 hours	
Information Source:	AAIB Field Investigation

Synopsis

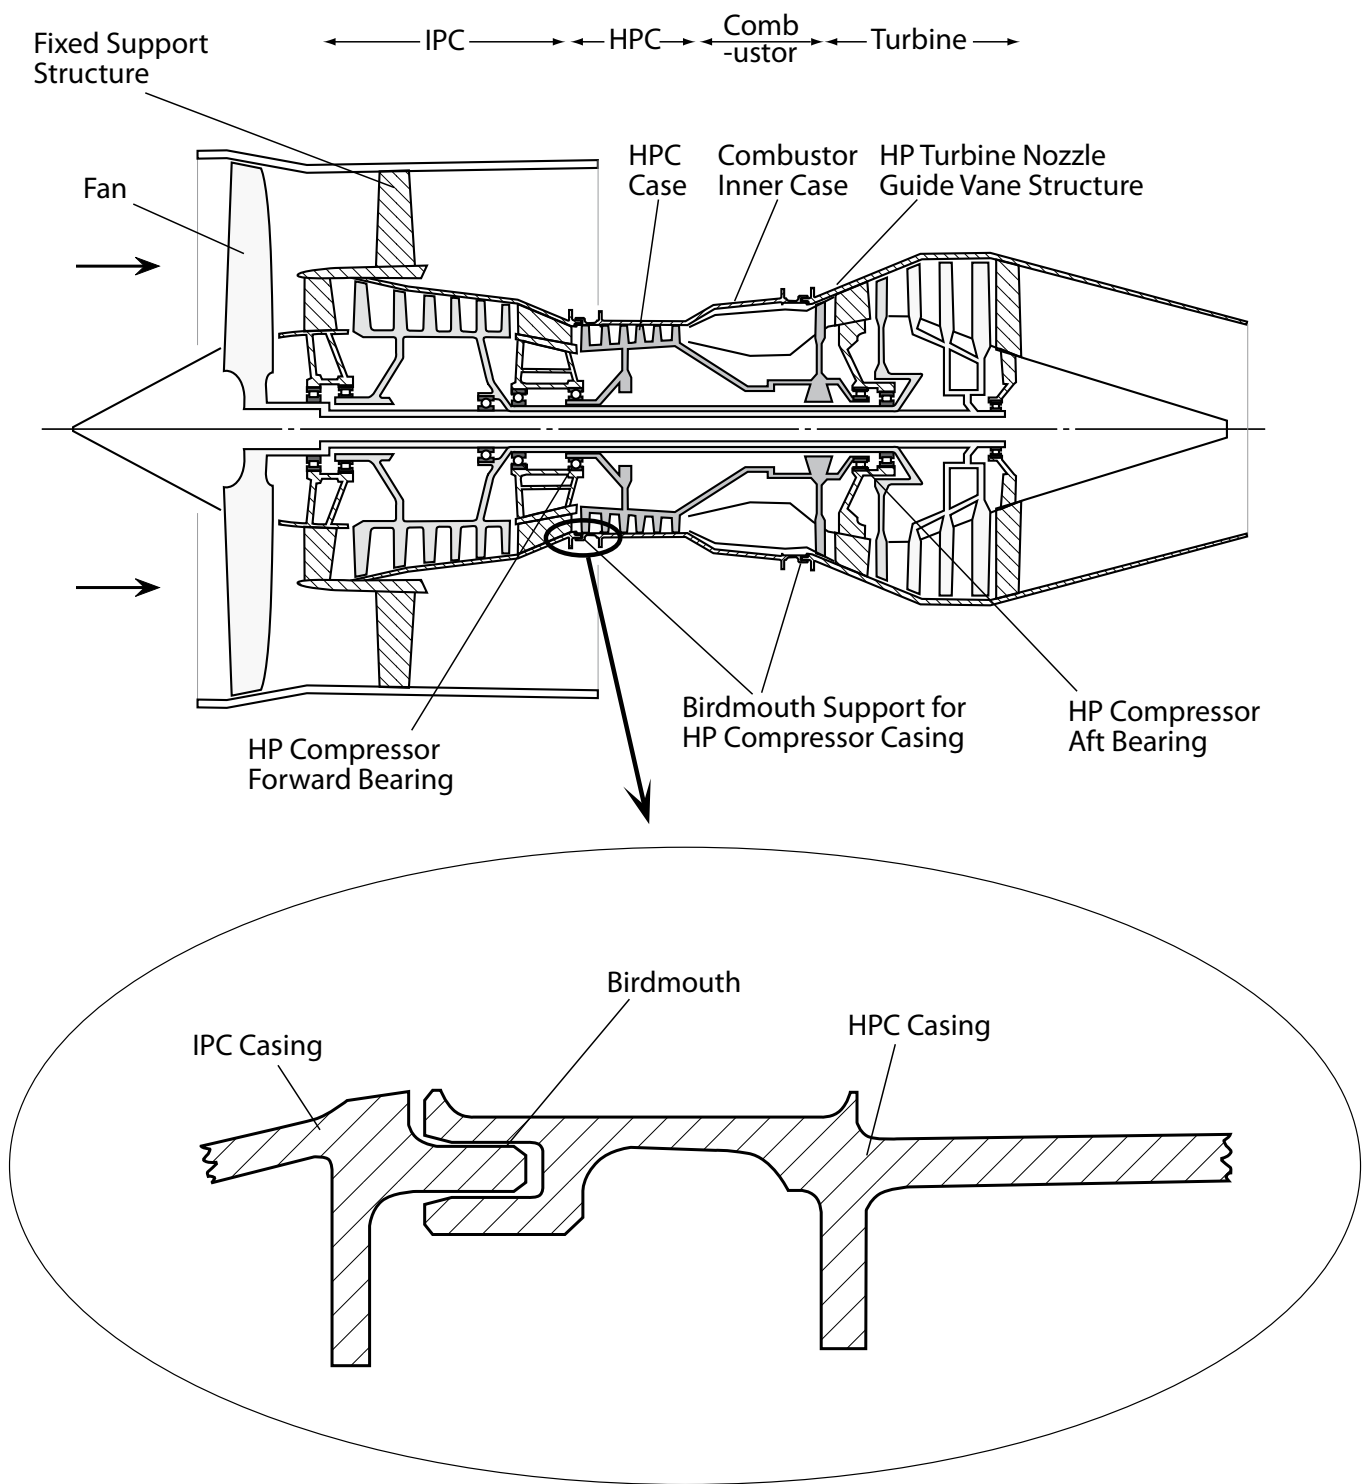
Figure 1
Engine HP Compressor Support Arrangement

Rotor blade tip clearance can be affected by wear of the HPC casing birdmouth feature. Excessive wear allows the forward end of the HPC casing to displace radially downwards, thereby increasing blade tip clearances over the lower half of the compressor and causing the rotor blades to contact the liner over the upper part and erode, further increasing the lower clearances. Experience has shown that where this has led to a compressor stall and engine surge the HPC tip clearance has increased to around 0.020-0.040 inch, with the engine typically having accumulated in the order of 3,500 cycles. Commonly, where the clearances have become excessive, a stall will occur when power is increased in reverse thrust. Information suggested that this may have been used as an indicator that repair was required. Two previous cases of RB211 in flight shut downs (IFSDs) due to surge resulting from HPC birdmouth wear had been reported, on RB211-524G-T and 524H-T type engines.

It was clear from the evidence found during the investigation that the initial No 2 engine problem had been a surge. The degree of wear found to the front of the HPC casing birdmouth locating ring allowed radial displacement of the front of the HPC casing that would have increased the HPC rotor blade tip clearance and thus eroded the normal compressor stall margin. The further increase in clearance, that was a consequence of the loading and thermal effects when engine power was advanced, was predicted to peak around 50 seconds after setting take-off power. The surge that occurred just after G-BNLG took off was consistent with the effects of a compressor stall induced by the increase in HPC tip clearance from these combined effects.

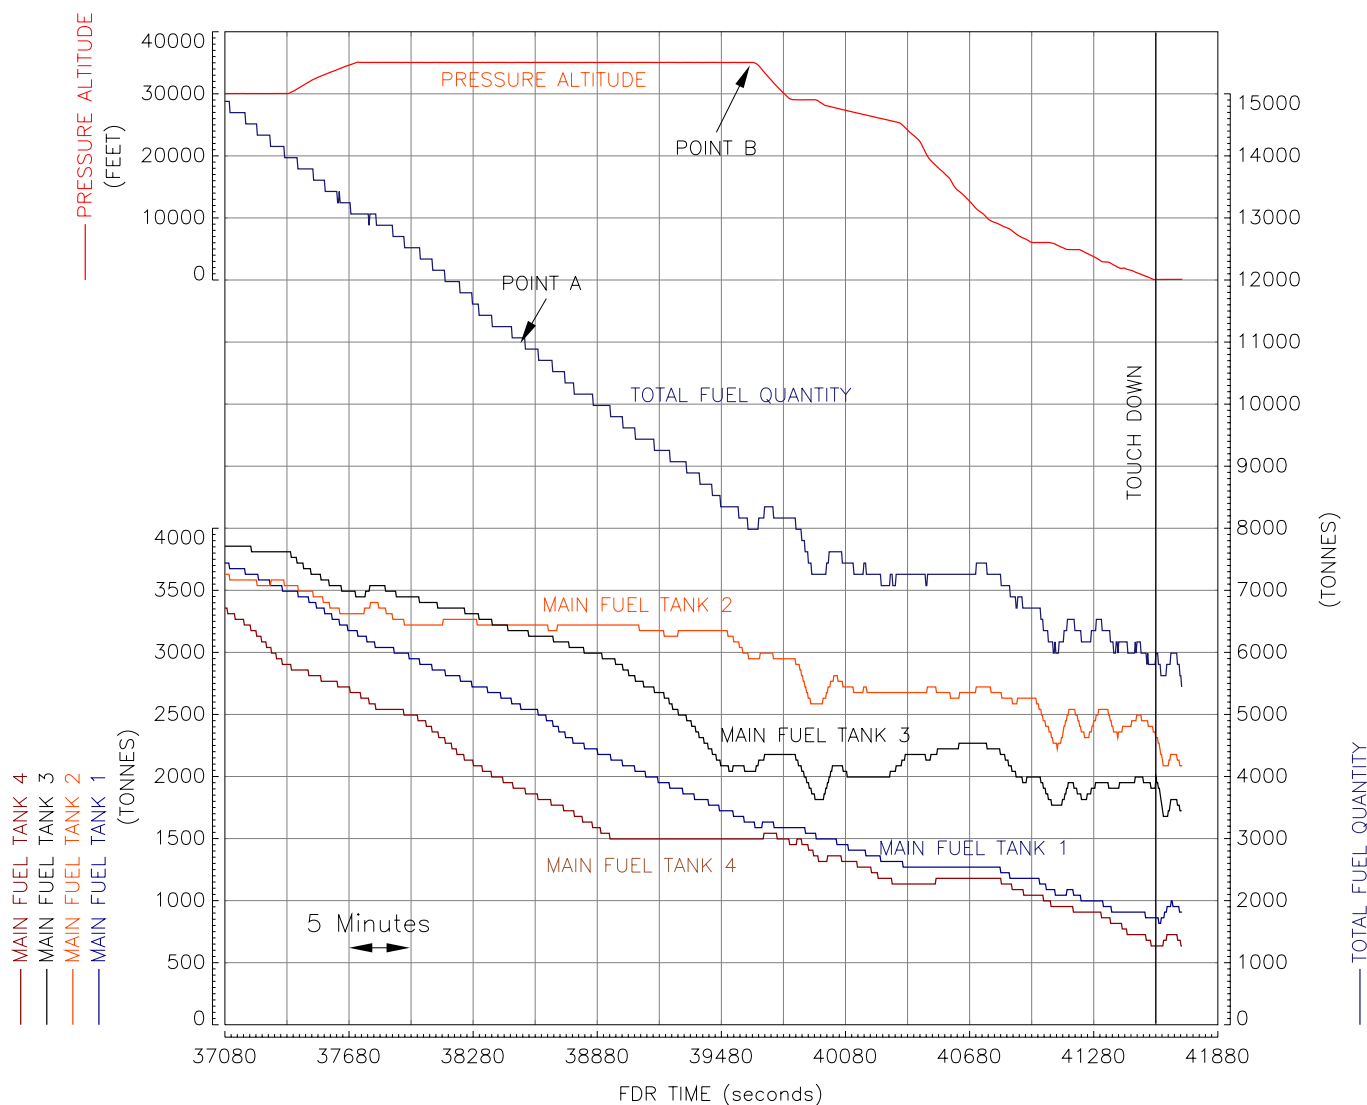
Figure 4
 Salient FDR Parameters
 (Incident to G-BLNG on 20 February 2005)

The main tank fuel quantities prior to the top of descent until the landing are depicted in Figure 4. At 1513 hrs (Figure 4, point A) whilst at FL350, the total fuel quantity was 11 tonnes. The stabiliser, and both reserve fuel tank quantities were at zero with the centre tank at 0.2 tonnes and the main fuel tank quantities for No 1 to No 4 tanks were: 2.6 tonnes, 3.2 tonnes, 3.1 tonnes and 1.9 tonnes respectively. At 1532 hrs (Figure 4, point B), with a total fuel quantity of 8.1 tonnes, a descent to FL290 was initiated; this altitude was maintained until 1537 hrs when the final descent was commenced.

Touchdown occurred at 1604 hrs when the total fuel quantity was 5.8 tonnes. The fuel distribution across the No 1 to No 4 main fuel tanks was: 0.9 tonnes, 2.4 tonnes, 1.9 tonnes and 0.6 tonnes respectively. The FDR stopped recording at 1617 hrs when the aircraft was shutdown.
