SERIOUS INCIDENT

Aircraft Type and Registration:	Boeing 747-4H6, 9M-MPL	
No & Type of Engines:	4 Pratt & Whitney PW4056-3	
Year of Manufacture:	1998	
Date & Time (UTC):	17 August 2012 at 2320 hrs	
Location:	On approach to Runway 09R at London Heathrow Airport	
Type of Flight:	Commercial Air Transport (Passenger)	
Persons on Board:	Crew - 22	Passengers - 340
Injuries:	Crew - None	Passengers - None
Nature of Damage:	Electrical failures, hard landing and component failure to No 2 engine	
Commander's Licence:	ATPL	
Commander's Age:	40 years	
Commander's Flying Experience:	10,753 hours (of which 393 were on type) Last 90 days - 80 hours Last 28 days - 11 hours	
Information Source:	AAIB Field Investigation

Synopsis

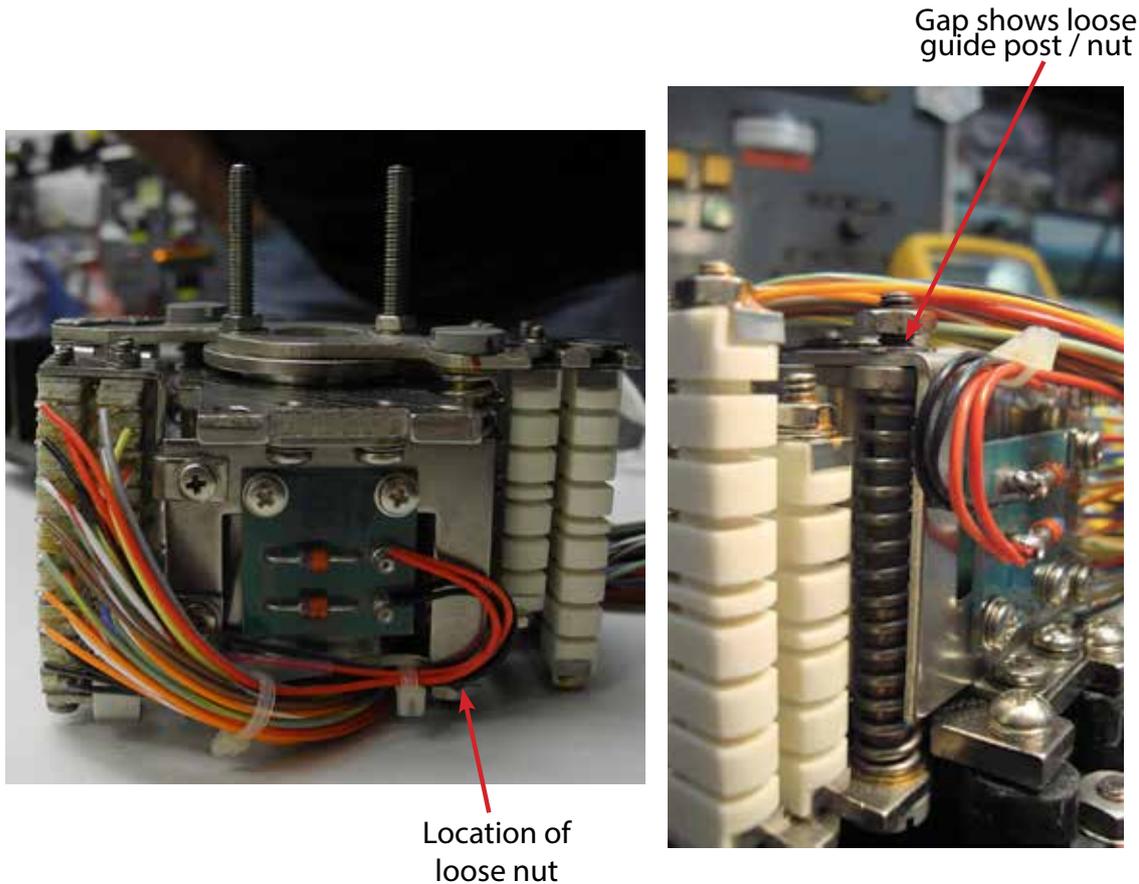
Figure 9
BTB loose guide post nut

After removal of the BTB outer housing, a nut on one of the armature guide posts was found not properly secured, causing the armature to be misaligned (Figure 9). Loctite⁹ was evident on the nut and threads of the guide post, in accordance with the design.

The lock washers on both guide posts had been compressed, as designed, when the nuts were tightened. This suggests either that the nut had backed off over time, perhaps due to airframe vibration, or that the contactor had been disassembled at some point after original assembly. The BTB manufacturer was not aware of any previous cases of the guide post nut loosening in service. The manufacturing drawing did not specify a torque requirement for the nut.

Examination of the main contacts revealed that they exhibited very little wear for a unit of its age (14 years), although there were indications that the contacts had been filed or buffed at some point after manufacture. BTB 3 had been installed on the aircraft since delivery and the component history records indicated that it had never been removed or overhauled.

The loose nut on the BTB 3 guide post allowed the armature to tilt as it moved, causing greater travel on one side than the other. As all of the BTB contacts are transitioned by a single movement of the armature, this defect meant that the correct transition of all of the contacts could not be assured. Tests demonstrated that the BTB could fail in a variety of intermediate states, corresponding to neither the closed nor the tripped state. It was not possible to predict reliably which contacts would correctly transition each time the BTB was commanded to change state. The precise effects on the aircraft electrical system might therefore differ each time the BTB was operated.

After tightening the loose nut and replacing the washers, the contactor operated correctly.

It is recommended that Boeing Commercial Airplanes notify all B747-400 and B747-8 operators of the characteristics of the bus tie breaker mechanical failure on 9M-MPL and nuisance difference current protection trips, emphasising the maintenance actions required if repetitive difference current protection trips occur.

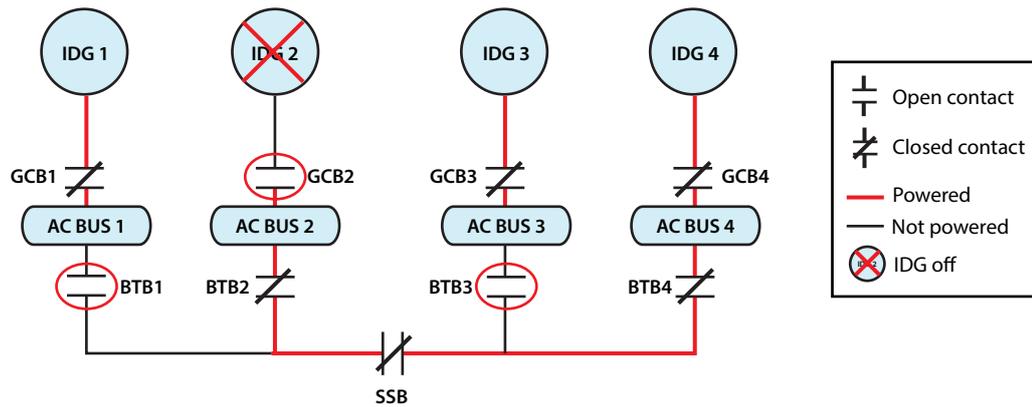
Figure 10

When all three autopilots were engaged to perform an autoland at 2301:55 hrs, the autoland request was sent to the BCUs by the FCCs and the electrical system automatically reconfigured to provide three independent channels for each of the FCCs. This was achieved by BTB 1 and 3 tripping to isolate AC Bus 1 and AC Bus 3; BTB 2 and 4 remained closed so that AC Bus 2 was powered by IDG 4 via the sync bus (Figure 10).

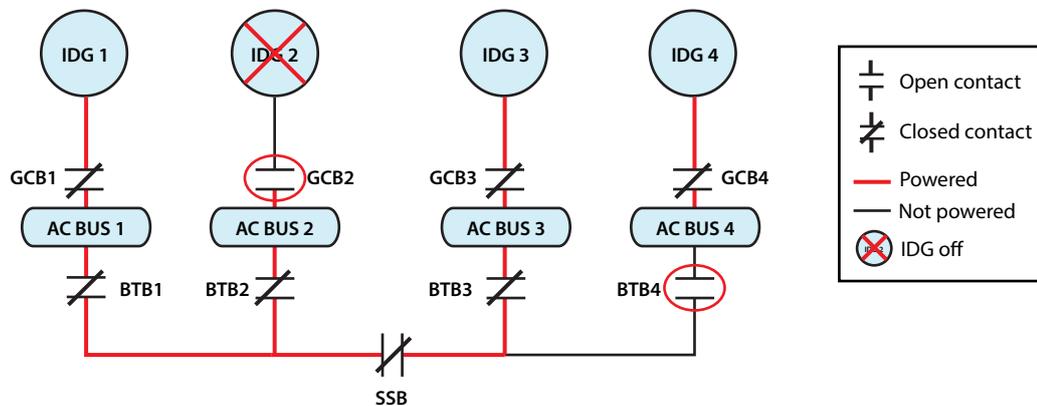
Figure 11

Eleven seconds later, BTB 4 tripped because Difference Current Protection isolated AC Bus 4 from the sync bus. Momentary power interruptions to AC Bus 2 and the First Officer's Transfer Bus were recorded. As three independent power supplies could no longer be assured the autoland operation was cancelled, indicated by the 'BUS CONTROL UNIT / FCC-C FAIL' and 'BUS CONTROL UNIT / FCC-L FAIL' faults. BTB 1 and 3 were commanded to return to their previous position and AC Bus 2 then became re-powered (Figure 11).

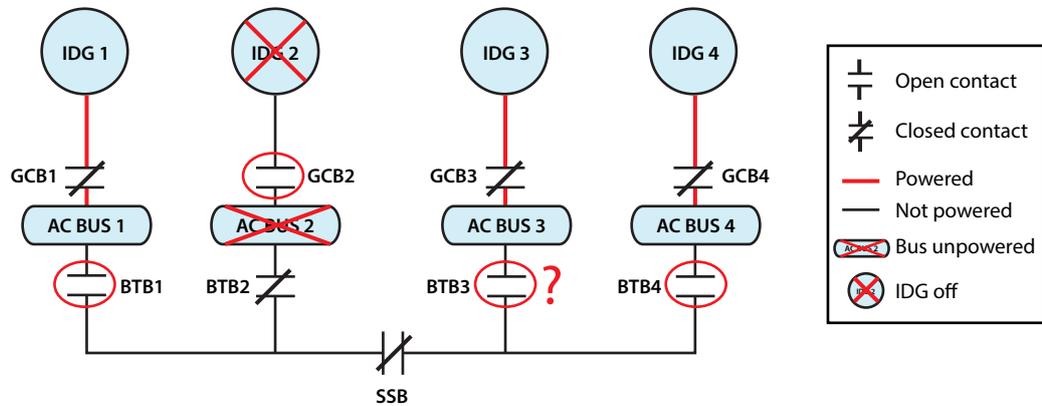
Figure 12

This configuration was sustained for a further three minutes until 2305 hrs, when BTB 1 also tripped due to Difference Current Protection, isolating AC Bus 1. DFDR and CMC data showed that power to AC Bus 2 was lost at this point. AC Bus 2 should still have received power from IDG 3 via BTB 3 but the loss of AC Bus 2 indicates that BTB 3 did

not successfully close and re-parallel to the sync bus when commanded (Figure 12). It is therefore likely that the mechanical failure of BTB 3 prevented some or all of its main contacts from re-closing, leaving it in an intermediate state.
