SERIOUS INCIDENT

Aircraft Type and Registration:	Britten-Norman BN2A-26, Islander, VP-MON	
No & Type of Engines:	2 Lycoming O540 piston engines	
Year of Manufacture:	1969	
Date & Time (UTC):	22 May 2011 at 2154 ¹ hrs	
Location:	John A Osborne Airport, Montserrat	
Type of Flight:	Commercial Air Transport (Passenger)	
Persons on Board:	Crew - 1	Passengers - 7
Injuries:	Crew - None	Passengers - None
Nature of Damage:	None	
Commander's Licence:	Commercial Pilot's Licence	
Commander's Age:	34 years	
Commander's Flying Experience:	3,600 hours (of which 2,000 were on type) Last 90 days - 13 hours Last 28 days - 13 hours	
Information Source:	AAIB Field Investigation

Synopsis

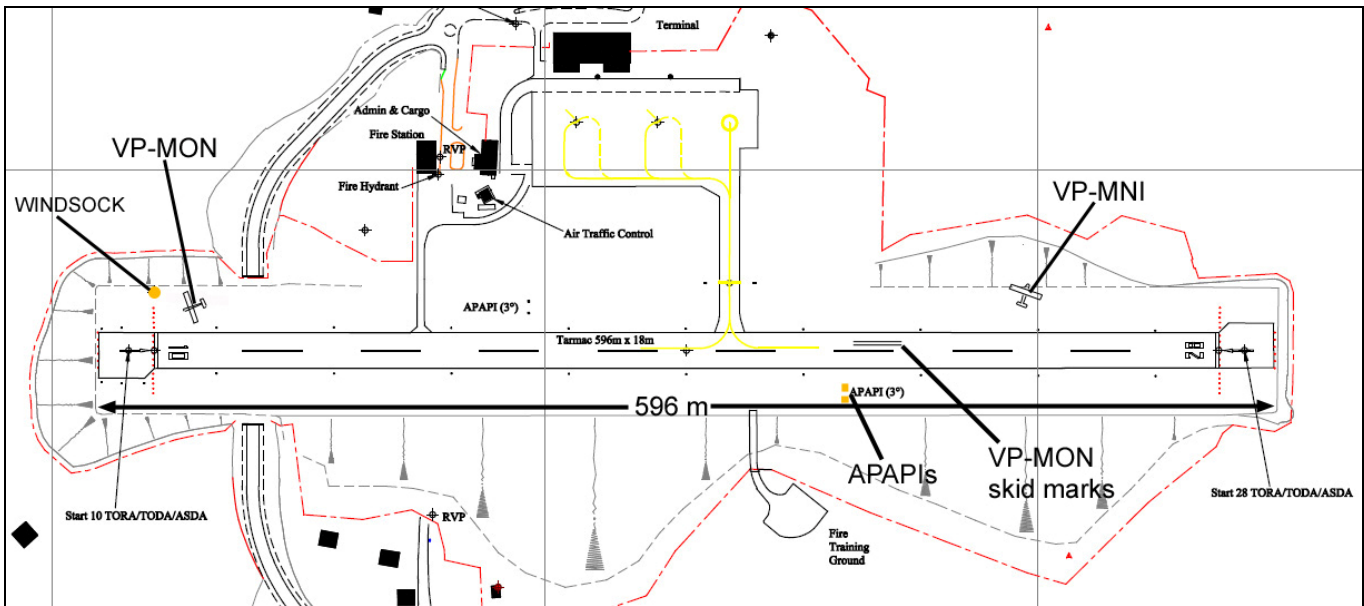
There are no overrun areas on either runway. At the end of each runway is a steep drop in excess of 200 ft. See Figure 2 for a diagram of the airfield.

Aerodrome chart showing the post-incident location of VP-MON and the location of VP-MNI following its runway excursion accident on 17 April 2011

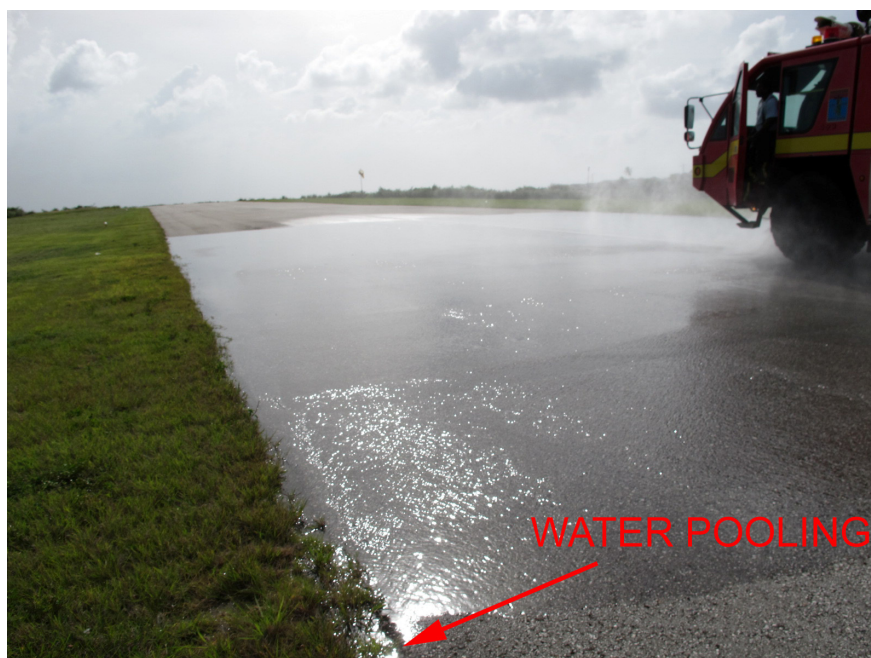
Figure 3

The runway surface consisted of un-grooved asphalt and it was cambered to assist water drainage to the sides. A fire truck was used to spray water on the runway surface which revealed that the water drained to the sides of the runway, but there was some pooling of water at the runway edges where the surface joined the grass (Figure 3). Some runways at other airports have carrier drains, sometimes consisting of stone aggregate, between the runway surface and the grass surface which aids drainage.

Water sprayed onto the runway surface revealed some pooling at the edges

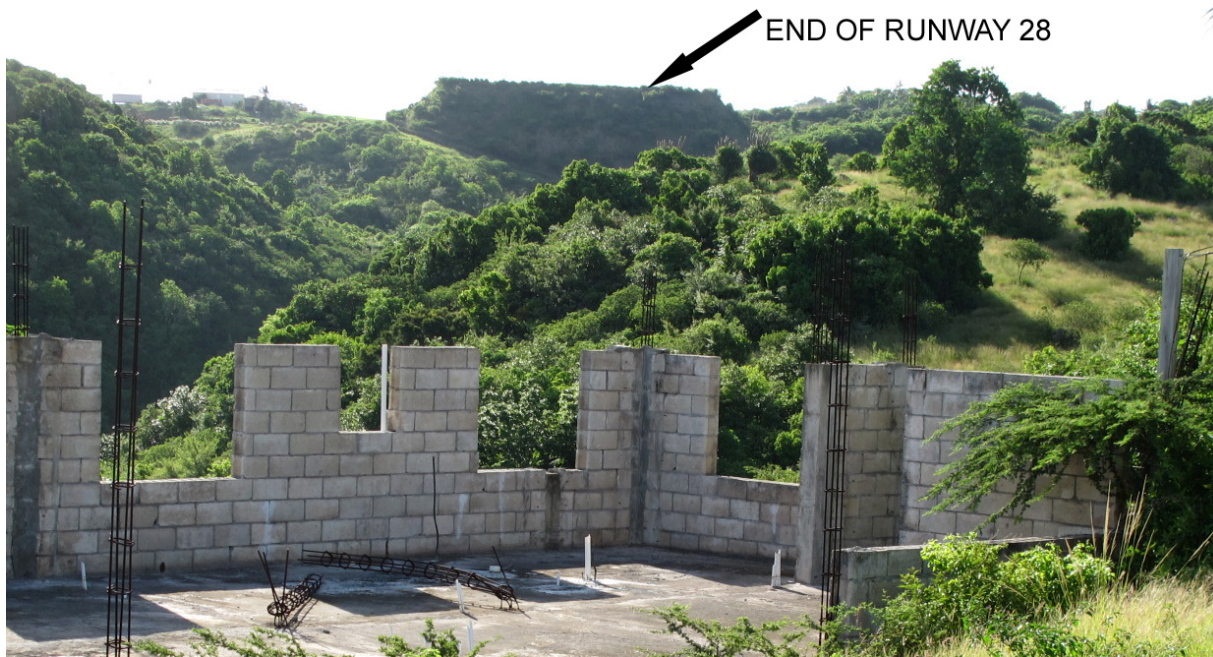
Figure 5

View looking south-east at the end of Runway 28. VP-MON came to rest 46 m from this end.

VP-MON came to rest 46 m from the end of the paved surface of Runway 28, beyond which is a steep drop, and 11 m from the edge of the steep drop on the northern side of the runway. When landing on Runway 10 the options for preventing a runway over-run are to veer to the left into a steep embankment or to the right into a ditch followed by a steep embankment. Although the runway environment is compliant with the minimum specifications in ICAO Annex 14, there are significant hazards associated with an aircraft departing the ends or the sides of the runway. In light of the incidents to VP-MON and VP-MNI the airport operator should carry out a risk assessment of the hazards associated with runway excursions as part of its Safety Management System. Accordingly, the following Safety Recommendation is made:

Safety Recommendation 2012-010

It is recommended that the operator of John A Osborne Airport, Montserrat, carry out a risk assessment of the hazards associated with runway excursions and implement any necessary mitigating action.

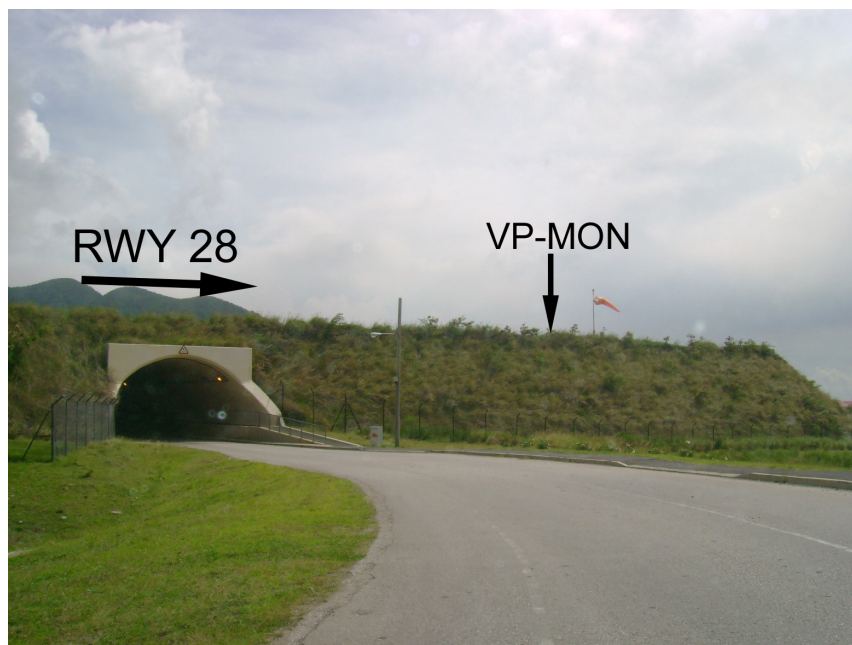
Figure 6

View looking south-west at the end of Runway 28 where VP-MON came to rest

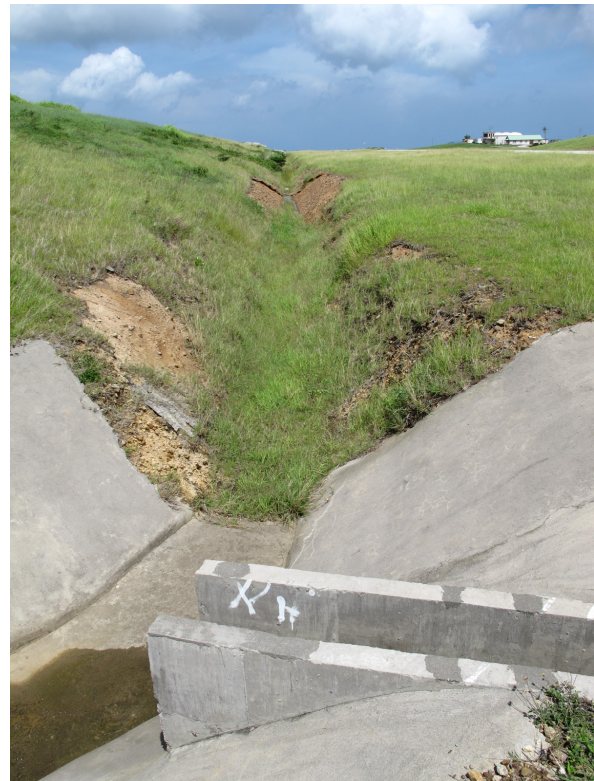
Figure 7

Towards the end of Runway 10 there are steep embankments on both sides of the runway located 23 m from the runway edge (Figure 2 and 10). The gradients of these embankments are within ICAO limits, but would cause damage to an aircraft hitting them at speed as in the case of the VP-MNI incident described later in this report. Along the southern edge of the runway there is also a ditch where the flat area of grass meets the southern embankment (Figure 7). The ditch, which serves as a drain and is about 4 feet deep,

would cause damage to an aircraft hitting it at speed, but it is just outside the 30 m wide designated area and therefore in compliance with Annex 14. There is also a drain along the northern side of the runway, but it has been filled with earth and does not present a hazard to aircraft.

Ditch serving as a drain along the south side of the runway

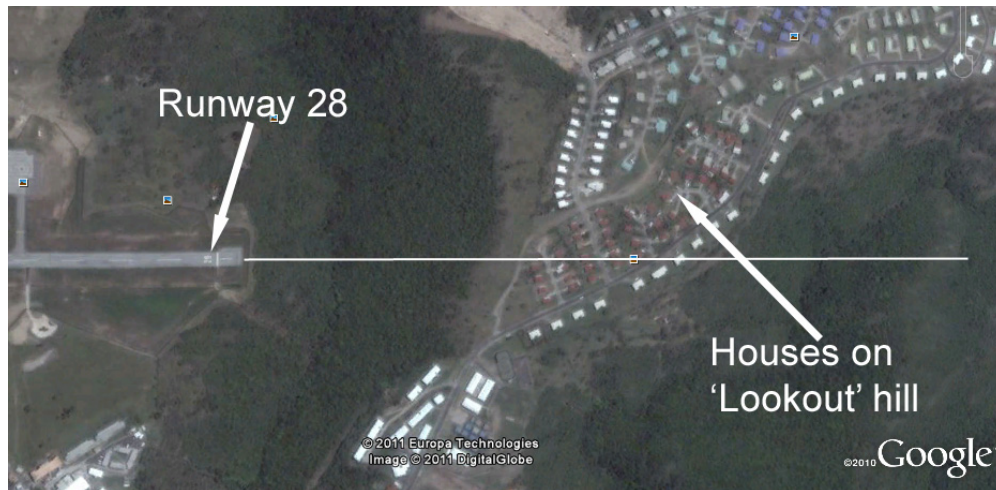
Figure 8

Below the approach area to Runway 28 there is a housing development on a hill called ‘Lookout’ located between 380 m and 650 m from the Runway 28 threshold (Figure 8). Its summit is approximately 40 to 50 ft above the runway. An aerodrome obstruction survey carried out in April 2009 revealed that there was a palm tree located on ‘Lookout’ which infringed the ICAO Annex 14 defined ‘Approach surface’ for a Code 1 airport. The ‘Approach surface’ is defined as an area extending from 30 m before the runway threshold out to 1600 m. According to ICAO no obstacle is

permitted within a 5% gradient (2.86°) of this surface extending up from 30 m before the runway threshold. The palm tree penetrated this by 9 ft. In the two years since this survey was carried out the palm tree has grown and now penetrates this surface by a greater, as yet undetermined, amount.

Aerial view of approach area to Runway 28

Safety Recommendation 2012-011

It is recommended that the operator of John A Osborne Airport, Montserrat, remove the obstacles that infringe the ICAO Annex 14 'Aerodrome Design and Operations' takeoff and approach surfaces.

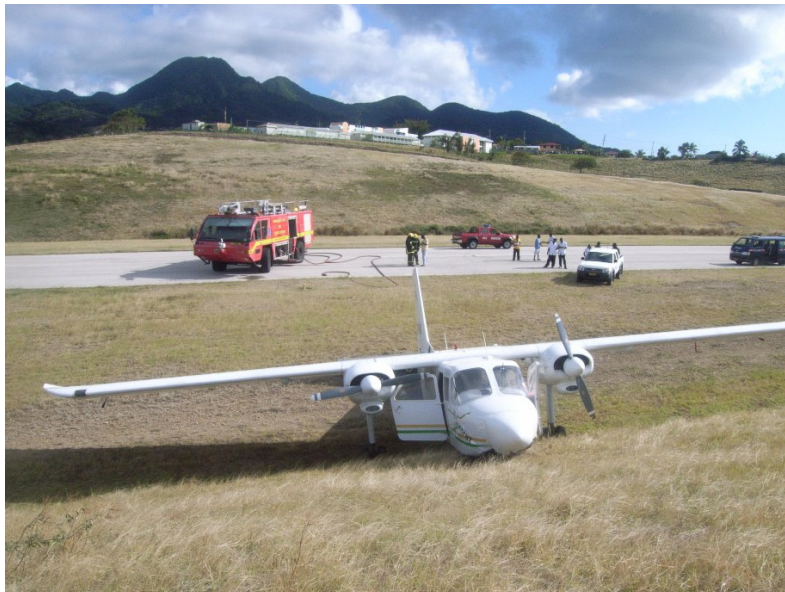
Figure 10

Northern embankment near the end of Runway 10 where VP-MNI came to rest (southern embankment visible in the distance)
