ACCIDENT

Aircraft Type and Registration:	Cessna F150L, G-BABB	
No & Type of Engines:	1 Teledyne Continental O-200-A piston engine	
Year of Manufacture:	1972	
Date & Time (UTC):	19 July 2006 at 1530 hrs	
Location:	Eastwood Park, Southend on Sea, Essex	
Type of Flight:	Training	
Persons on Board:	Crew - 1	Passengers - None
Injuries:	Crew - 1 (Fatal)	Passengers - N/A
Nature of Damage:	Aircraft destroyed	
Commander's Licence:	Student pilot	
Commander's Age:	16 years	
Commander's Flying Experience:	15 hours (all of which were on type) Last 90 days - 7 hours Last 28 days - 4 hours	
Information Source:	AAIB Field Investigation

Synopsis

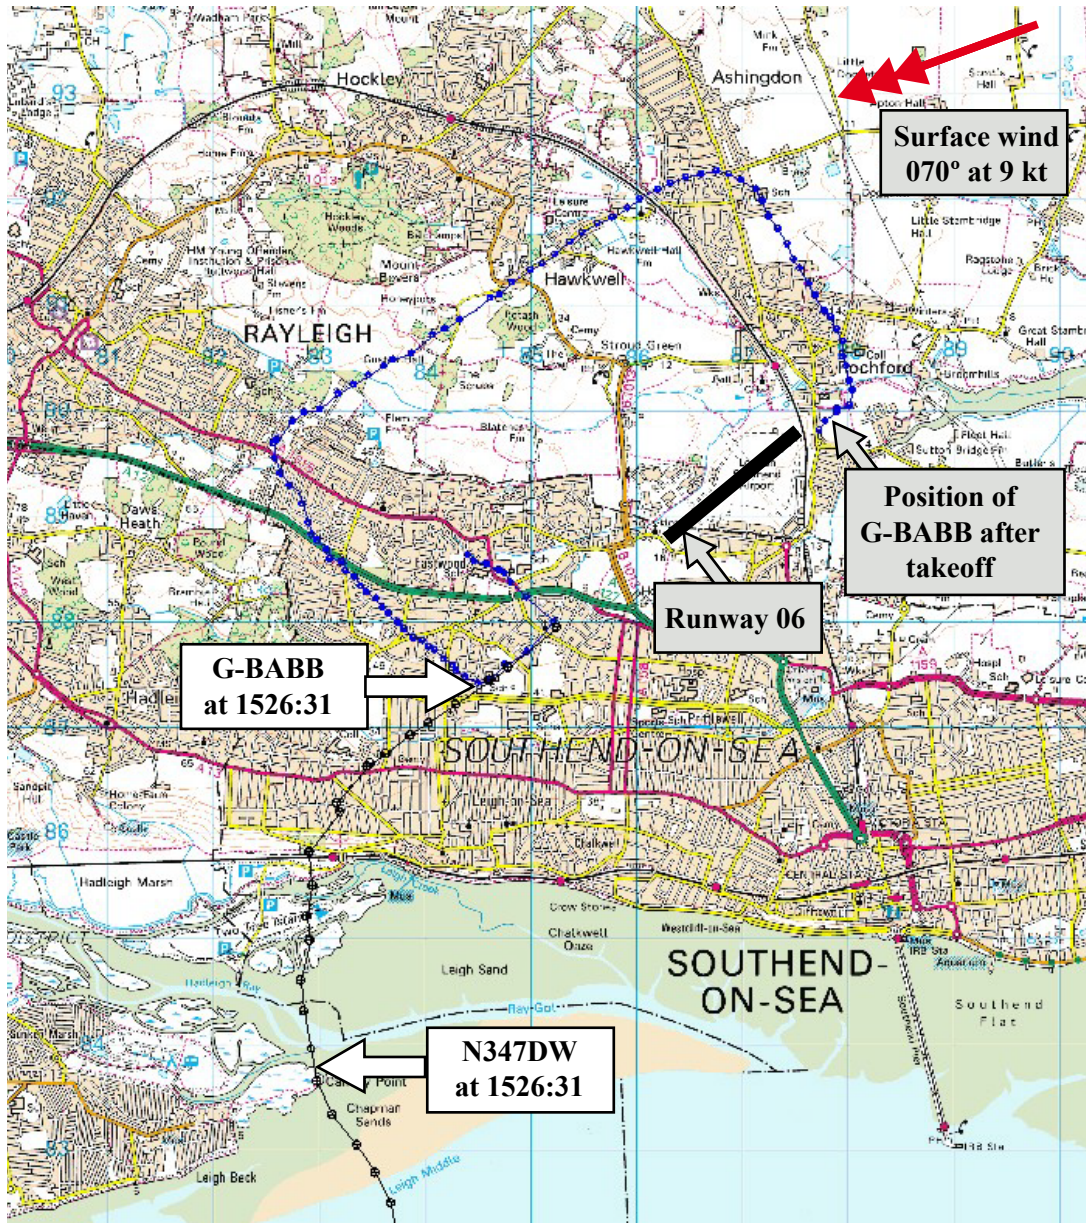
Figure 1

At 1526:30 hrs the student reported on final; the positions of the two aircraft when the student pilot reported on final approach is shown in Figure 1. The ADC replied “GOLF BRAVO BRAVO ROGER AND ER MAINTAIN RUNWAY CENTRELINE BUT GO AROUND ER CIRCUIT HEIGHT ONE THOUSAND FEET THERE’S FAST TRAFFIC BEHIND TO LAND”. The student replied “BRAVO BRAVO MAINTAIN CENTRELINE”. At this stage the ADC was concerned that N347DW’s high speed might result in it having to go-around beneath G-BABB, a situation he considered dangerous and which he intended to resolve before it could occur. Consequently the ADC replied “ER GOLF BRAVO BRAVO DISREGARD THAT JUST TAKE A LEFT TURN AND FLY NORTH I’LL CALL YOU BACK IN VERY SHORTLY”. At that moment the

Locations and tracks of G-BABB and N347DW at 1526:31 hrs

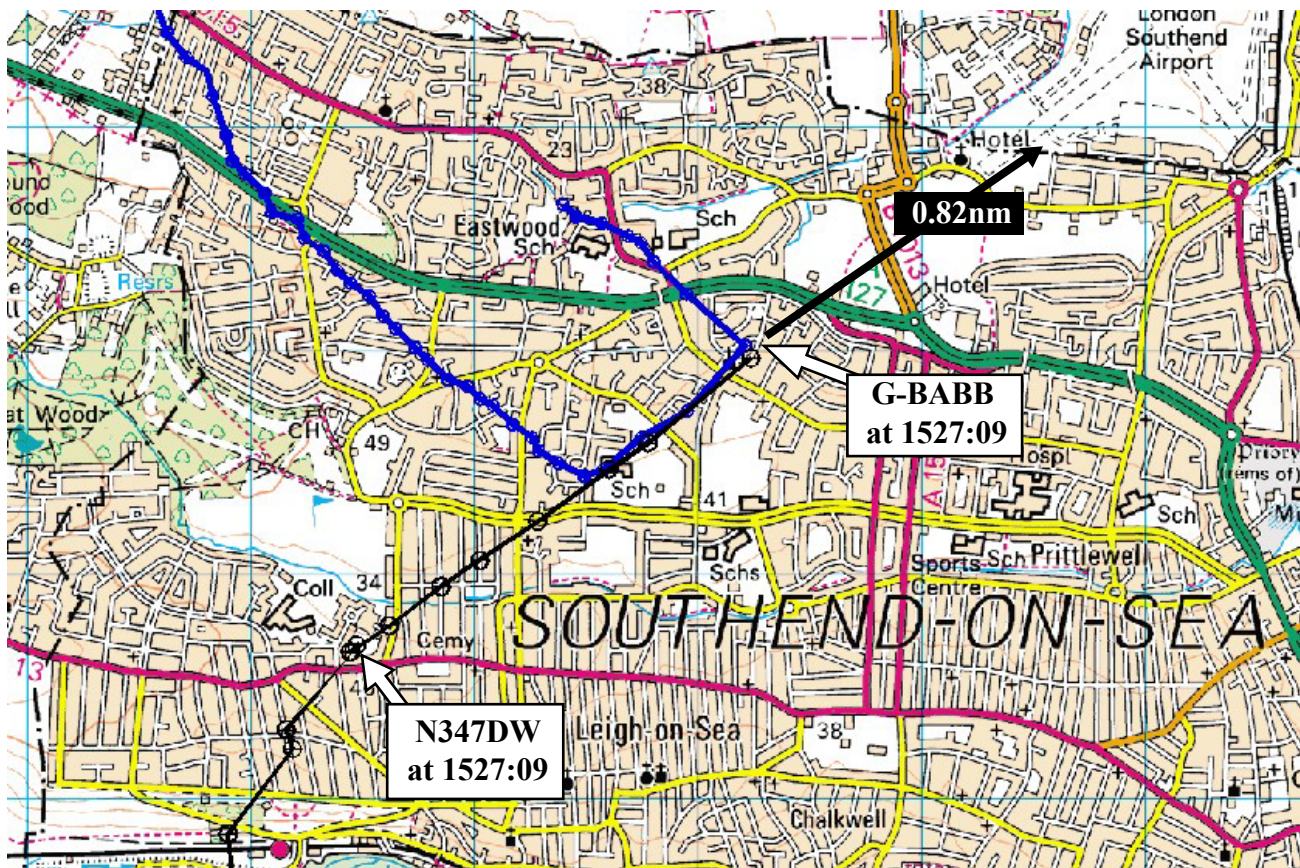
the time of the instruction to turn north which reduces the resolution of this position. After the instruction to turn north there were seven further recorded points which showed G-BABB tracking north-west. Due to the tolerances of the radar recording system, it was not possible to calculate an accurate instantaneous groundspeed towards the end of this flight. However, after applying the surface wind reported to N347DW of 070°/09 kt to the radar derived groundspeeds, the aircraft’s average true airspeed on final approach was 69 mph (60 kt) whereas its average true airspeed on its north-westerly track was 54 mph (47 kt). Computations were also carried out using the aftercast 500 ft mean wind of 120°/12 kt; these produced likely average speeds of 67 mph (58 kt) on final approach and 46 mph (40 kt) on the north-westerly track.

Figure 2
Locations of G-BABB and N347DW at 1527:09 hrs
