**ACCIDENT**

<b>Aircraft Type and Registration:</b>	DH82A Tiger Moth, G-AOIL	
<b>No &amp; Type of Engines:</b>	1 De Havilland Gipsy Major I piston engine	
<b>Year of Manufacture:</b>	1940	
<b>Date &amp; Time (UTC):</b>	15 May 2011 at 1408 hrs	
<b>Location:</b>	Near Witchampton, Dorset	
<b>Type of Flight:</b>	Private	
<b>Persons on Board:</b>	Crew - 1	Passengers - 1
<b>Injuries:</b>	Crew - 1 (Serious)	Passengers - 1 (Fatal)
<b>Nature of Damage:</b>	Aircraft destroyed	
<b>Commander's Licence:</b>	Private Pilot's Licence	
<b>Commander's Age:</b>	44 years	
<b>Commander's Flying Experience:</b>	210 hours (of which 41 were on type) Last 90 days - 3 hours Last 28 days - 2 hours	
<b>Information Source:</b>	AAIB Field Investigation

**Synopsis**

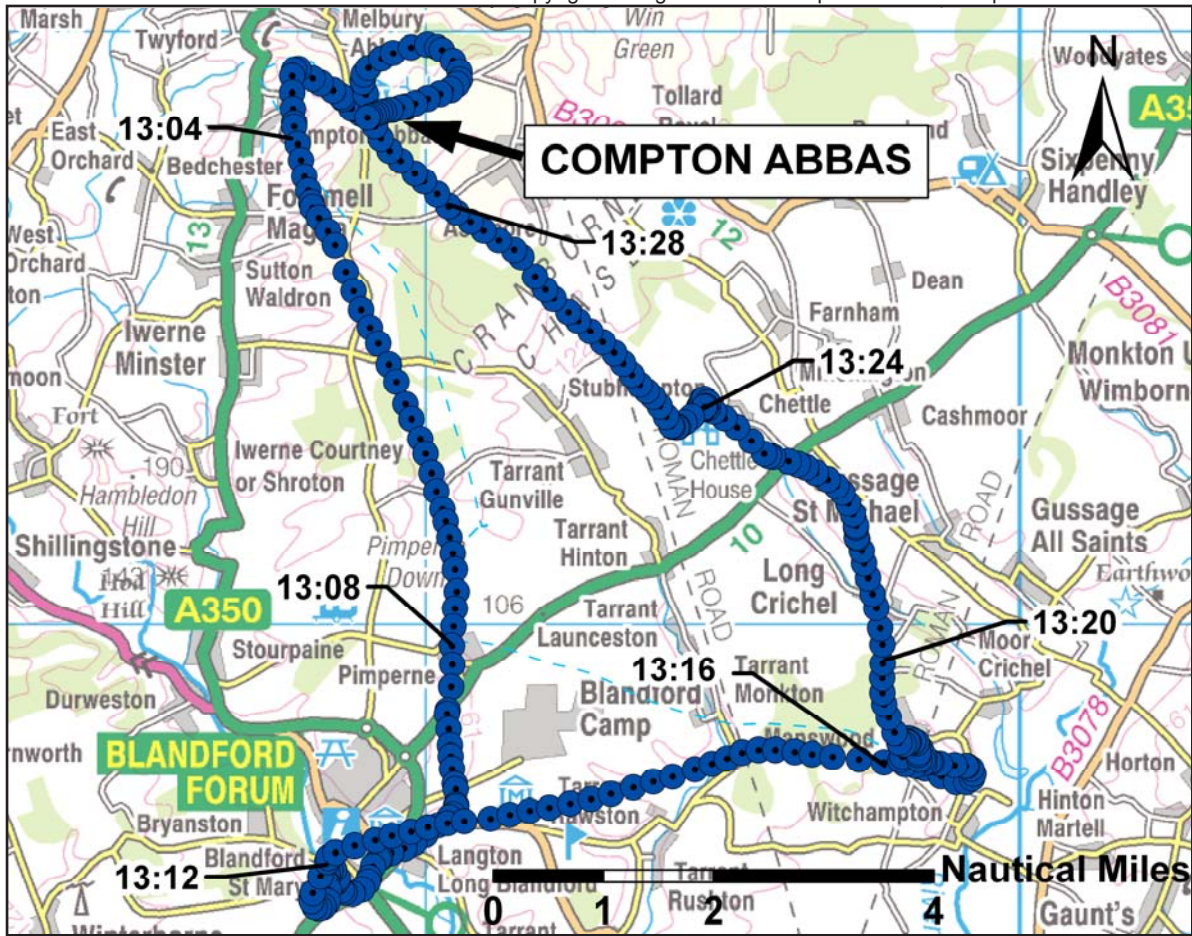
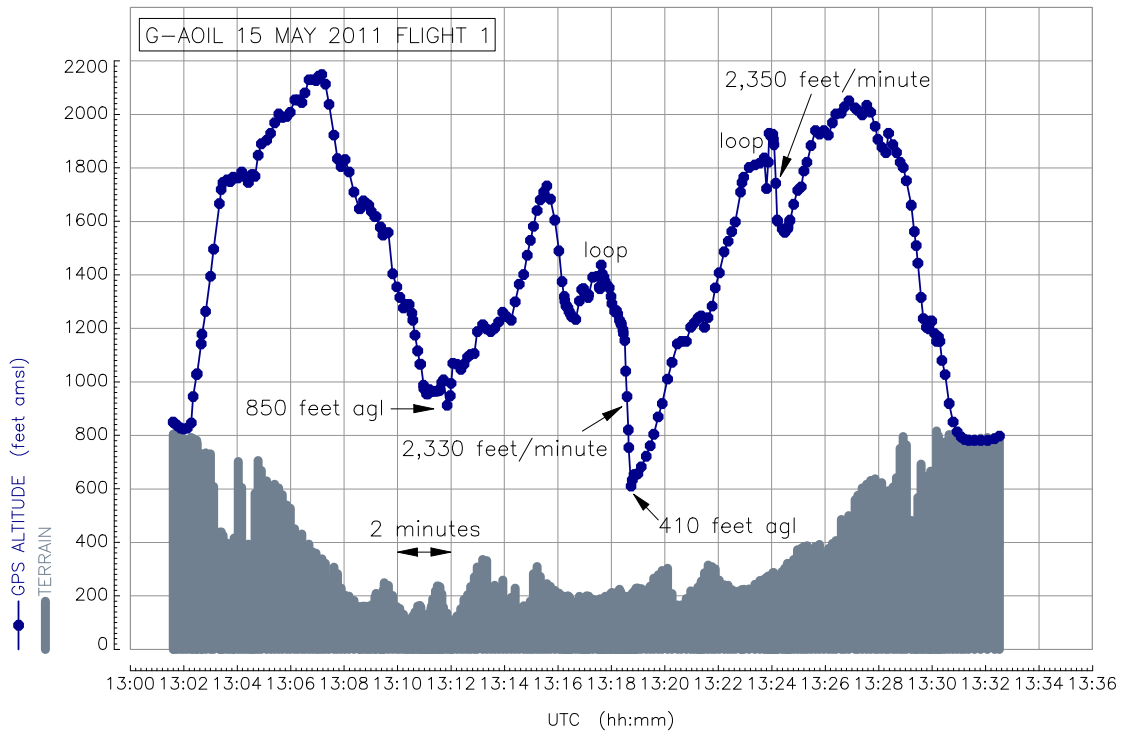
Figure 1

The first recorded flight was a local flight from Compton Abbas with a duration of 31 minutes. (Figure 1 depicts the ground track and altitude trace). Indicated on the altitude trace are significant points in the flight in terms of minimum altitude, descent rates and manoeuvres, as well as the height of the ground below the aircraft. Of note was the minimum altitude of 850 ft agl close to the town of Blandford Forum, some tight level turns, and a loop at about 1,200 ft agl followed by a descending turn to the right at 2,330 ft/min, from 1,000 ft agl down to a height of 410 ft agl, near Witchampton. This loop was performed on a north-westerly heading, into the prevailing wind, and was started within 20 m of the position of the subsequent accident site. Further on, near Chettle House, there was a second loop at about 1,600 ft agl, followed by an immediate right descending turn of 300 ft at 2,350 ft/min. The maximum recorded altitude during the flight was 2,150 ft amsl.

GPS track and altitude data for first flight of G-AOIL on 15 May 2011

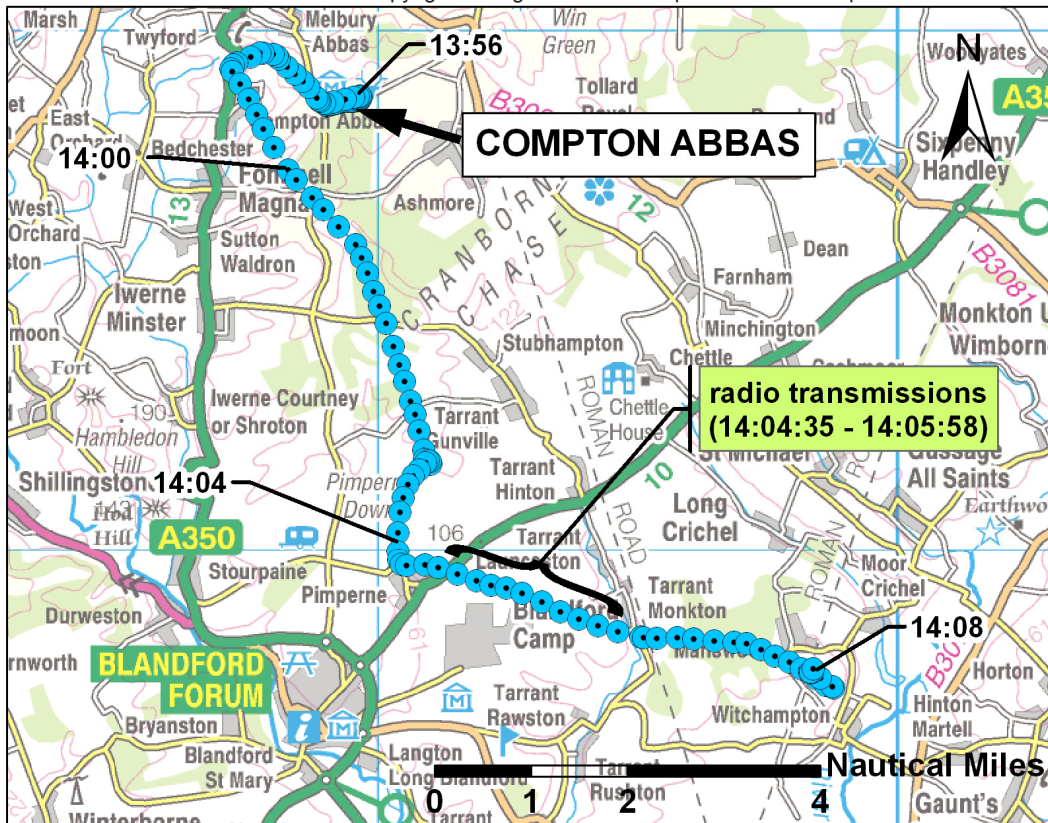
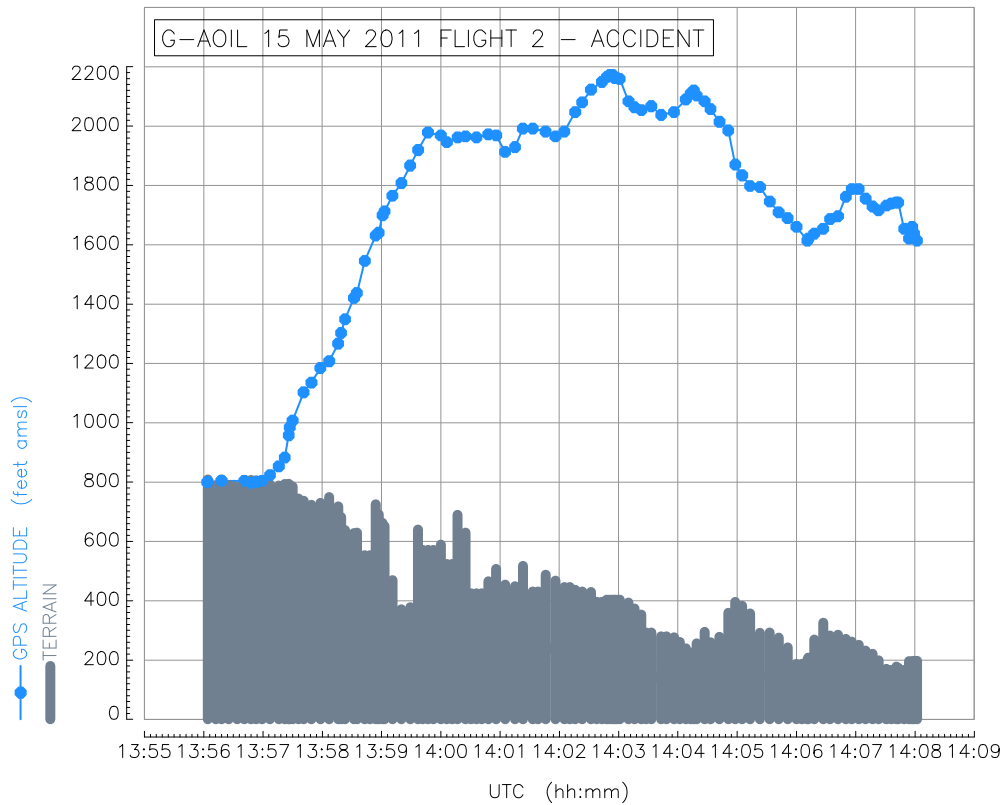
Figure 2 shows the ground track and altitude trace for the accident flight. The track again heads south south-westerly with the aircraft climbing to, and levelling off at, 2,000 ft amsl for two minutes. It then climbs to 2,170 ft amsl (the maximum recorded altitude for the flight), before descending and climbing a little as it turned onto a southerly track, followed by a left turn towards Bournemouth Airport. The aircraft then descended to 1,610 ft amsl, during which time the pilot was in contact with Bournemouth Radar. Over the next 100 seconds the aircraft made a series of short

GPS track and altitude data for accident flight of G-AOIL on 15 May 2011

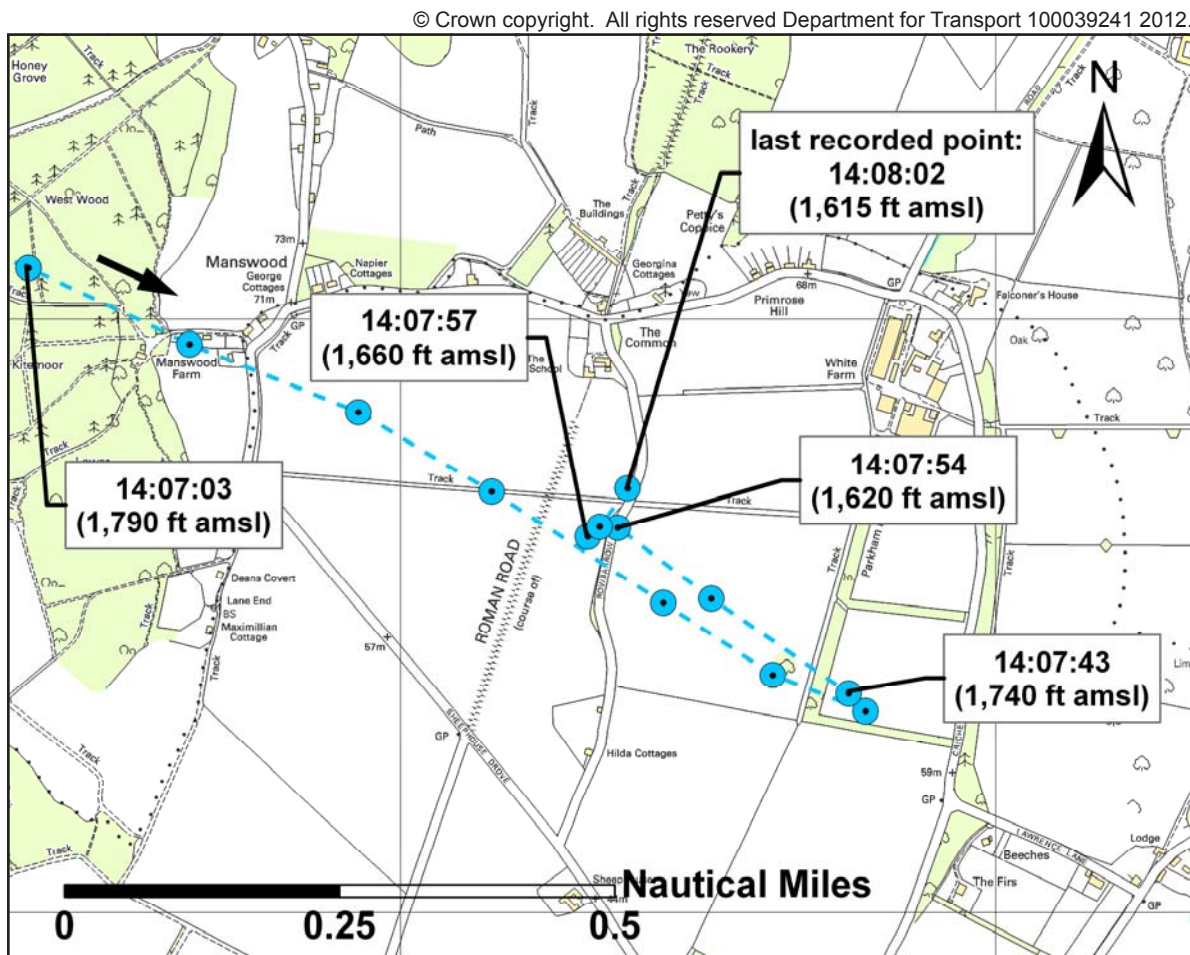
climbs and descents before turning left through 180° in the vicinity of Witchampton. This portion of the flight is illustrated in Figure 3 and shows the aircraft, after the turn, descending 120 ft over a distance of about 0.25 nm. The forward movement then stops and the aircraft climbs 40 ft to a point left of track 3 seconds later before descending 45 ft in the opposite direction to a point about 1,400 ft agl over 5 seconds. This was the last recorded point on the GPS. The absence of any further recording was probably due to the recording algorithm calculating that the horizontal position of the

aircraft relative to the ground (ie ignoring height) had not changed sufficiently; lack of satellite reception is unlikely but could not be ruled out.

**Figure 3**  
GPS track for the last one minute of the accident flight
